Forensic evaluation of pavement failure Using GPR and UAV technology

Vahid Ganji, Ph.D., P.E.

Pavement Department Manager, Michael Baker International

NJDOT Research Showcase 2019

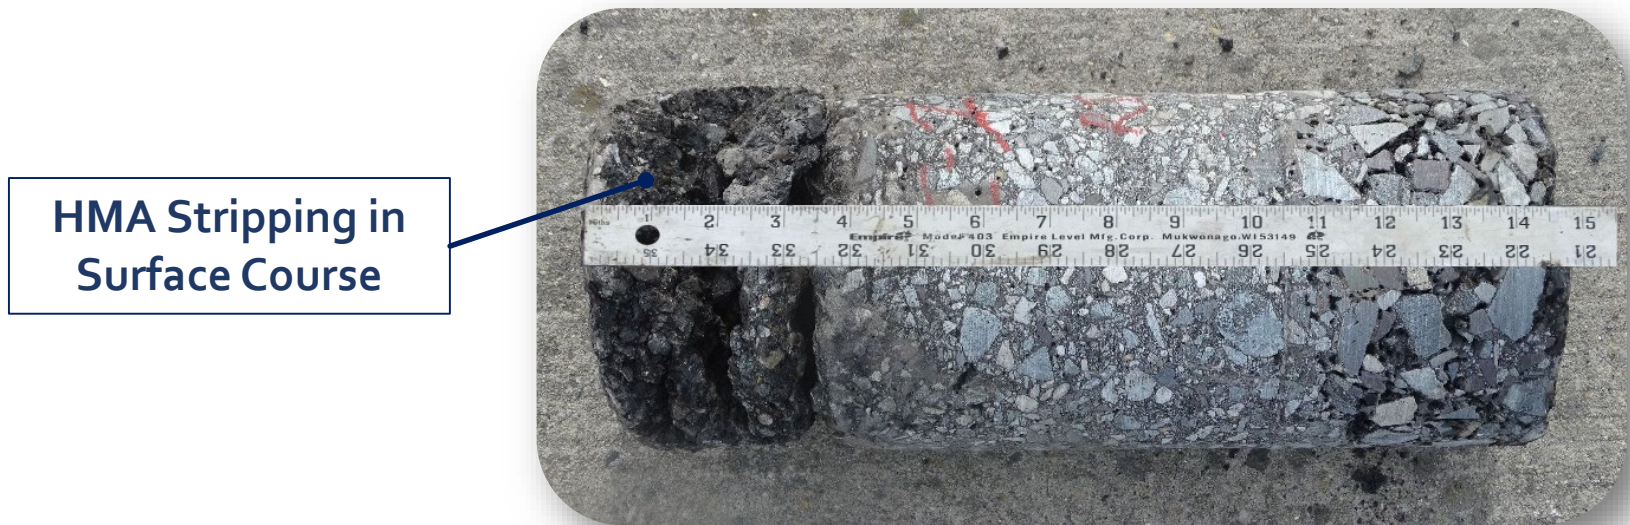
Core 1 (Failed area)

- The core results indicated **significant stripping** of the Hot Mix Asphalt (HMA) surface course in the failed area due to prolonged presence of stagnant water on pavement.

- Seal coat the pavement that was placed circa 2012 between Stations 103+90 to 109+90 (600') to delay further raveling and loss of aggregates.
- Remove the surface course in the failed pavement area to a depth of 4" and replace with a binder rich mix that can resist HMA stripping better. Use of anti-stripping agents in the mix may be considered.
- Regularly remove the deposited aggregates to allow for free flow of surface run-off water and avoid ponding potential.

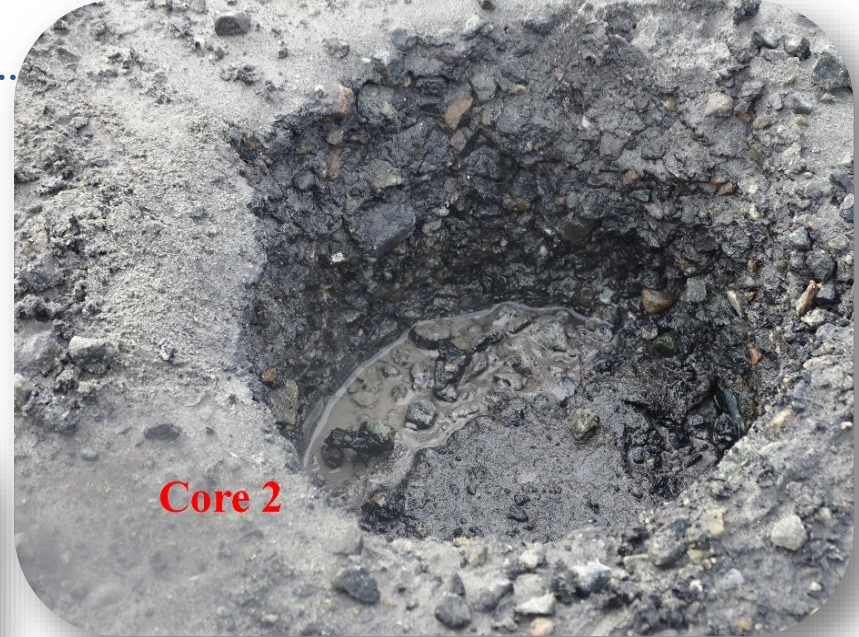
Core 2 (Failed Area; **Severe HMA Stripping**)

HMA Stripping in
Surface Course

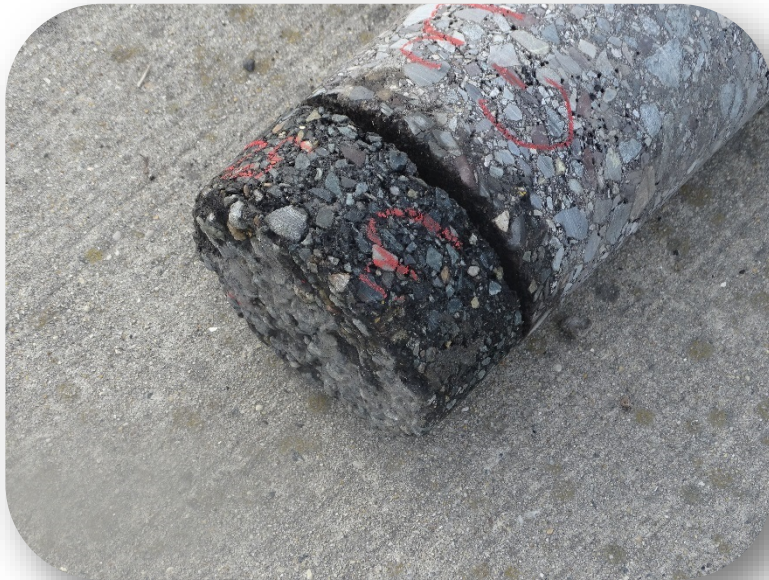
Core 3 (Slight HMA Stripping)

- The HMA stripping was **less severe** further from the failed area.
- Failed pavement area has been subjected to **prolonged presence of stagnant water** that intensifies HMA stripping.

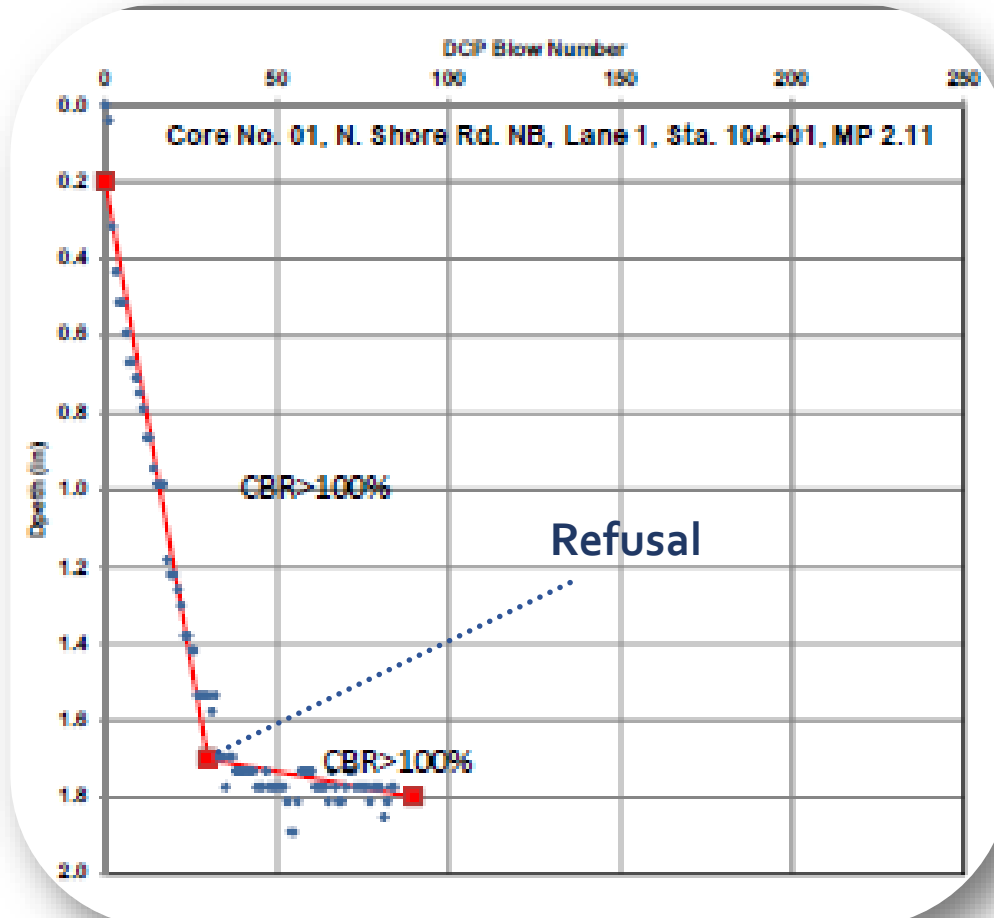
- DCP Testing Indicated a Strong Pavement Base (CBR>100%)

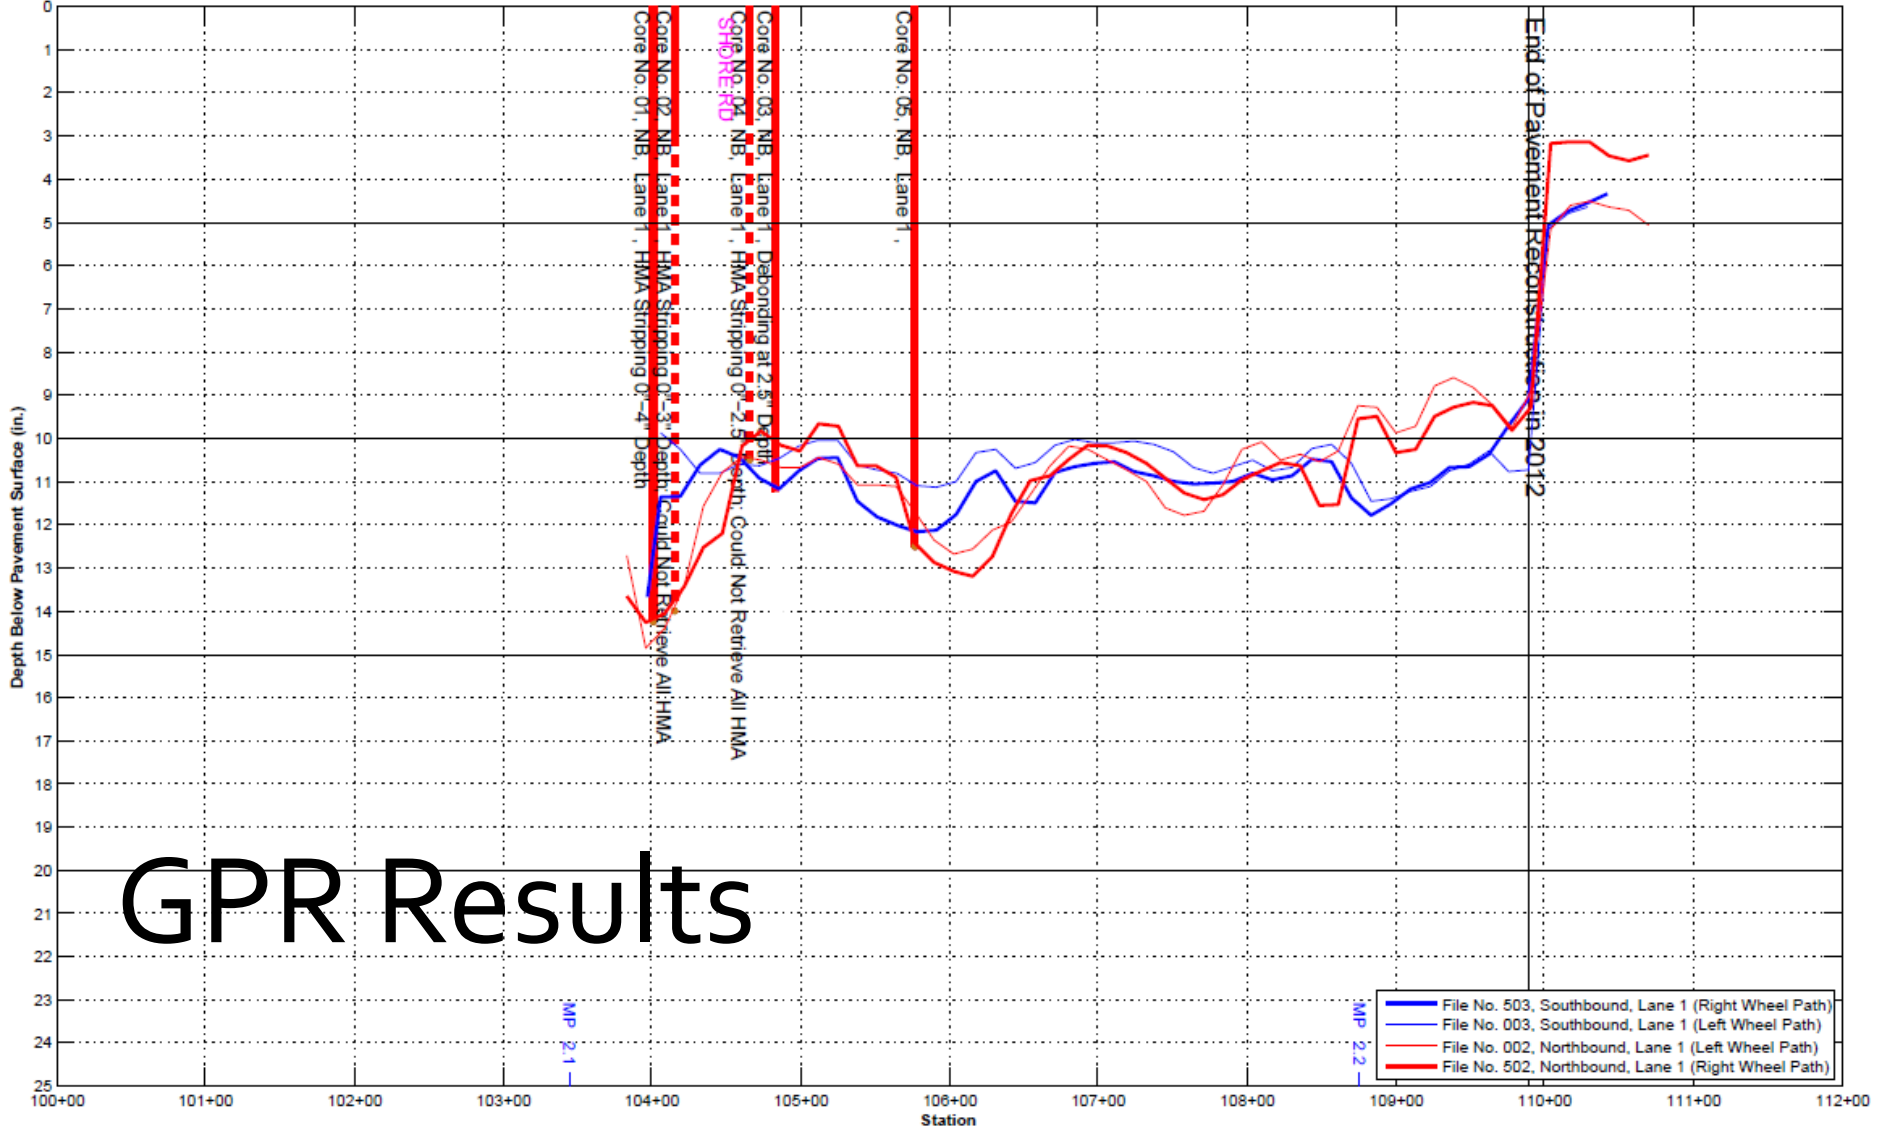
HMA Thickness for Route 52 MP 2.11 (Both Directions)

- Five (5) core samples were extracted from the pavement.
- DCP testing was conducted for three (3) of the cores.
- Based on the core and GPR results, the pavement AC thickness varies from 9" to 14" (average 10").
- The aggregate base layer appears to have been stabilized and DCP could not penetrate indicating California Bearing Ratio (CBR) values more than 100%.
- The relatively thick pavement, strong aggregate base layer, and light traffic indicate that the pavement is structurally adequate. Hence, the cause of the pavement failure is not the structural capacity of the pavement.

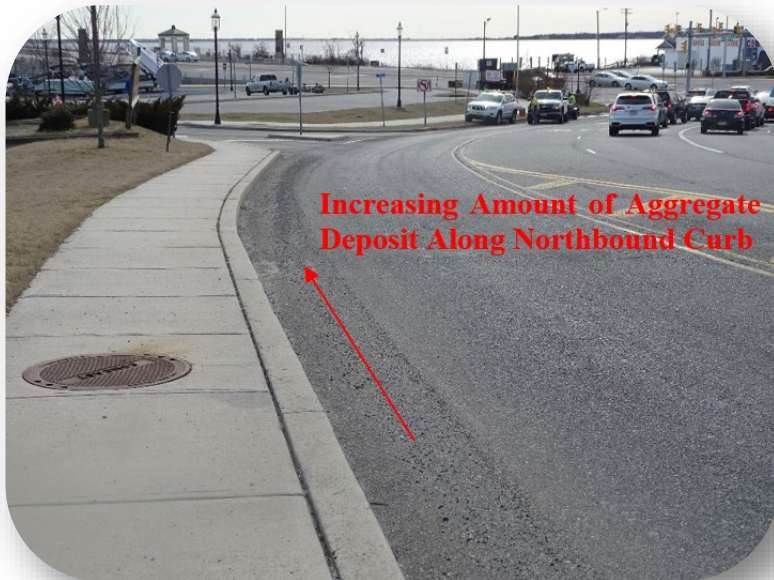
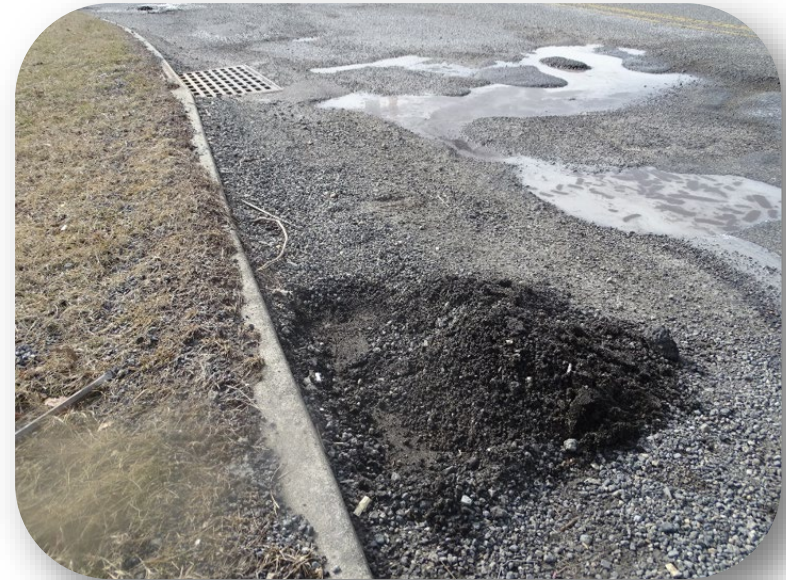
- considerable amount of deposited aggregates observed along the northbound curb on North Shore Road.

- The increasing aggregate deposits are indicative of reduced water velocity (due to decreased slope).

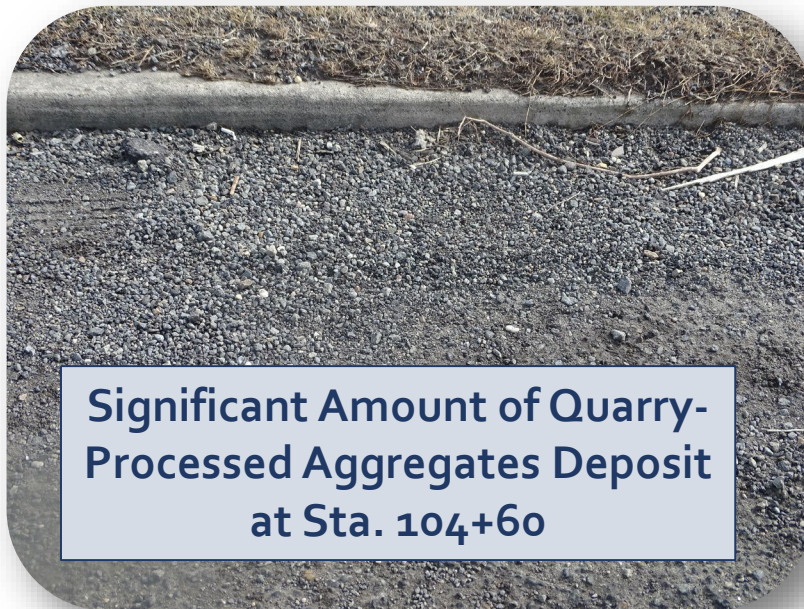
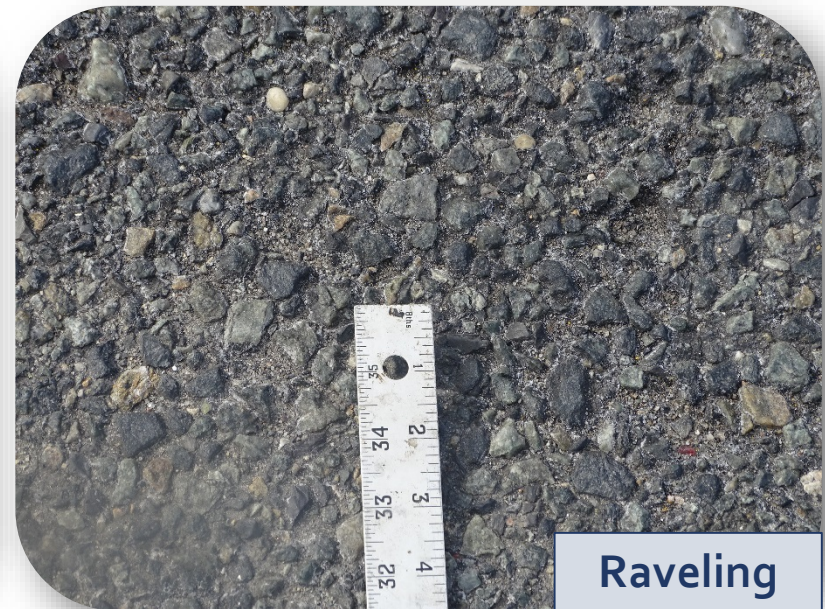
- A review of the pavement surface condition within the project area indicated that the pavement surface course placed circa 2012 shows **signs of raveling** and loss of aggregate, which can be the source of quarry processed aggregates along the curb.

- Mill 3" of the pavement from the intersection of Route 52 to Sta. 109+90 to remove the raveled surface course and overlay with a binder rich surface course resistant to HMA stripping. Use of anti-stripping agents may be considered.
- Survey the area and study drainage issues.
- Use of concrete curb and gutter may be considered to better channel the surface run-off water into the inlets.

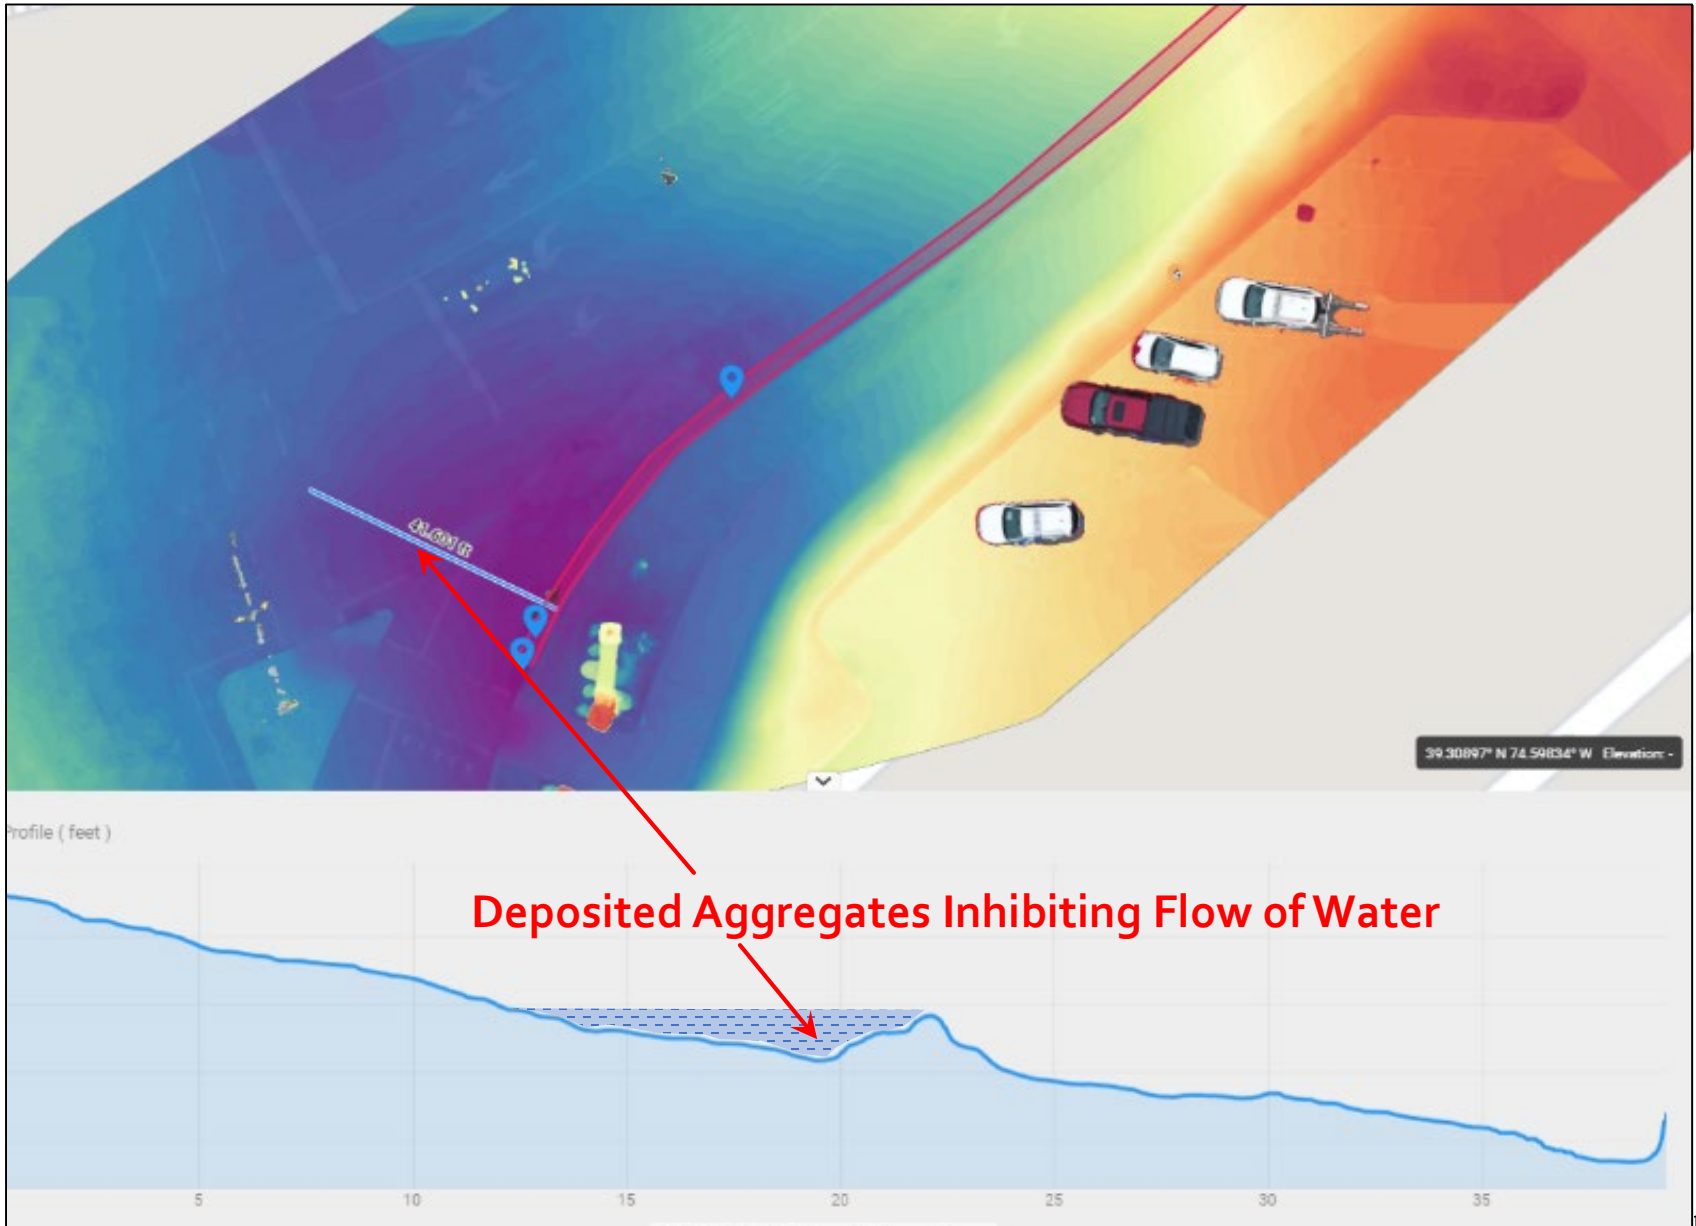
Deposited Aggregates Inhibiting Flow of Water

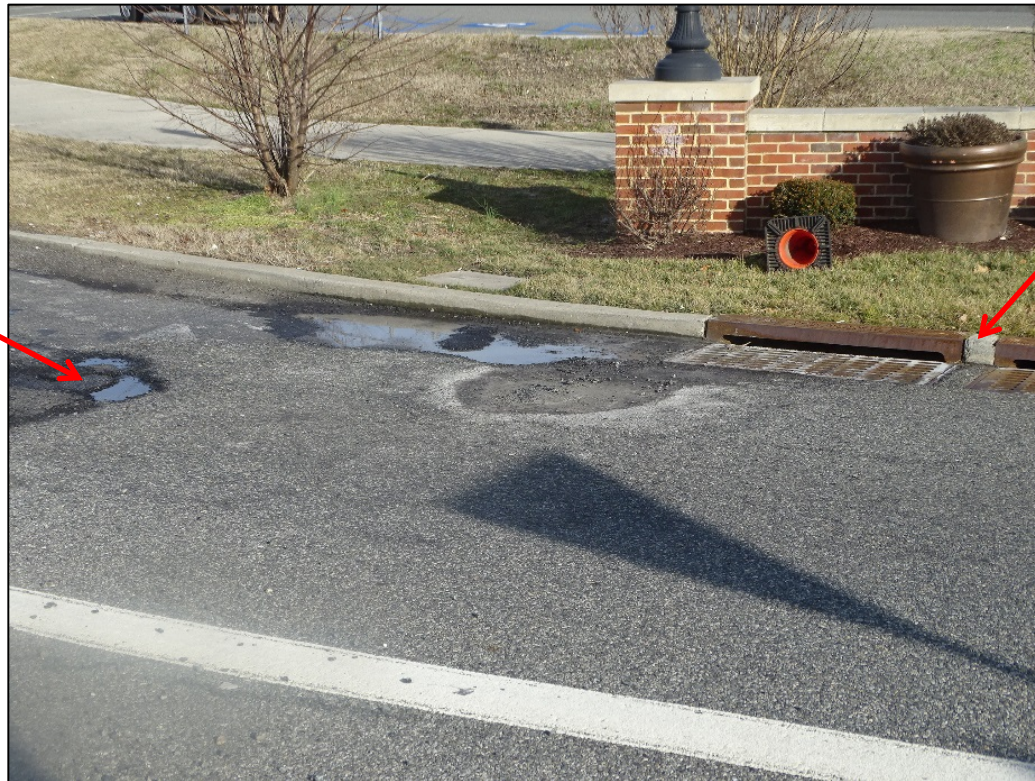
Inlets 1 and 2 Do Not Coincide with Low Point of Road

Approximate
Location of
Low Point of
Road

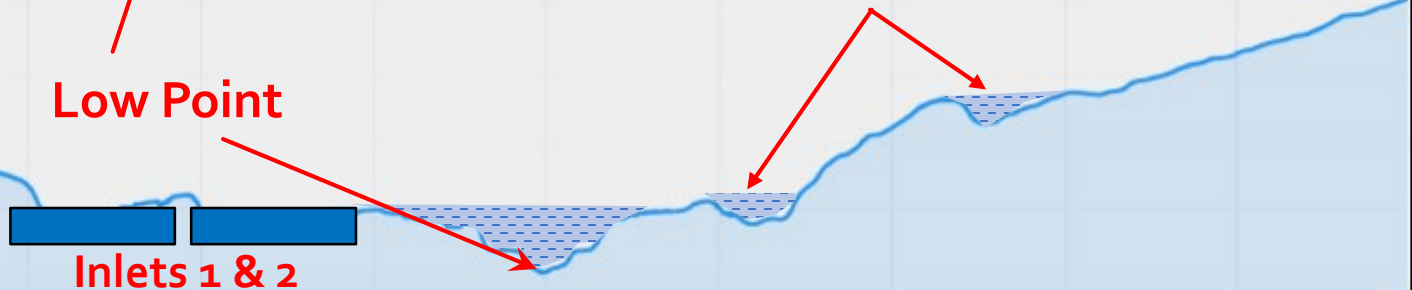
Deposited Aggregates Inhibiting Flow of Water

Low Point

Inlets 1 & 2
