Miami Pedestrian Bridge Collapse: A Computational Forensic Analysis

Anil K. Agrawal, Ph.D., P.E. and Ran Cao
The City College of New York, New York, NY

Sherif El-Tawil, Ph.D., P.E.
University of Michigan, Ann Arbor, MI

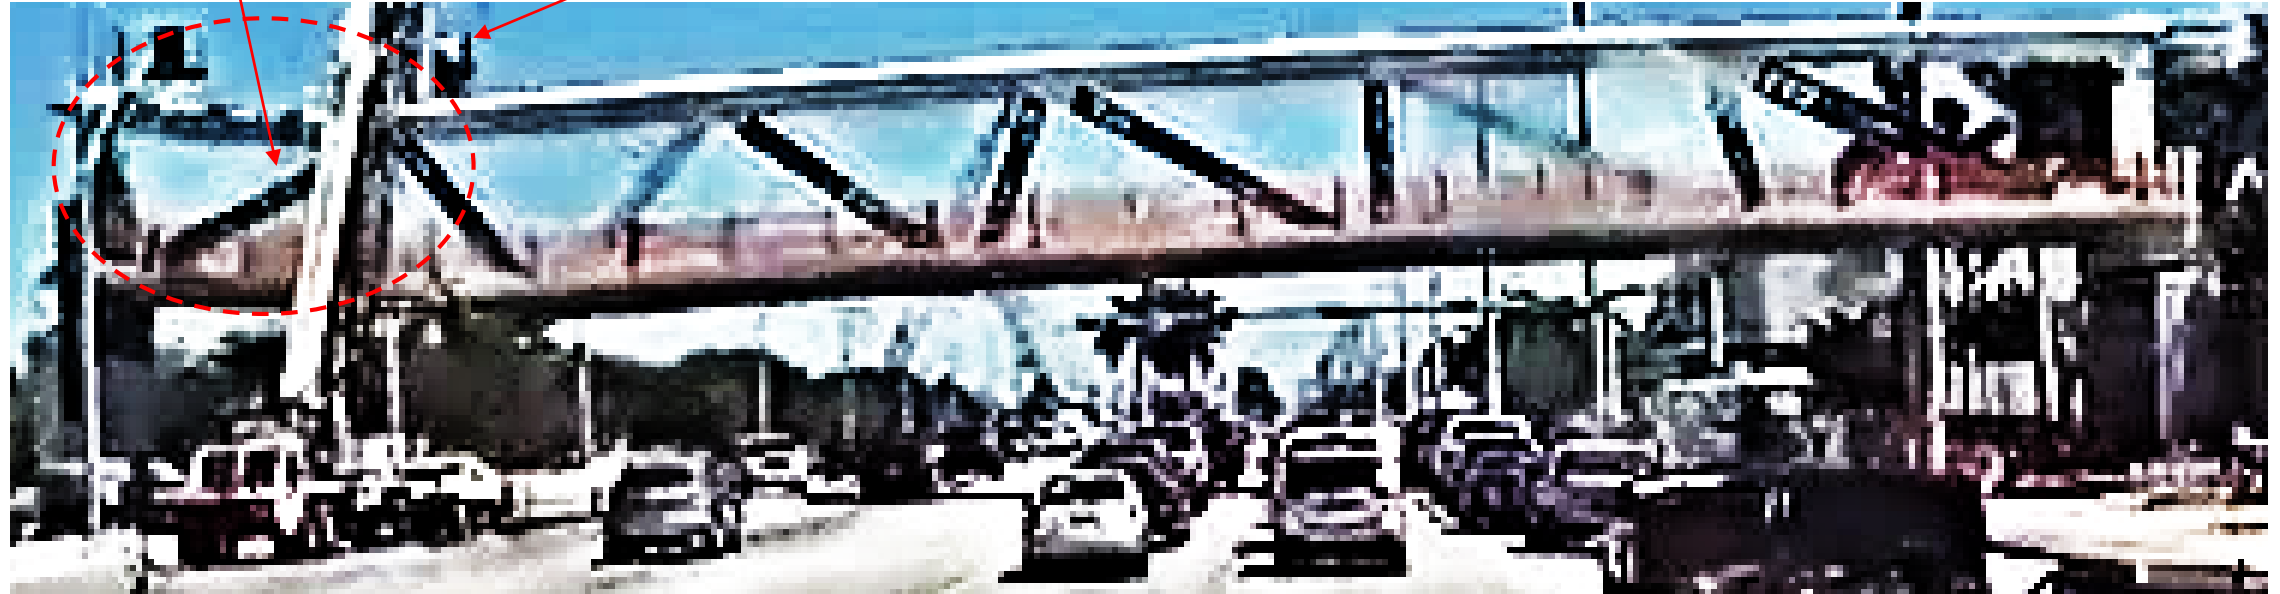
- Failure initialized

Member 11

Re-tensioning

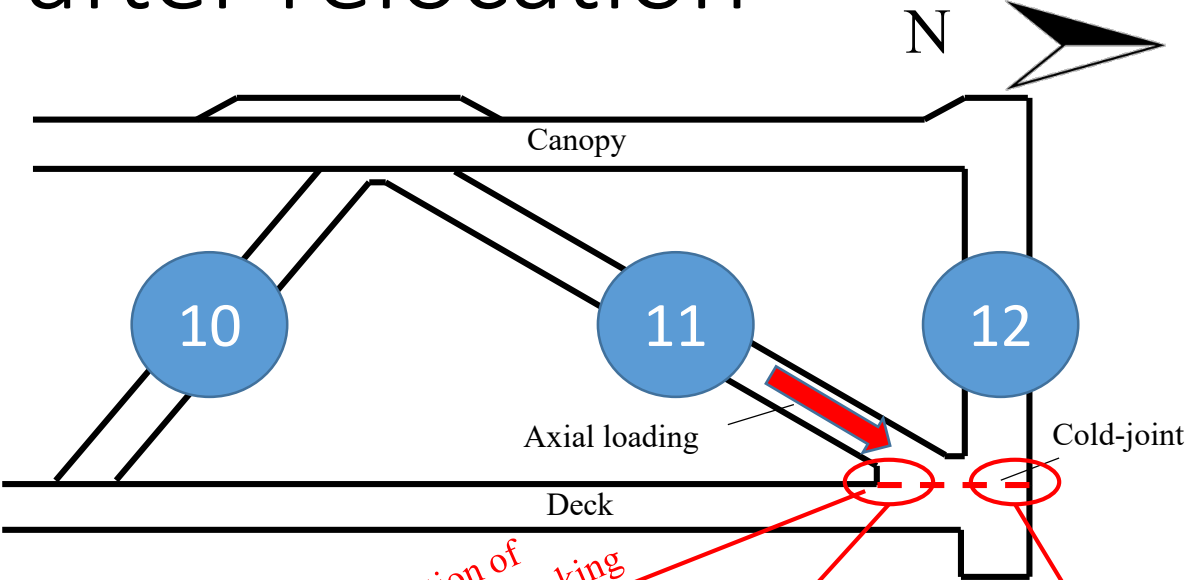
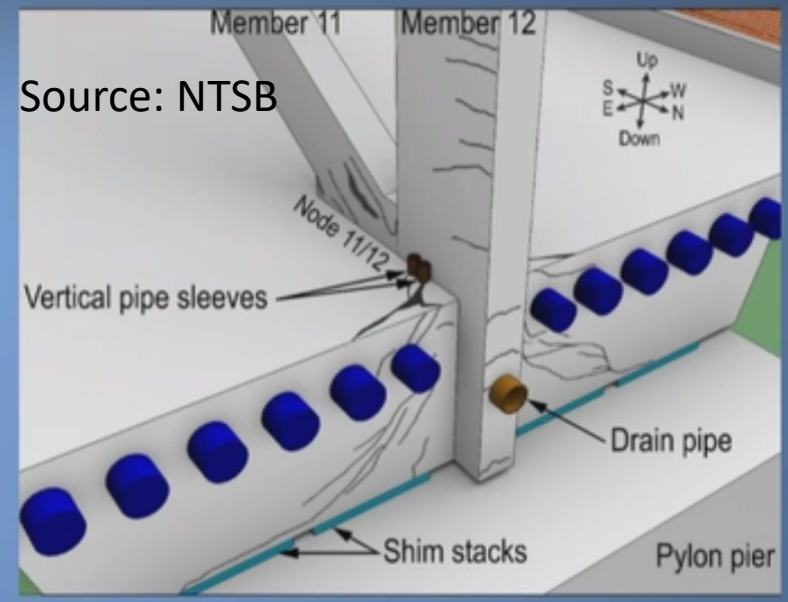
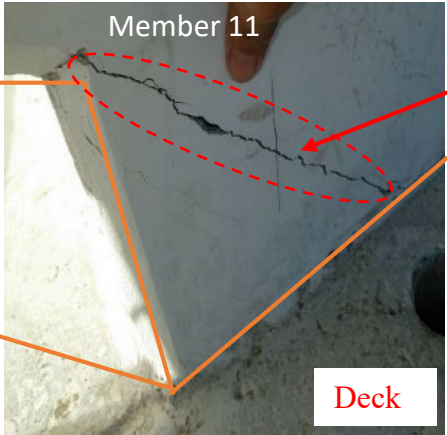
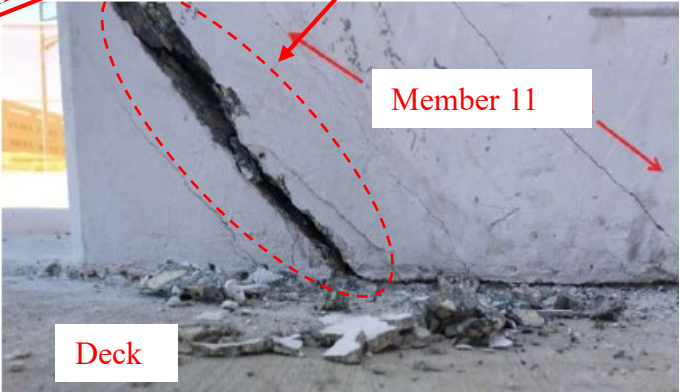
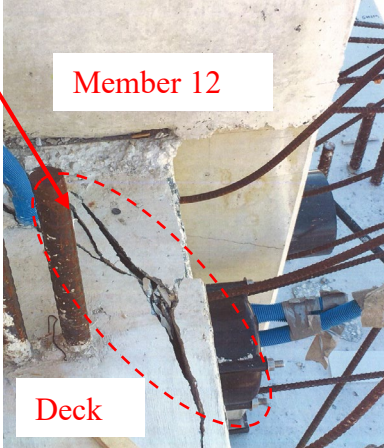
Damage mode of the cold-joint before and after relocation

Location of concrete cracking

Structural cracks in the joint area were up to 0.750 inch wide, which is **40 times wider** than typically acceptable width of the crack (0.016 inch) (NTSB report)

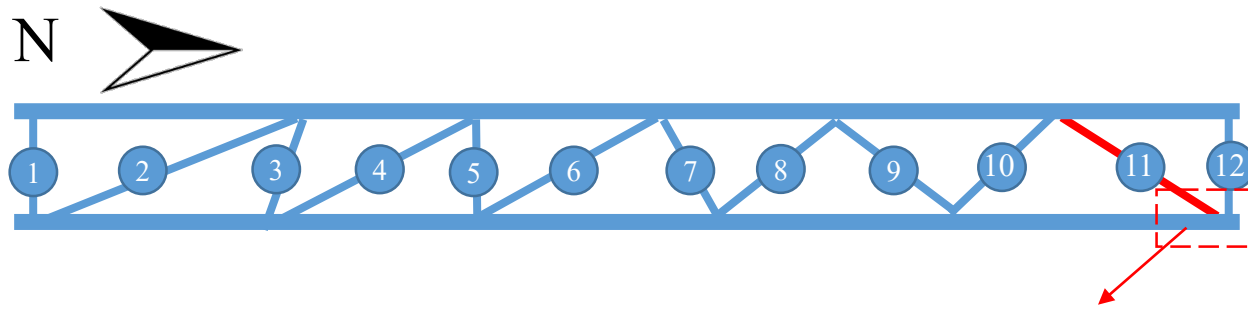
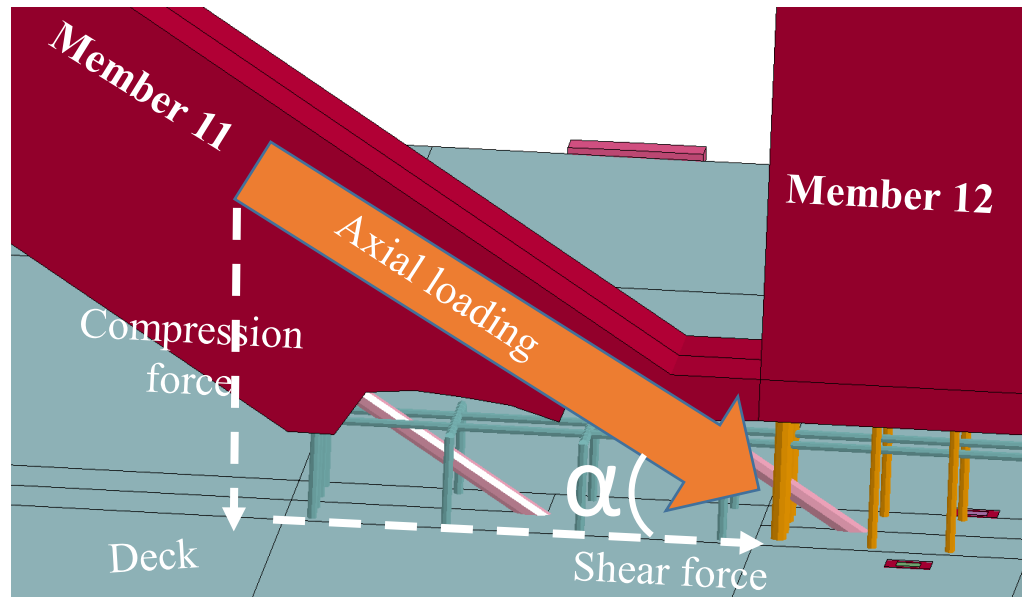
Shear Capacity of the Construction Joint

Frictional capacity

$$f = \mu(F_p + F_G) \sin \alpha$$

$$= 1.0 \times (2491 + 8205) \times \sin(31^\circ) = 5509 \text{ kN}$$

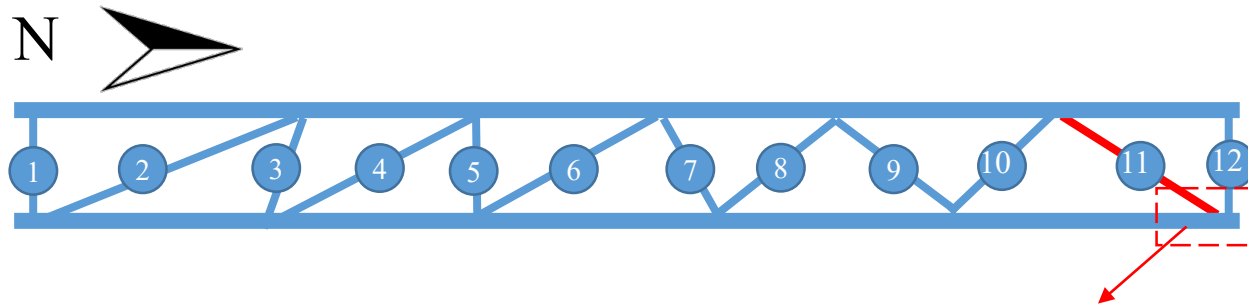
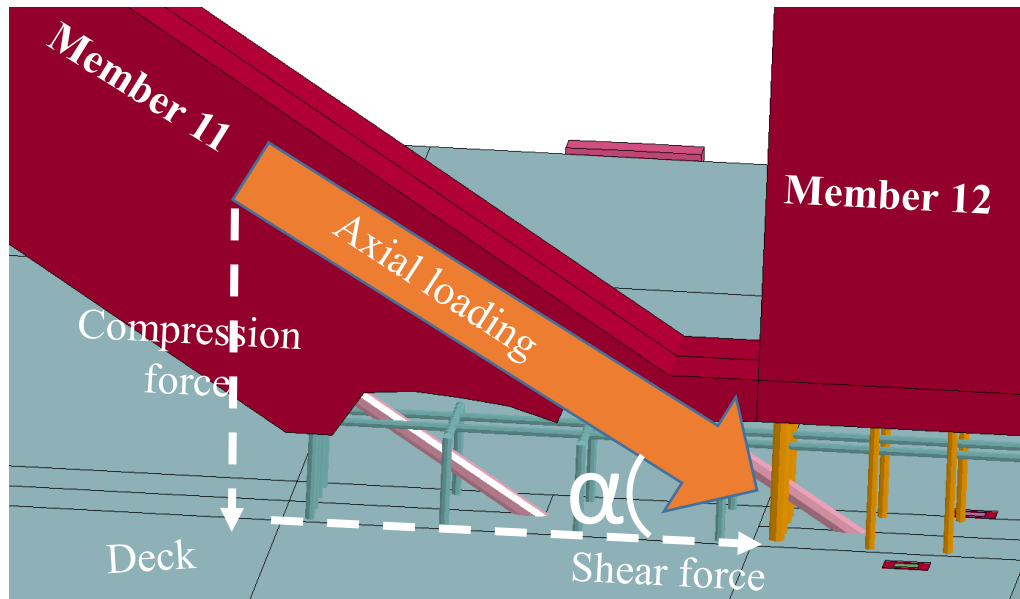
Shear Capacity of the Construction Joint

$$\begin{aligned}
 Q_n &= 0.5 A_{sa} \sqrt{f'_c E_c} \\
 &= 0.5 \times 10012 \times \sqrt{58 \times 36233} = 7257 \text{ kN} \\
 &> R_g R_p A_{sa} F_u = 1.0 \times 0.75 \times 10012 \text{ mm}^2 \times 414 \text{ Mpa} \\
 &= 3109 \text{ kN} \\
 &\rightarrow Q_n = 3109 \text{ kN}
 \end{aligned}$$

$$\begin{aligned}
 C &= f + Q_n = 5509 \text{ kN} + 3109 \text{ kN} = 8618 \text{ kN} \\
 D &= (F_G + F_P) \times \cos(\alpha) = (8205 + 2491) \times \cos(31^\circ) \\
 &= 9168 \text{ kN} > C = f + Q_n = 8618 \text{ kN}
 \end{aligned}$$

The shear capacity is insufficient

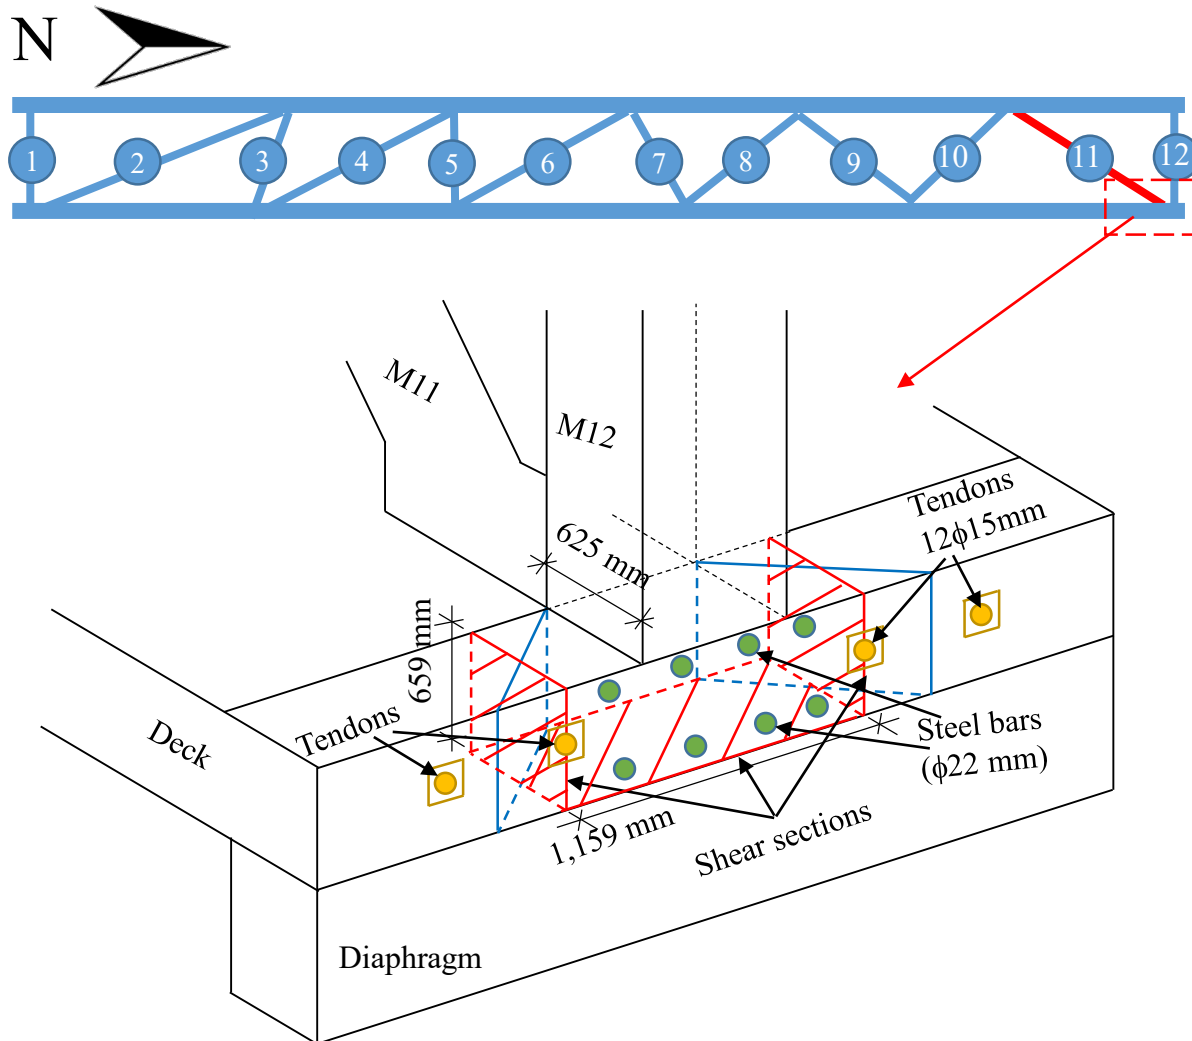
Punching-Shear Capacity of the Deck

$$\begin{aligned} V_{total} &= V_c + V_{ps} + V_s = 3918 + 3550 + 1282 \\ &= 8750 \text{ kN} < D = 9168 \text{ kN (demand)} \end{aligned}$$

$$\begin{aligned} V_{total} &= V_c + V_s = 3918 + 1282 \\ &= 5200 \text{ kN} < D = 9168 \text{ kN (demand)} \end{aligned}$$

➔ The joint may have been deficient regarding this type of failure regardless of how much of the tendons prestressing capacity had been engaged in preventing punch out.

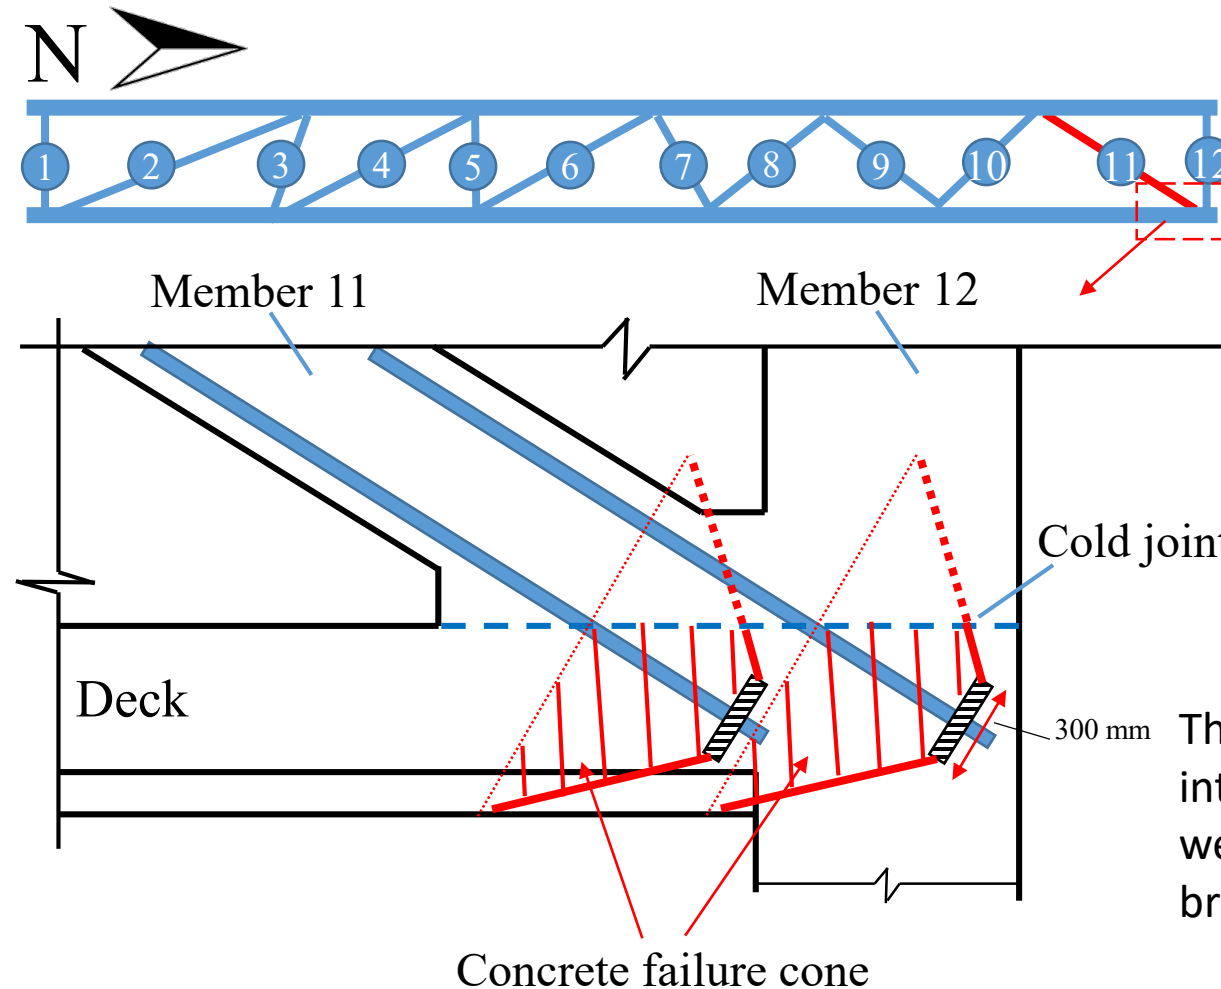
Blowout Damage from Pre-stressing Bars

The anchor plates could have caused internal damage during transportation, weakening the joint region before the bridge went into service.

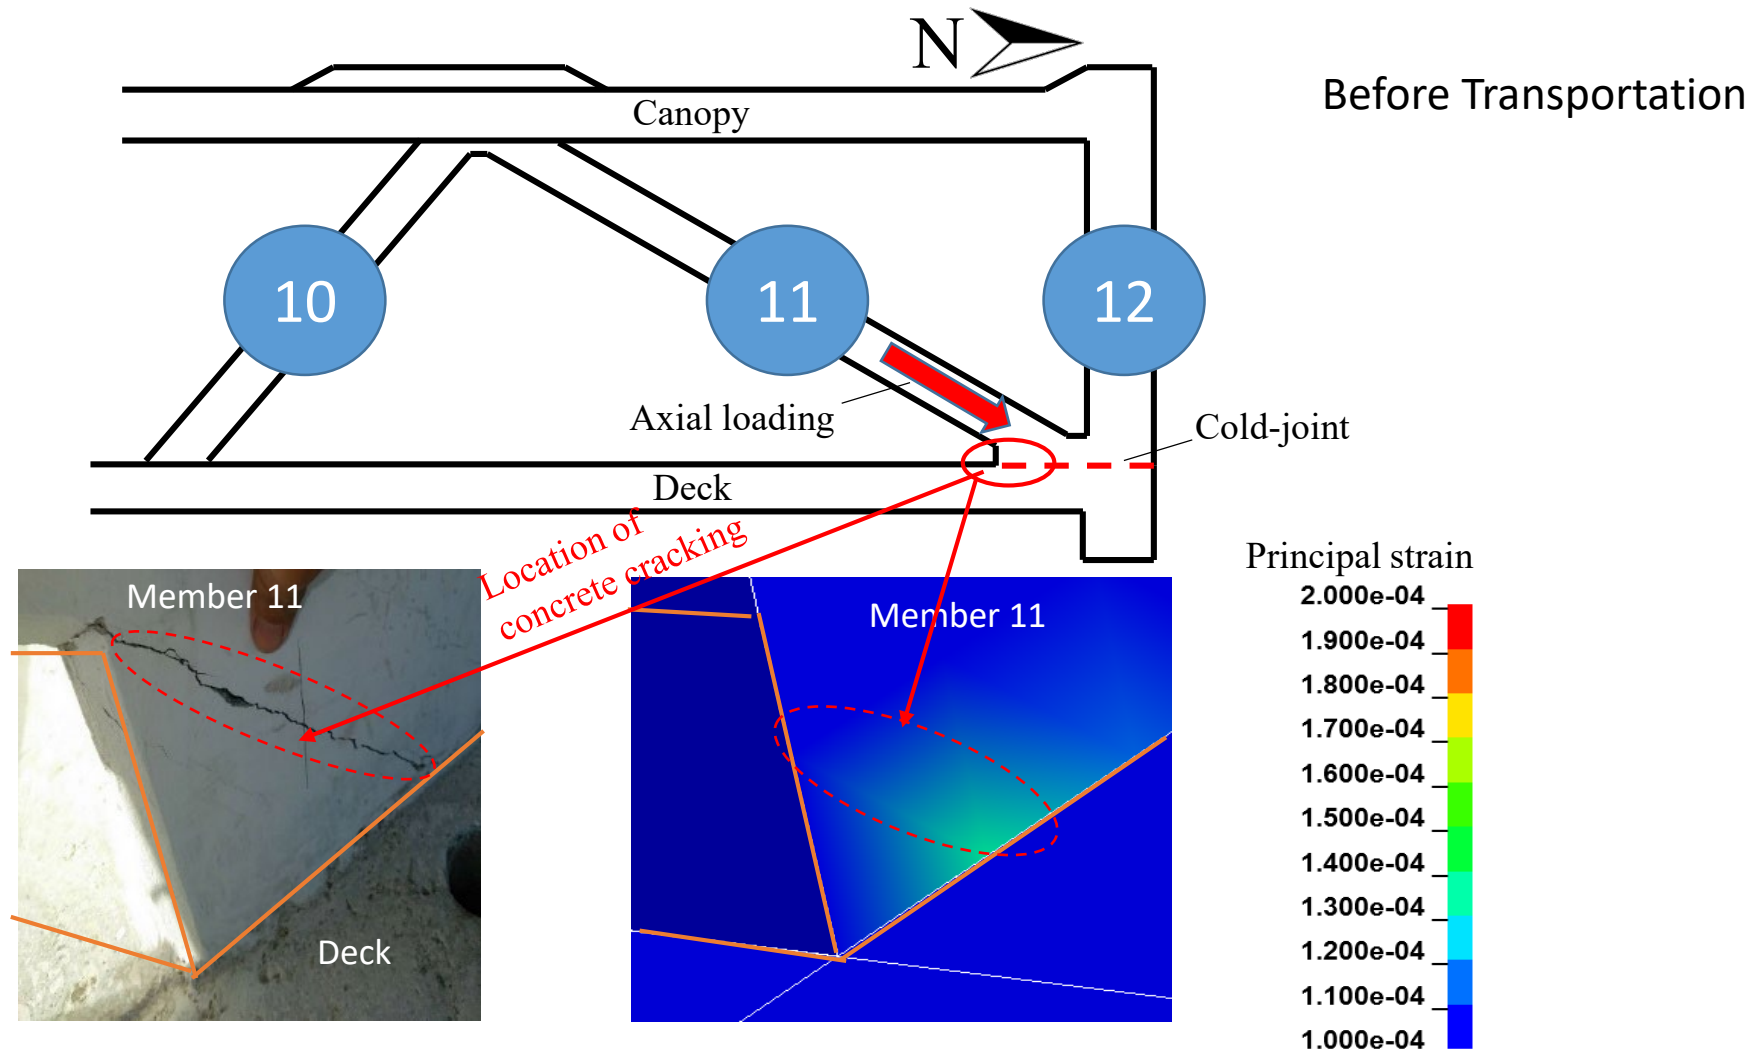
- Comparison of cracks in the joint area of member 11 after pre-stressing

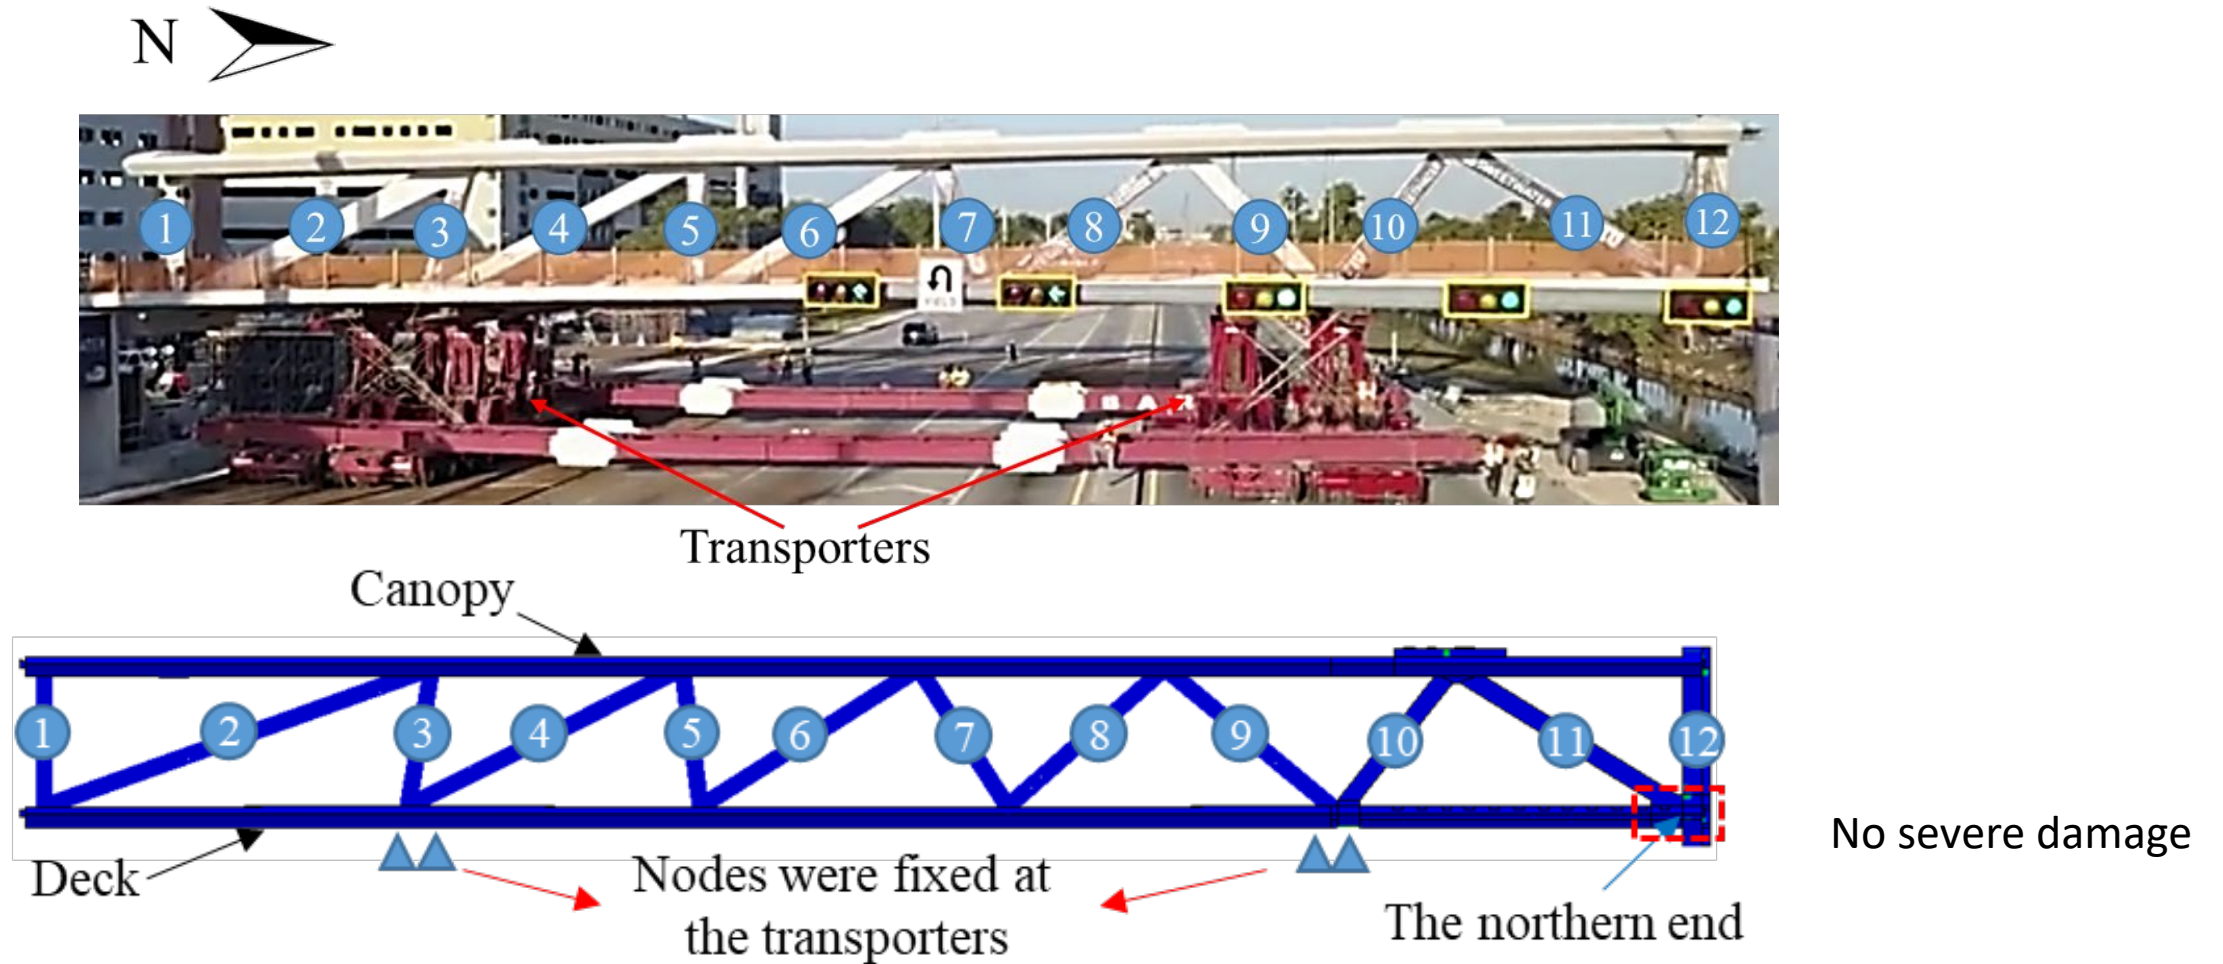
- Transportation stage: no severe damage in the northern joint area

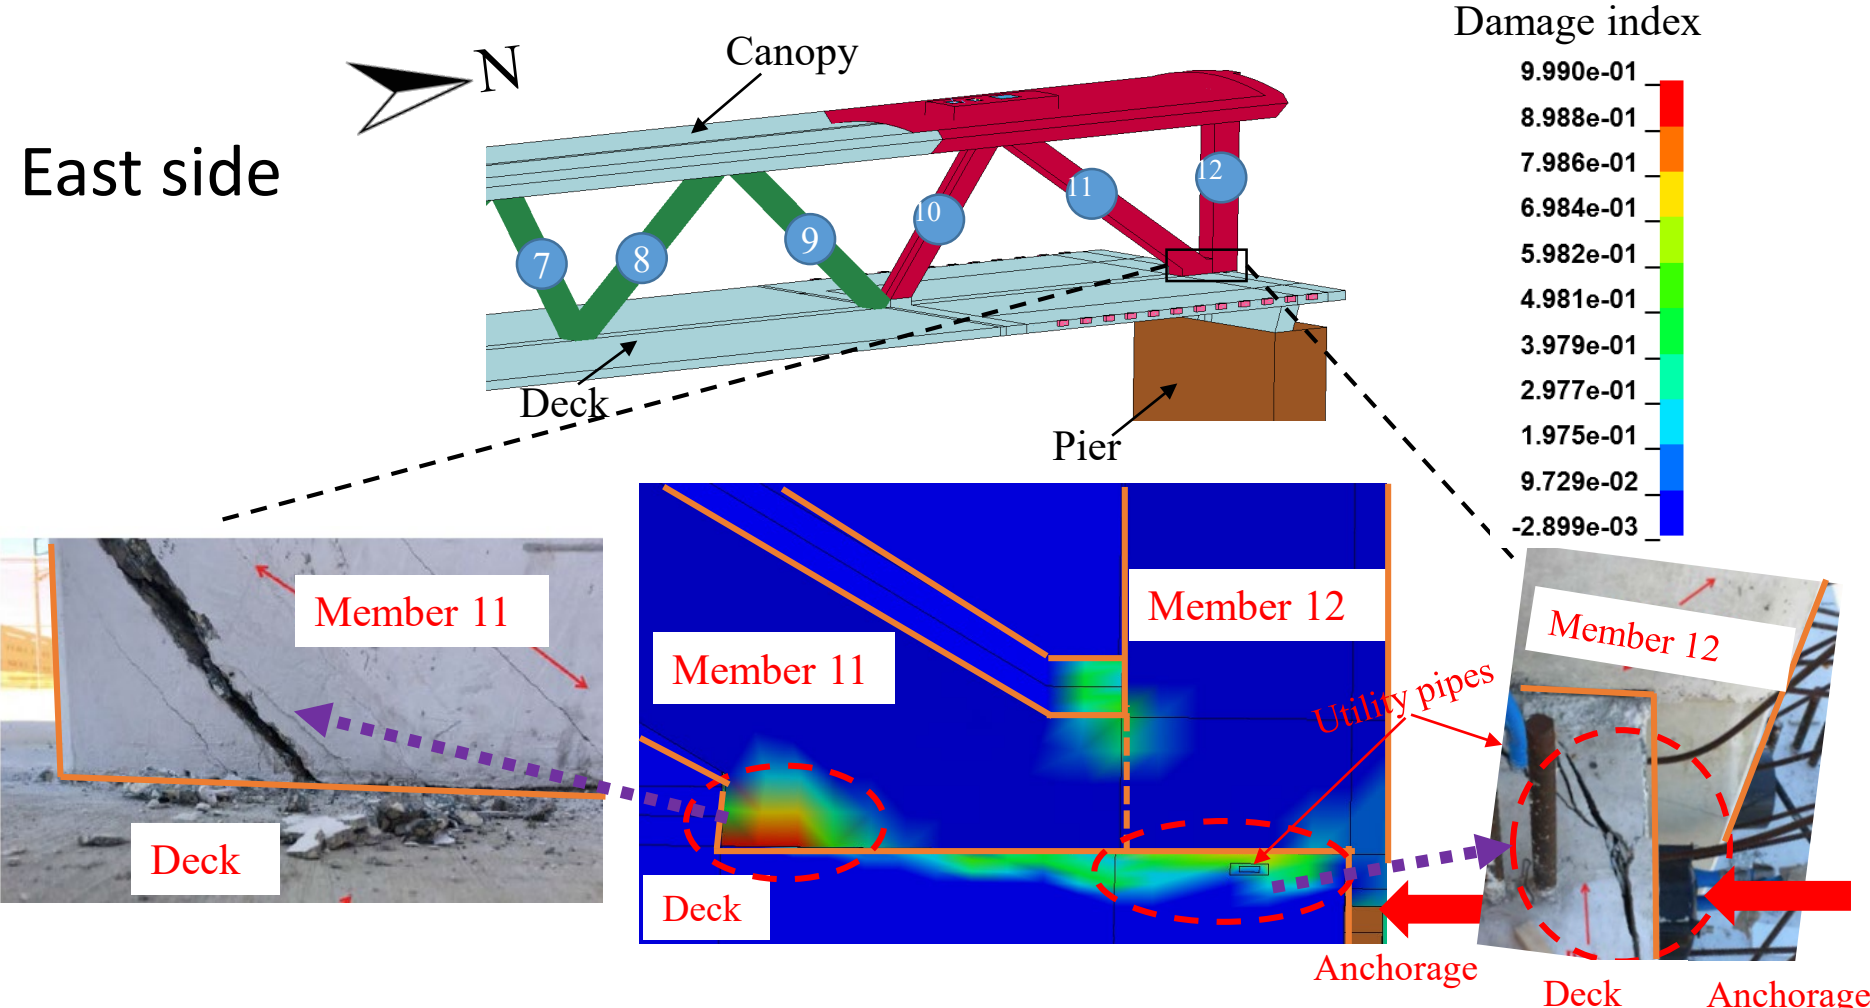
- East side

- Comparison of cracks in the joint area of member 11 after relocation

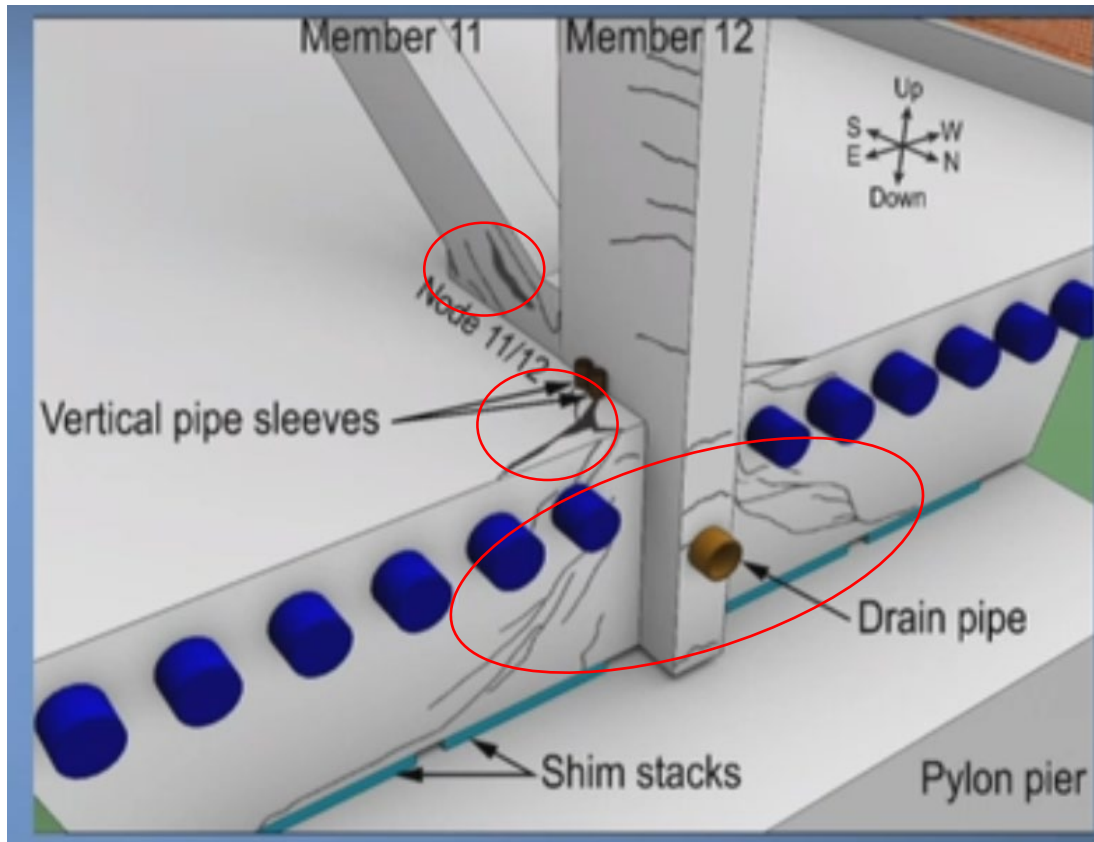
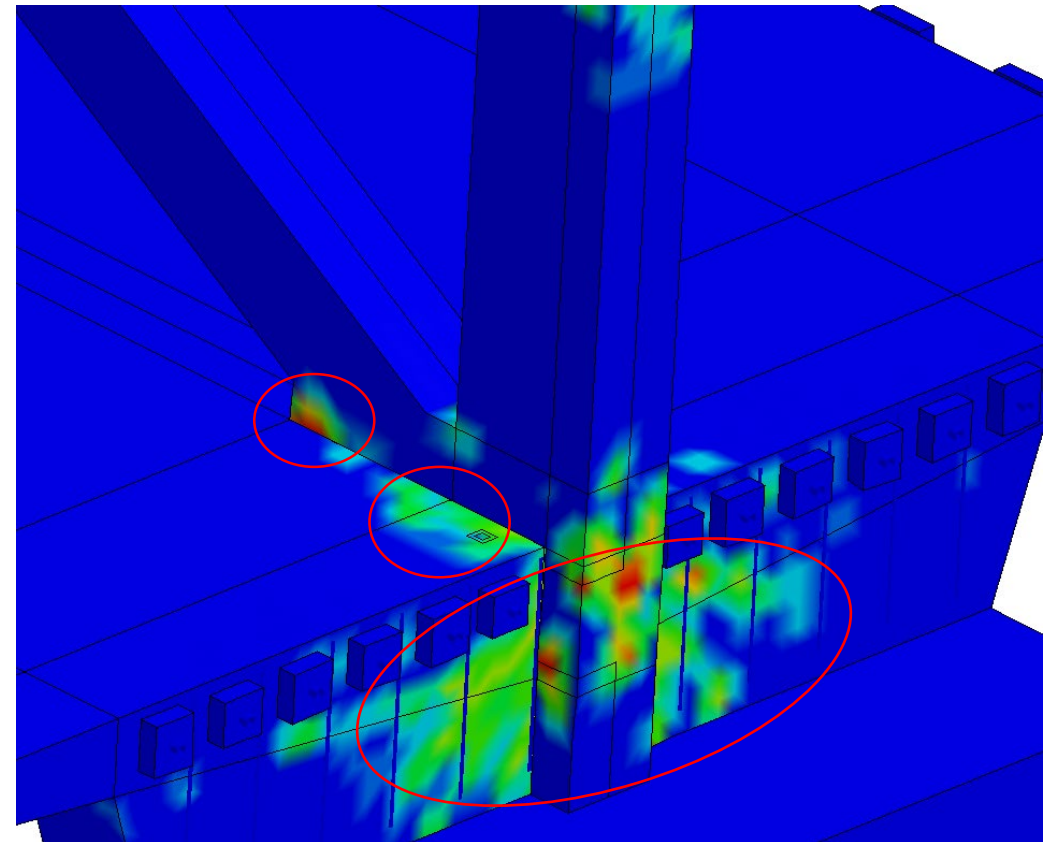
Cracks were still developing before retensioning, but the bridge didn't collapse. Instead of repairing the bridge, the contractor / designer decided to retension member 11, which further damaged the already cracked joint.

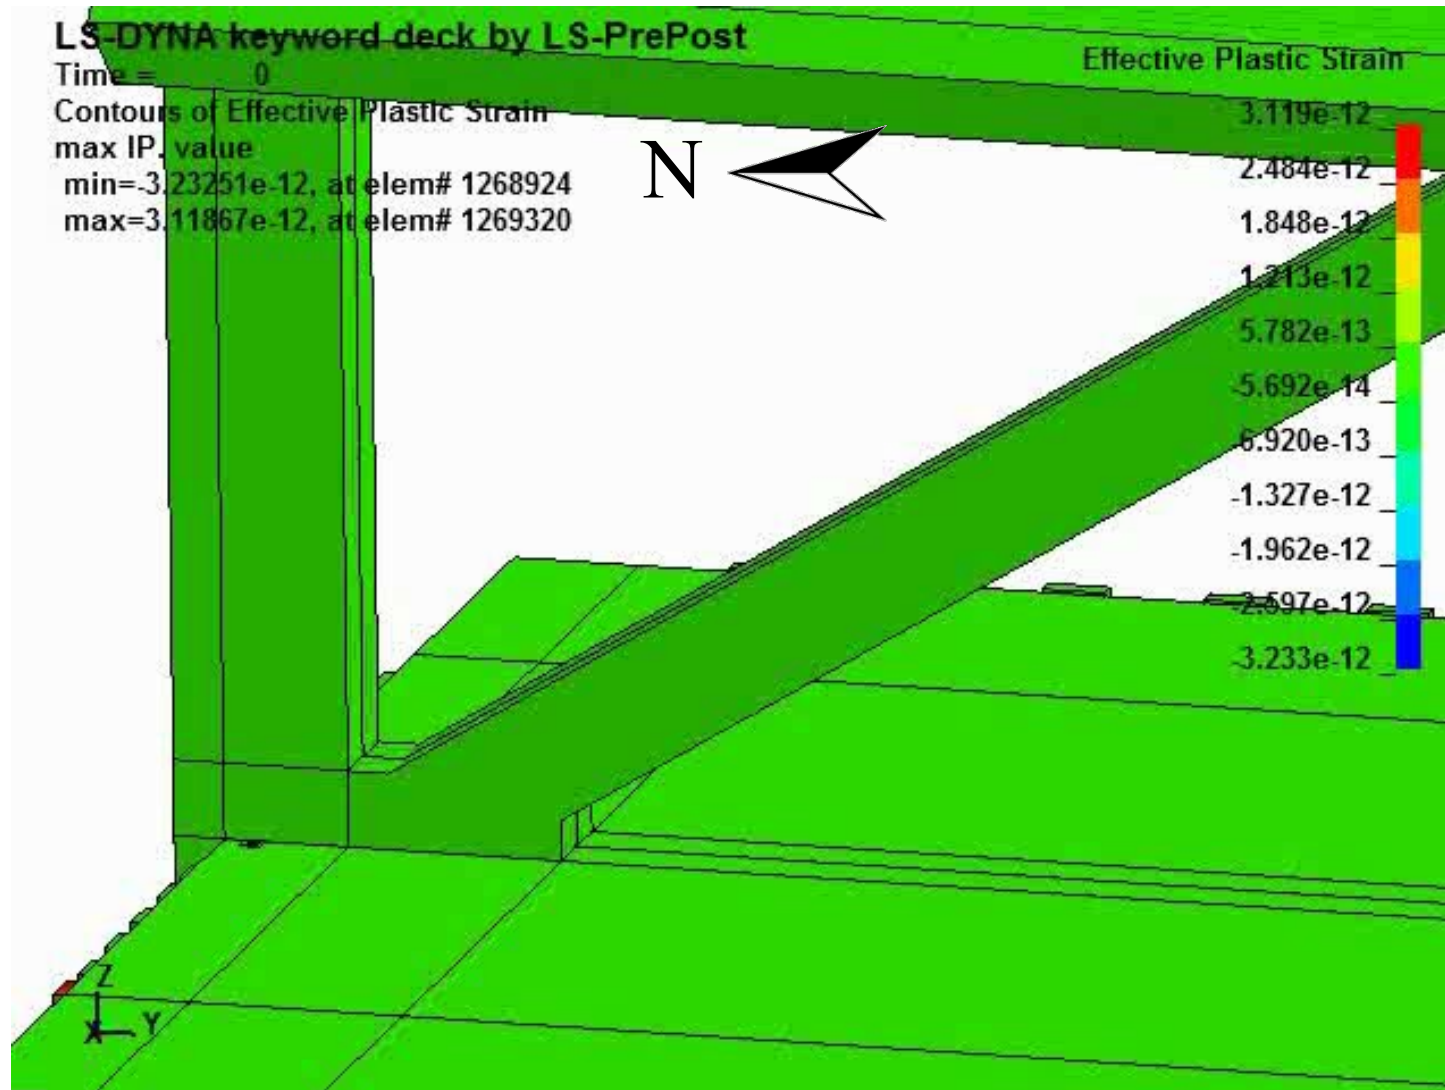
- Failure sequence:

1. Damaged heel of member 11 under gravity and pre-stressing (before re-tensioning).
2. After re-tensioning, concrete in the cold joint area was severely damaged by excessive sliding and mobilization of dowel action, which also caused punching shear failure.
3. Member 11 and member 12 were pushed off the deck. The deck fell off the support, leaving behind a portion of member 11/12's joint wedged onto the pier.

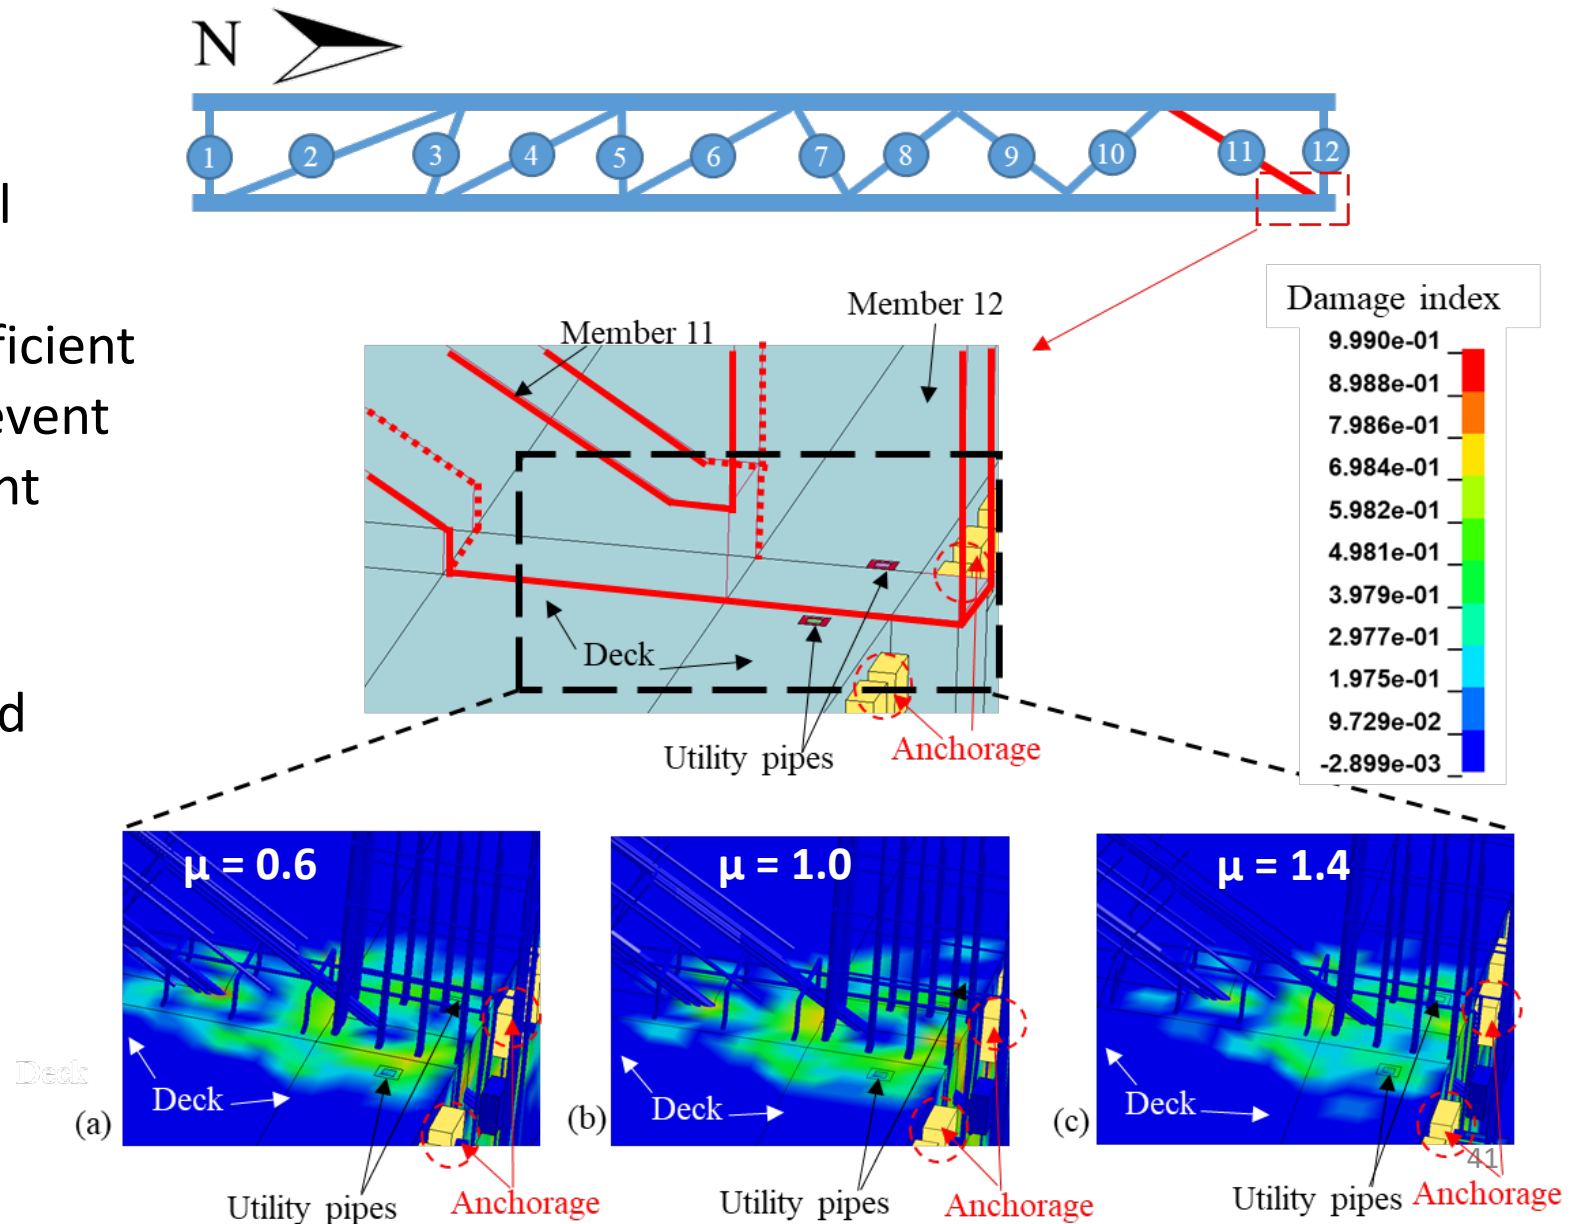
- The original design relied on friction to resist the horizontal shear forces, but simulation showed that even a high coefficient of friction of 1.4 could not prevent severe damage in the cold-joint area.
- According to OSHA and NTSB reports, the surface of the cold joints was not intentionally roughened.

- Damage mode of the cold-joint area

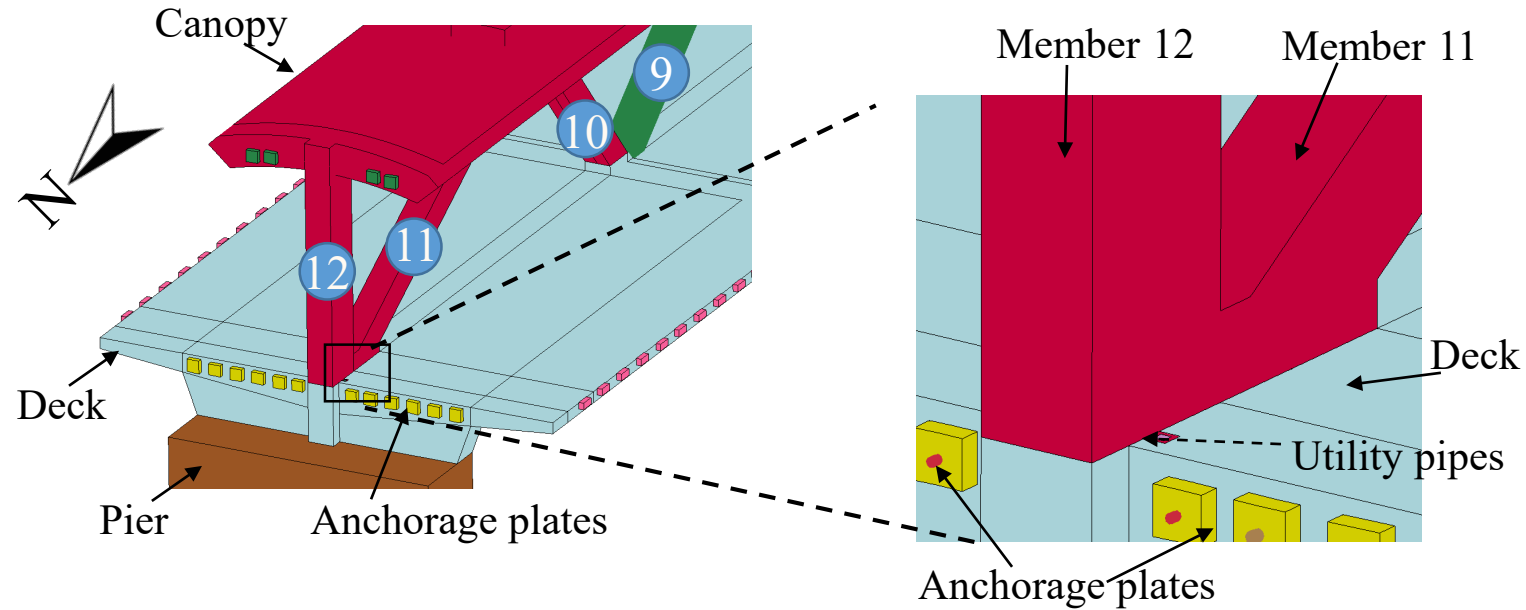
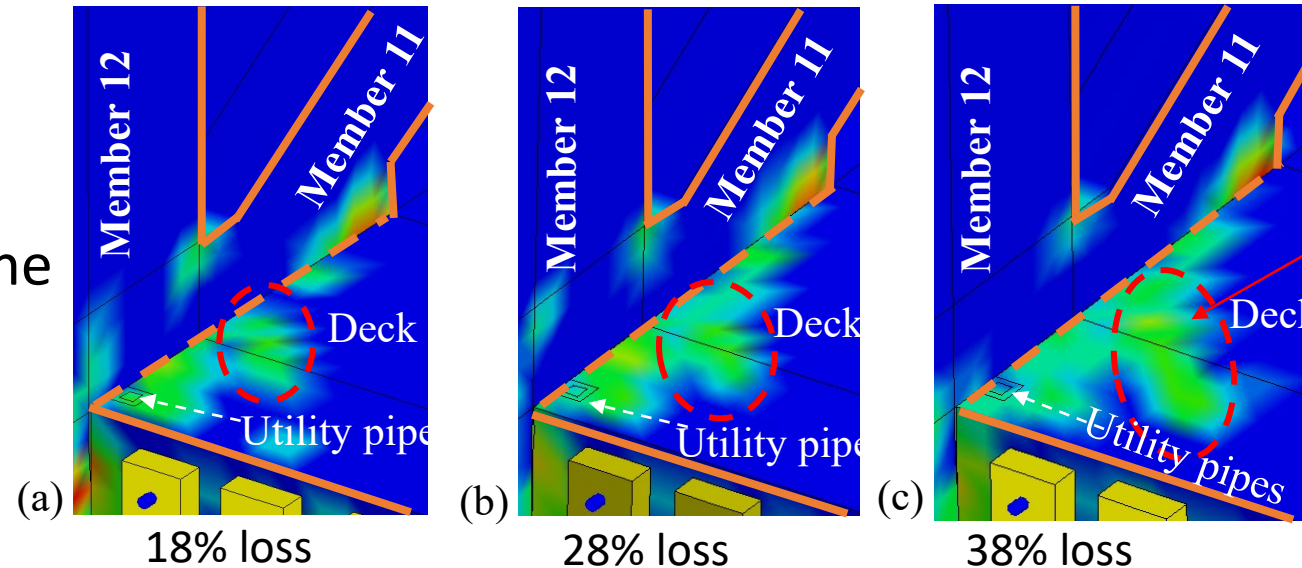
- Damage mode of the cold-joint area

the zone of punching-shear damage expanded as the prestressing losses increased
