Miami Pedestrian Bridge Collapse: A Computational Forensic Analysis

Anil K. Agrawal, Ph.D., P.E. and Ran Cao
The City College of New York, New York, NY

Sherif El-Tawil, Ph.D., P.E.
University of Michigan, Ann Arbor, MI

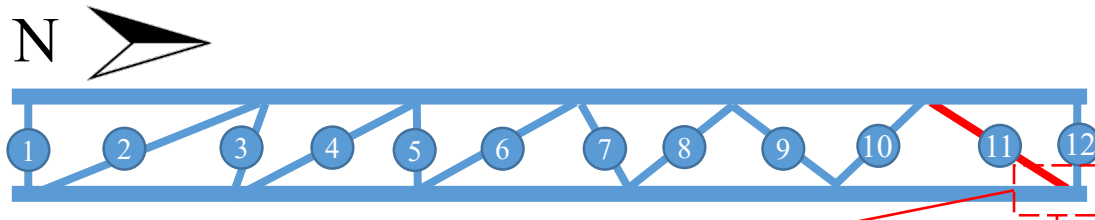
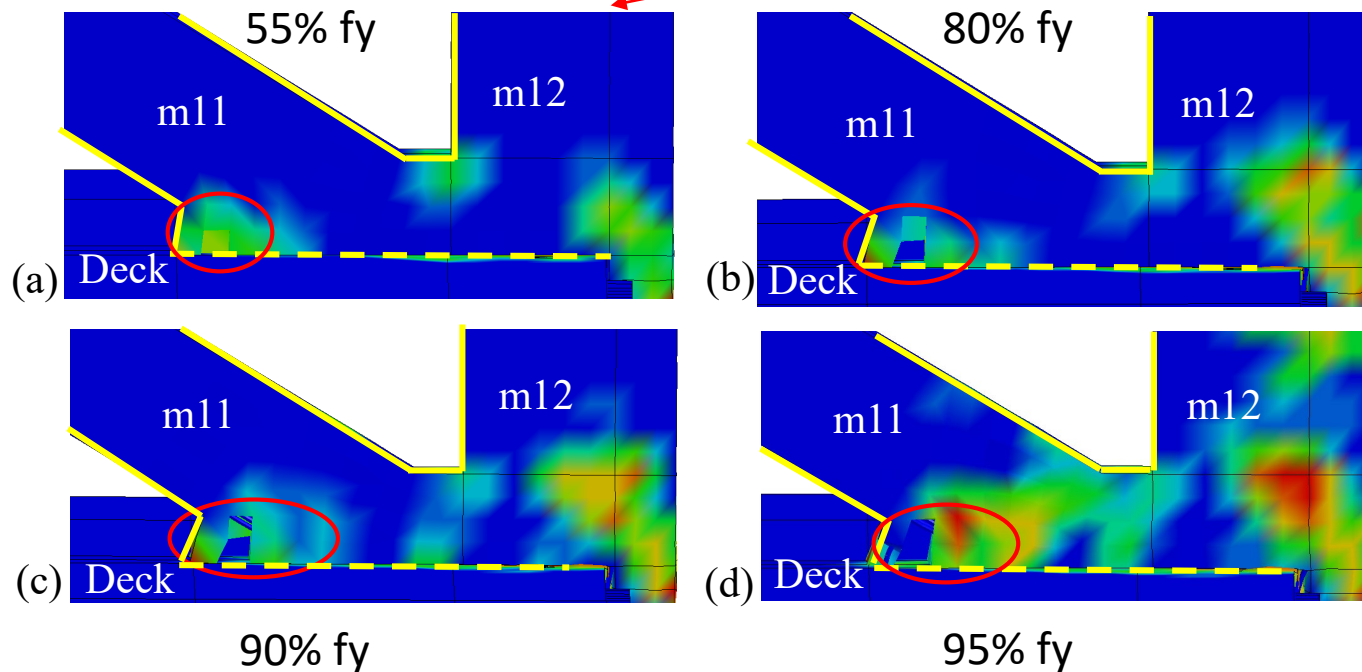
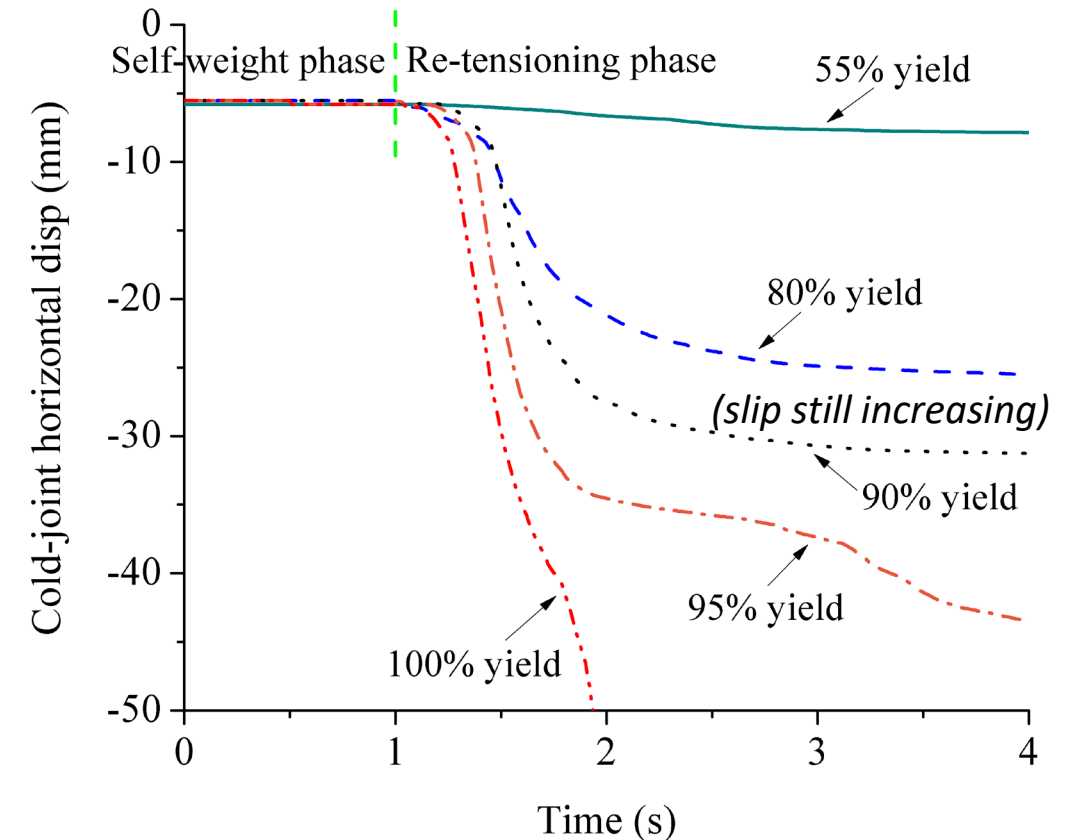
Based on OSHA report, the tendons in member 11 were re-tensioned over 80% of the yield strength, which could cause significant increase in the cold-joint slip and may further cause collapse of the bridge.

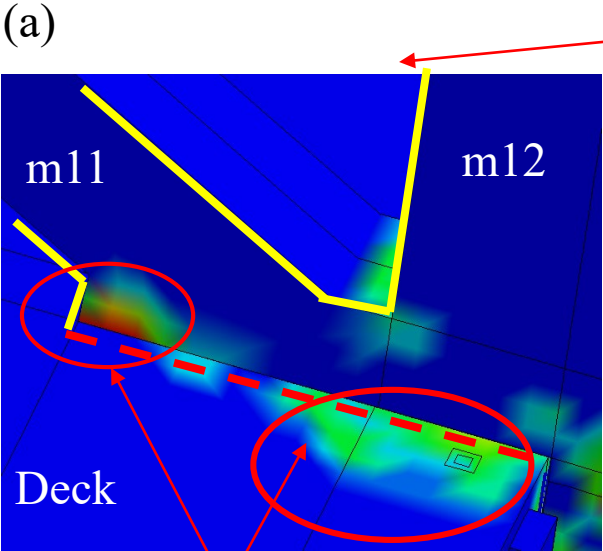
Damage due to sliding
original shear connector design (cold-joint)

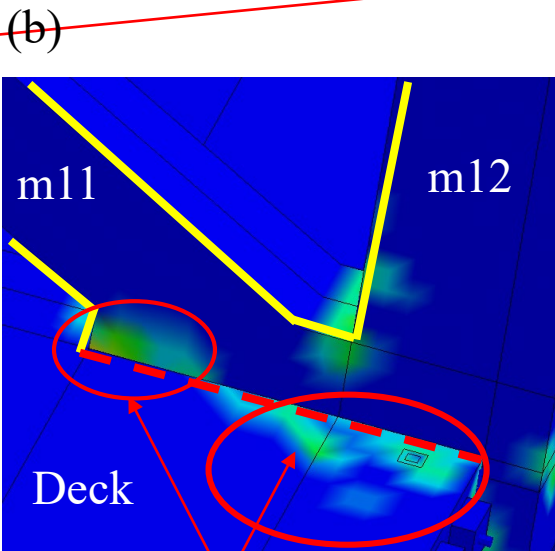
Damage due to sliding
revised shear connector design (cold-joint)

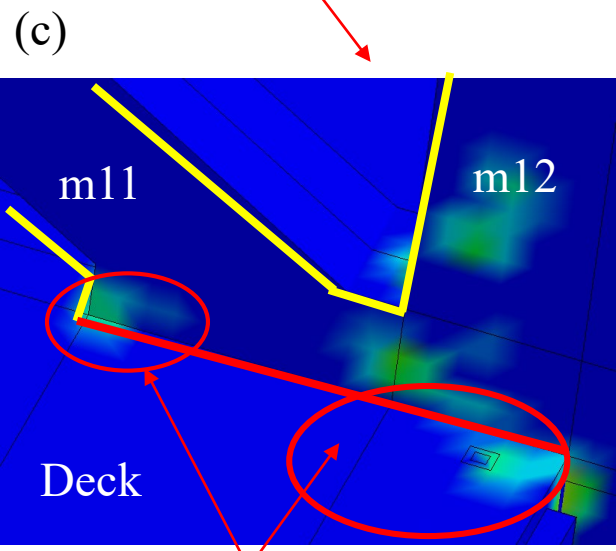
Damage due to sliding tendency
monolithic joint design (with original reinforcement)
