Load Rating, Analysis, and Monitoring of the Sagging Fascia Girder of I287 Bridge over US202/206

Thales C. Braguim, Ph.D Candidate, Chan Yang, Ph.D. Candidate, He Zhang, Ph.D. Candidate, Serap Hanbay, Ph.D. Candidate, Peng Lou, Ph.D., Chaekuk Na, Ph.D., Graziano Fiorillo, Ph.D, Hani Nassif, Ph.D P.E., and Scott Cavanaugh, P.E.

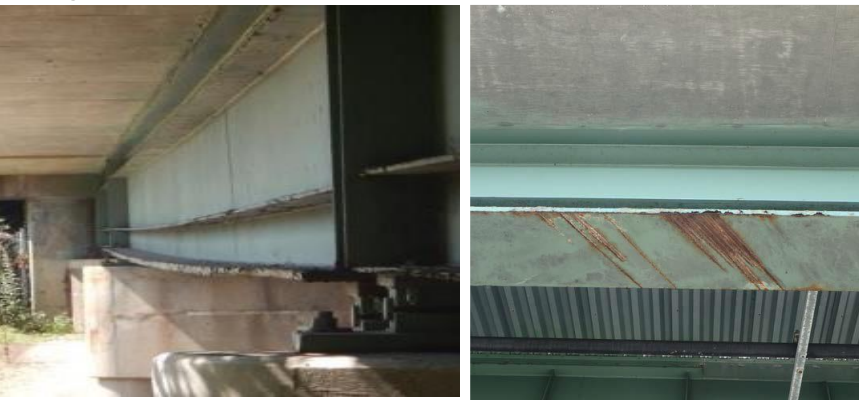
Background
Recently, it was reported a sagged posture of the east fascia girder in the center span of the I287 bridge.

The tensile dead load stress in the fascia girder midspan increased 38% due to the extended overhang. The stresses do not reach the yielding stress, however the site-specific truck traffic is needed.

- Add steel cover plate in the bottom flange of the fascia girder.
- Add new girder or add new supplemental support
- Replace the existing parapet by a light-weight parapet.

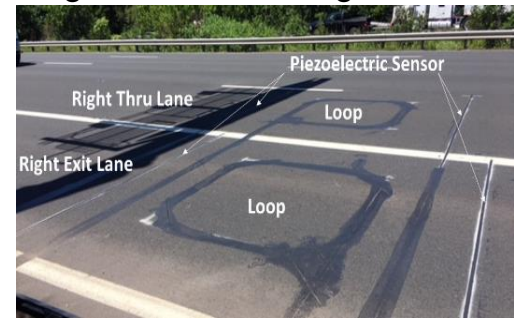
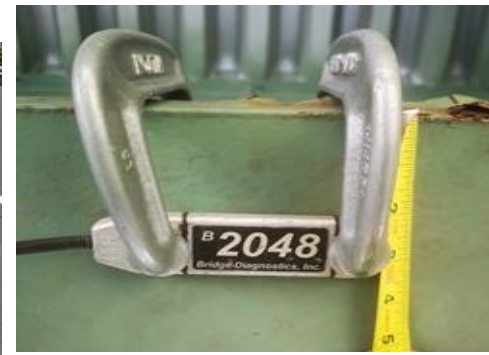
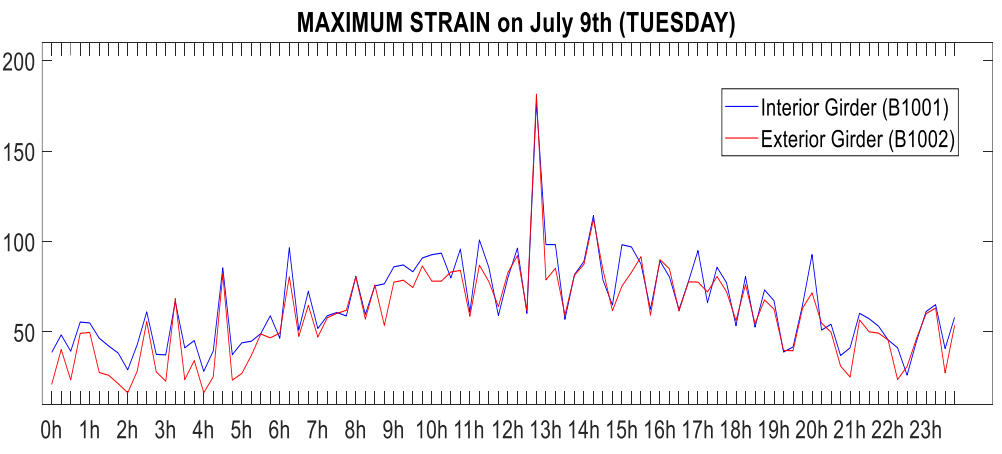
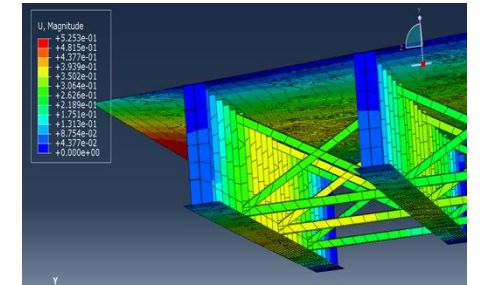
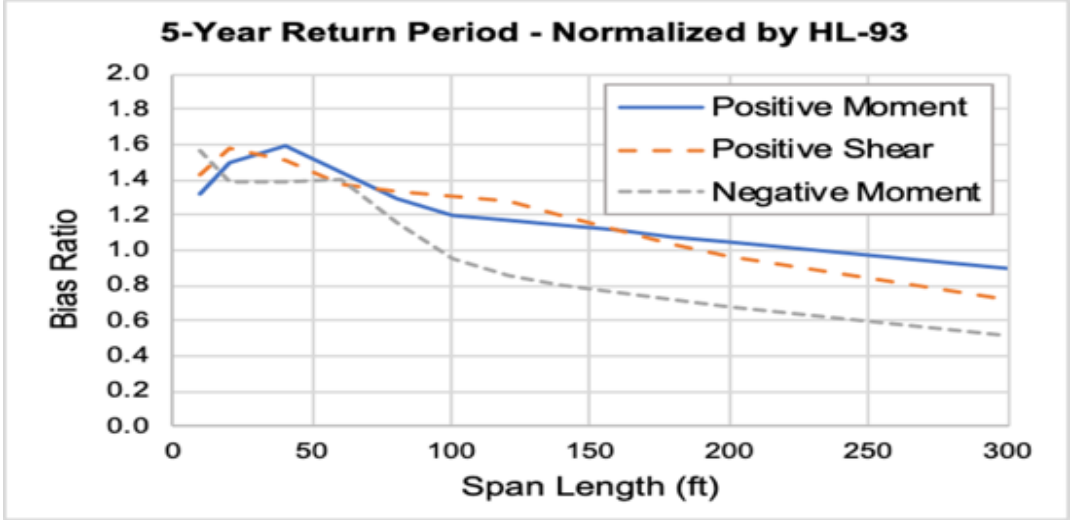
WIM System was installed to monitor the traffic. It was found that 8.5% trucks was OW and 13% trucks violated FBF. SHM was installed for diagnostic load tests and long-term monitoring.

- Large overhang causes overstress in the fascia girder.
- 8.5% are overweight trucks and 13% do not follow FBE B.
- The exceedance of 1.3*HL93 moment effect is 5 times higher than the national average.
- Bending moment of 1.24*HL93 causes yielding in the fascia girder. It happened 11 times within 1 year.
