HIGH FRICTION SURFACE TREATMENT - LESSONS LEARNED

NJDOT High Friction Surface Treatment Update

ROBERT BLIGHT
SUPERVISING ENGINEER
NJDOT PAVEMENT DESIGN & TECHNOLOGY SECTION

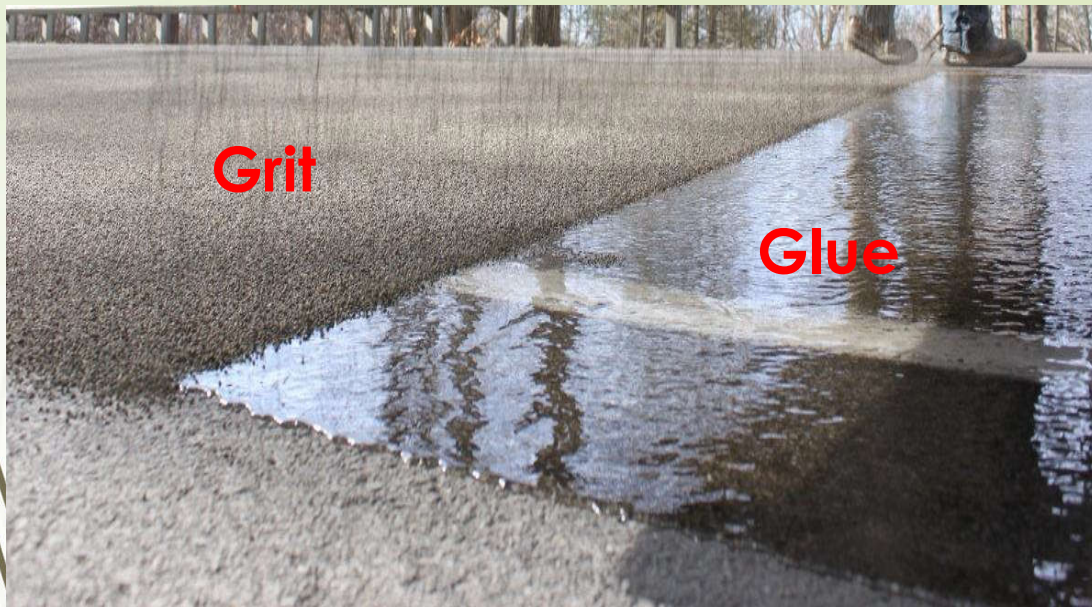
What is High Friction Surface Treatment (HFST)?

- ↴ HFST is a safety countermeasure
 - ↴ polish-resistant calcined bauxite aggregate (**grit**)
 - ↴ bonded to the pavement surface using a polymer resin binder (**glue**)

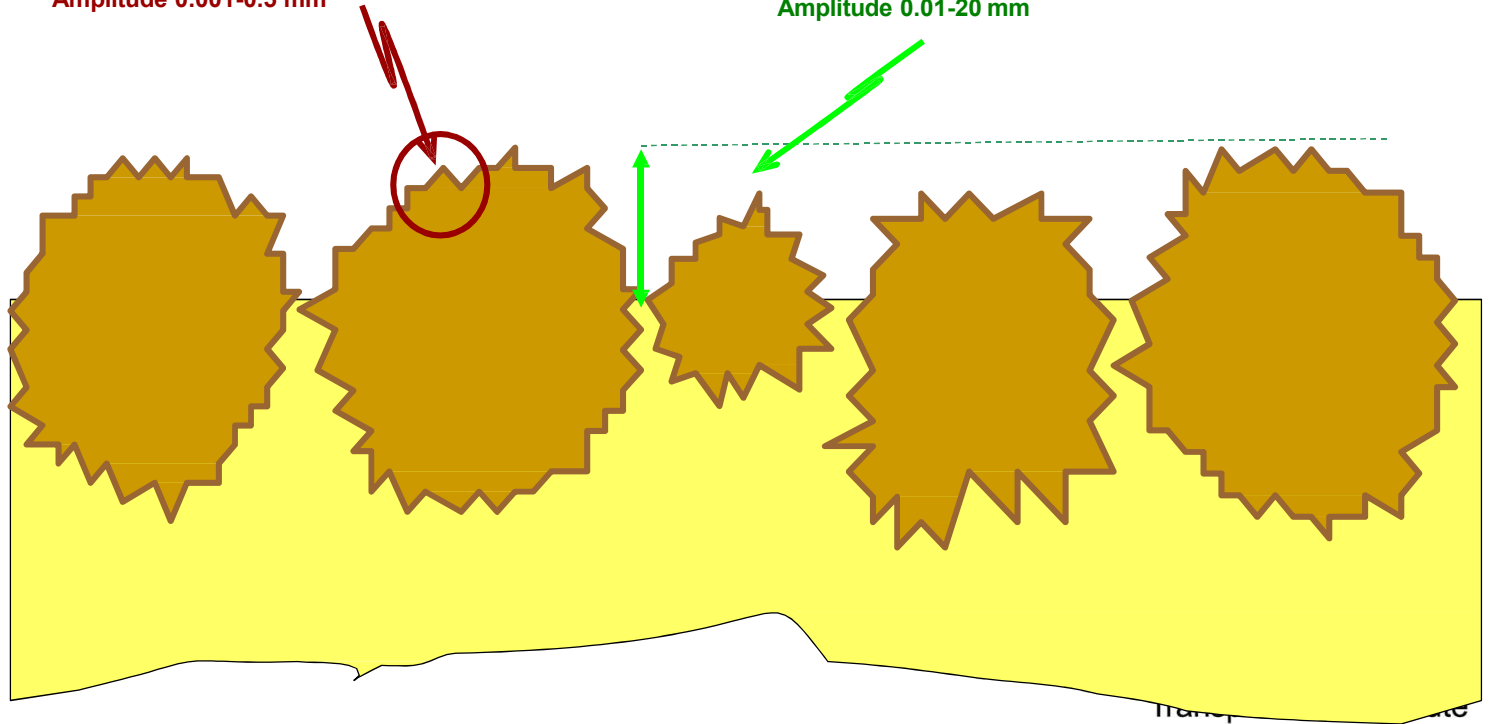
Textures that affects friction

Microtexture

Amplitude 0.001-0.5 mm

Macrotexture

Wavelength 0.5-50 mm
Amplitude 0.01-20 mm

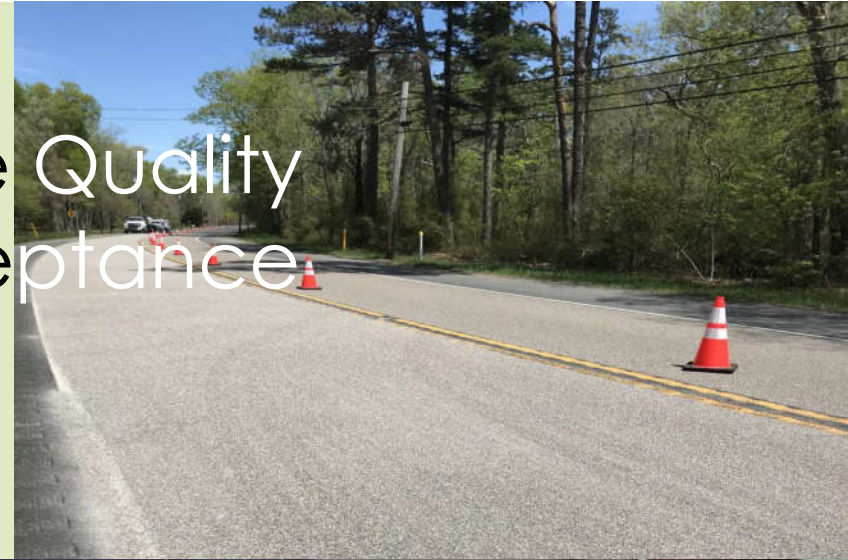
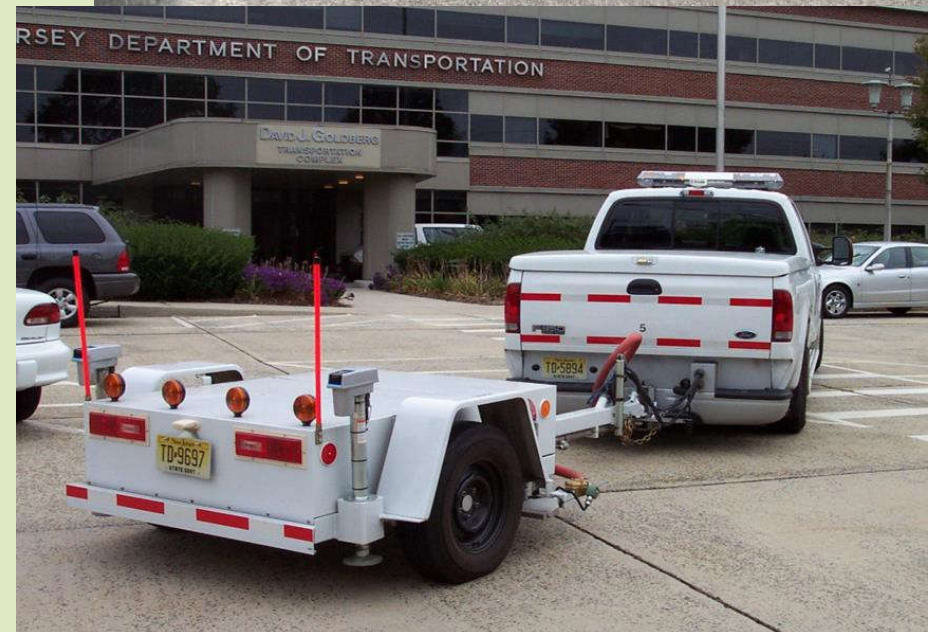
NJDOT SPEC. Surface Quality Skid Resistance Acceptance

- ↴ RE performs visual inspection of HFST
- ↴ RE can reject HFST based on visual assessment and require corrective action
- ↴ If RE visually approves HFST, then NJDOT Pavement Management performs Skid Resistance Testing using ASTM Test Method E 274 for Initial Acceptance
 - ↴ **Average Minimum SN \geq 65**

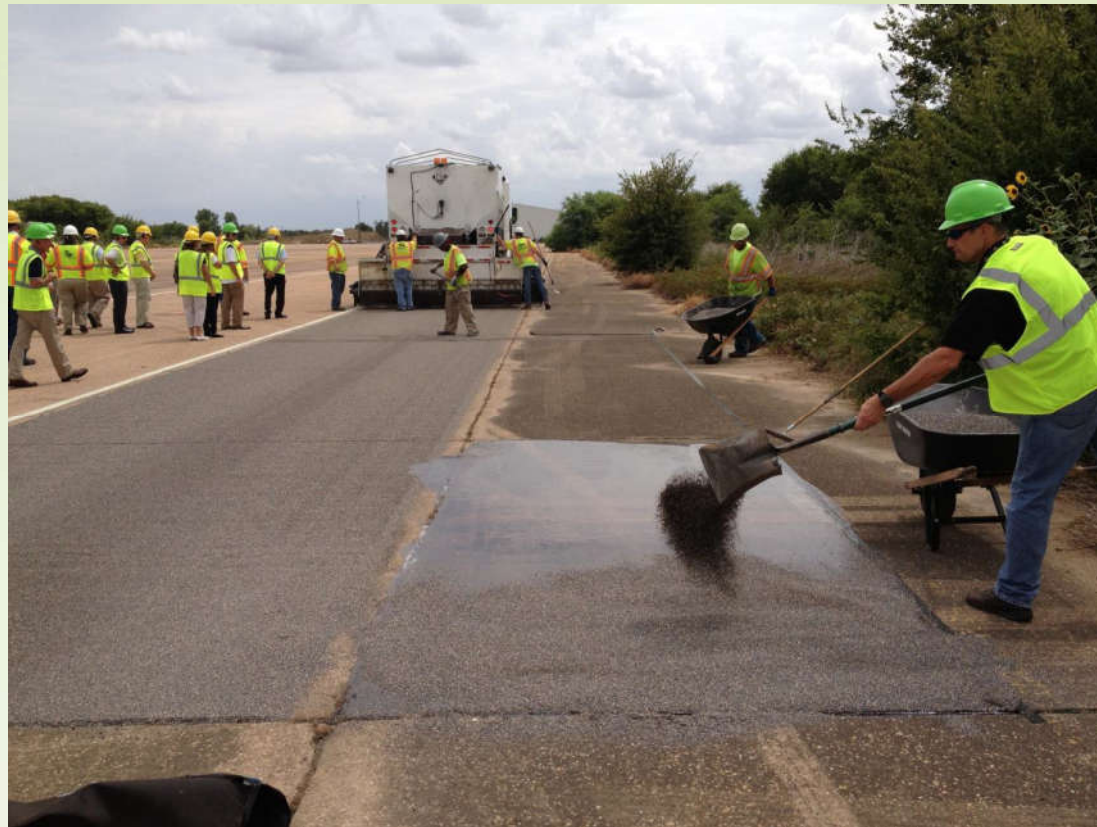
TRUCK MOUNTED HFST APPLICATION EQUIPMENT VS. MANUAL APPLICATION

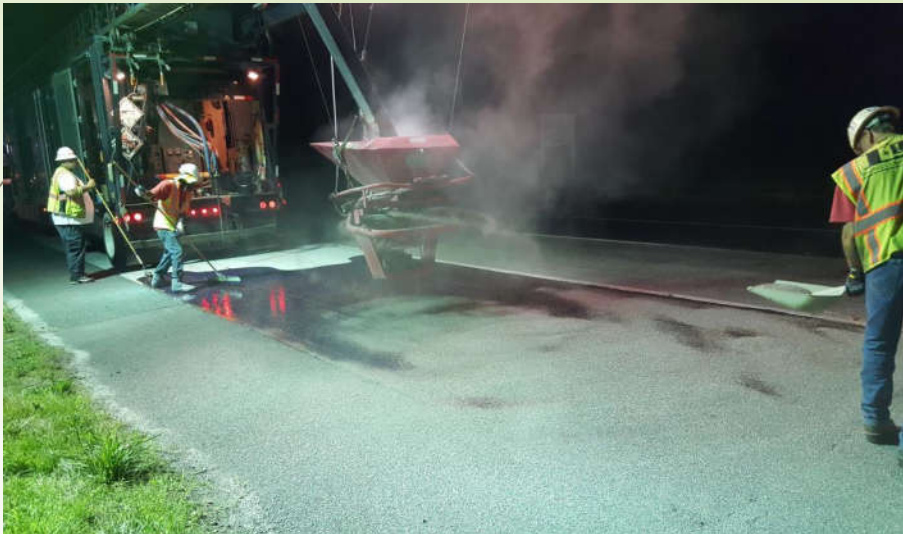
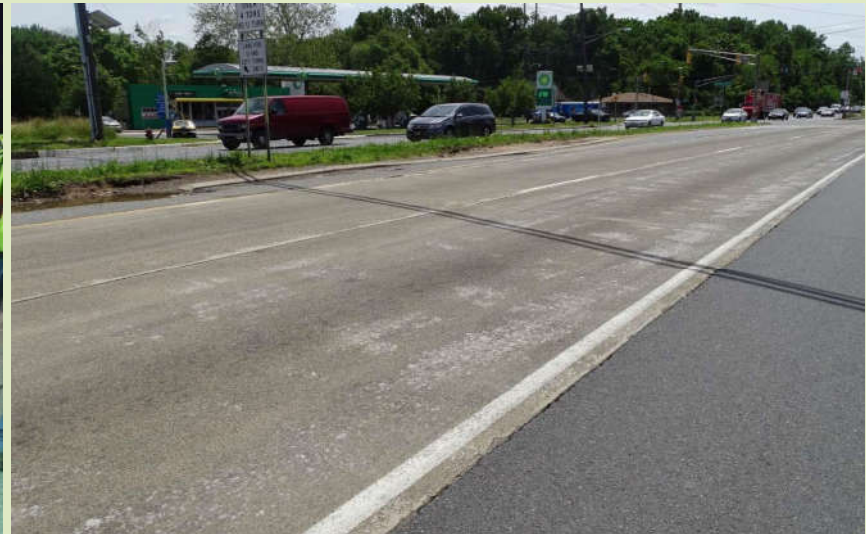
Manual HFST Placement or Mechanically Assisted Installation = Premature Failure

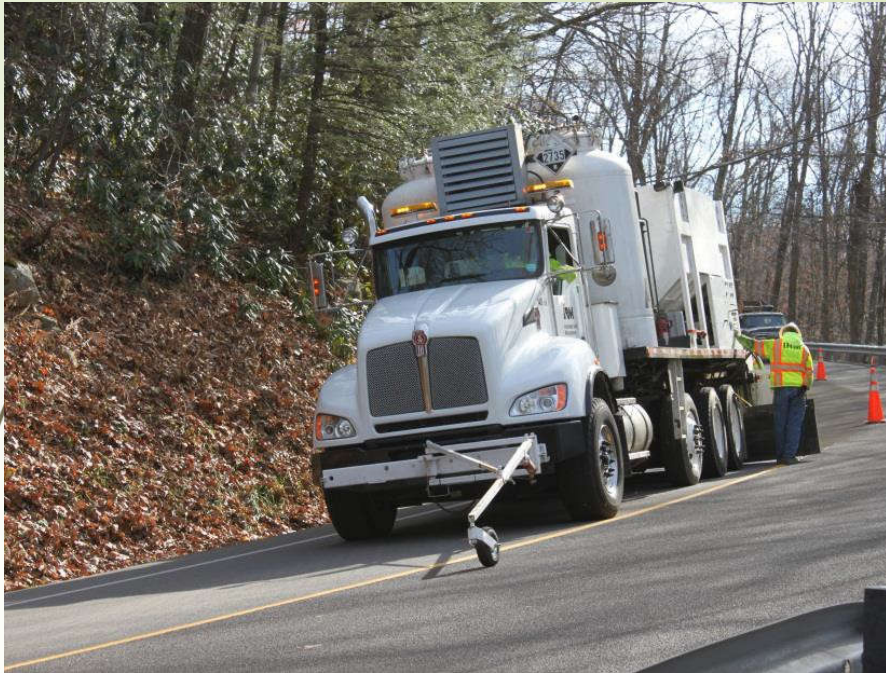
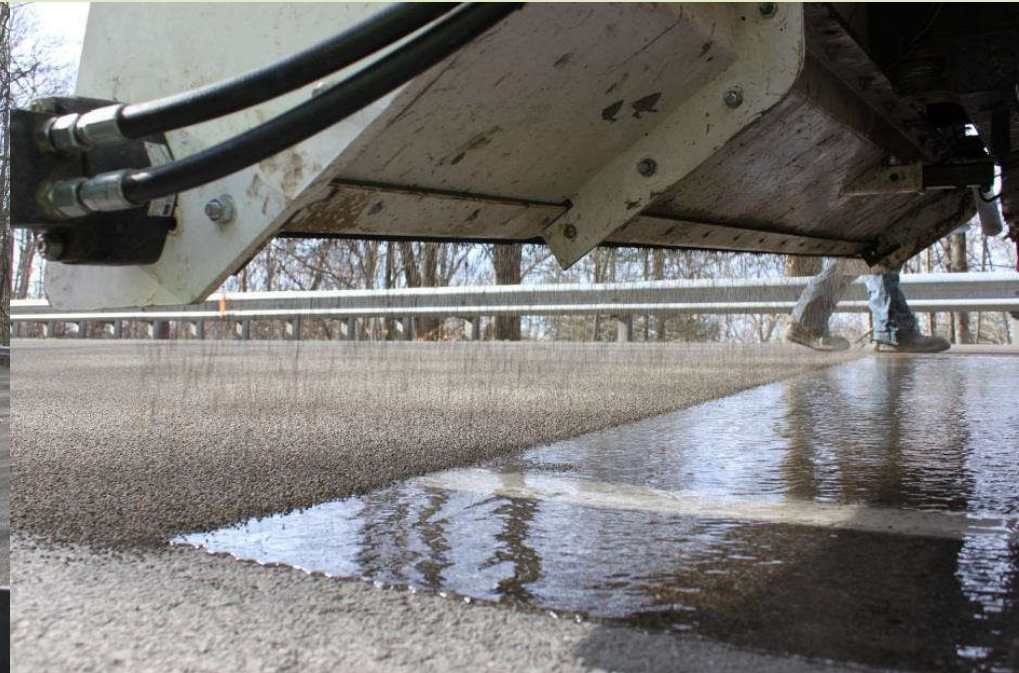
Automated Equipment Installation = Best Opportunity for Success

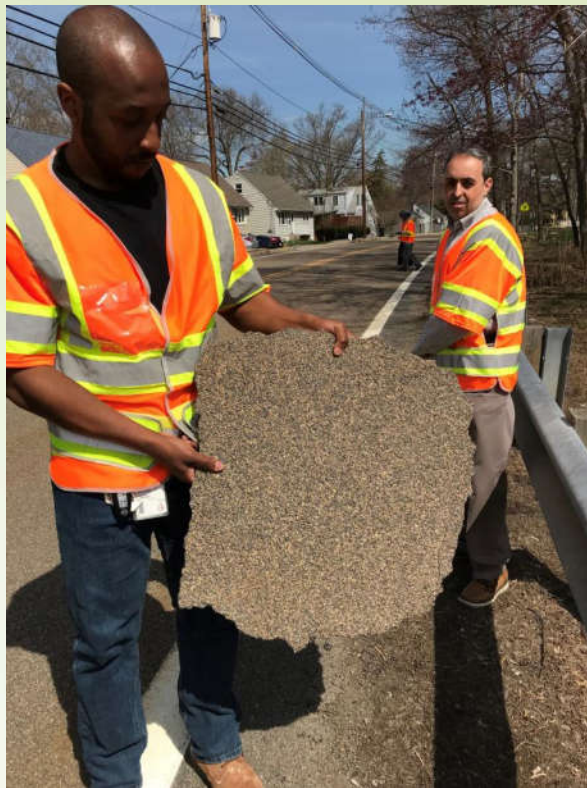
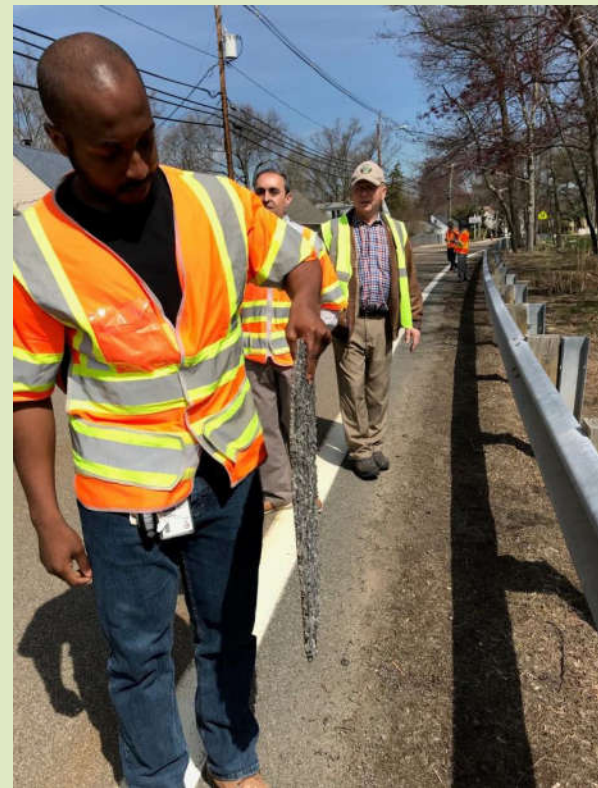
Equipment NOT Properly Designed

Pavement Condition & Proper HFST Equipment Matters

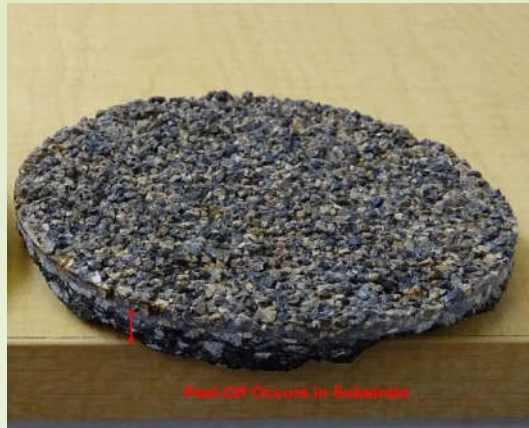
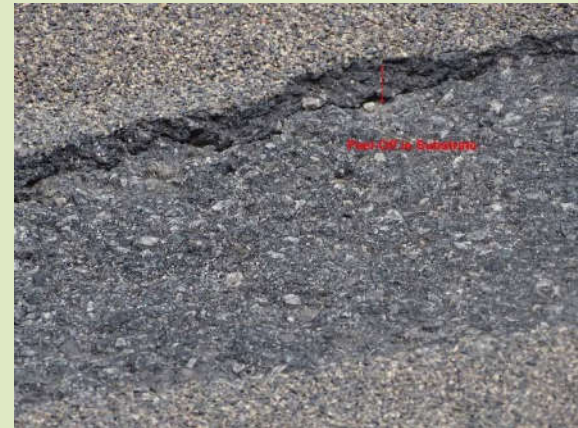
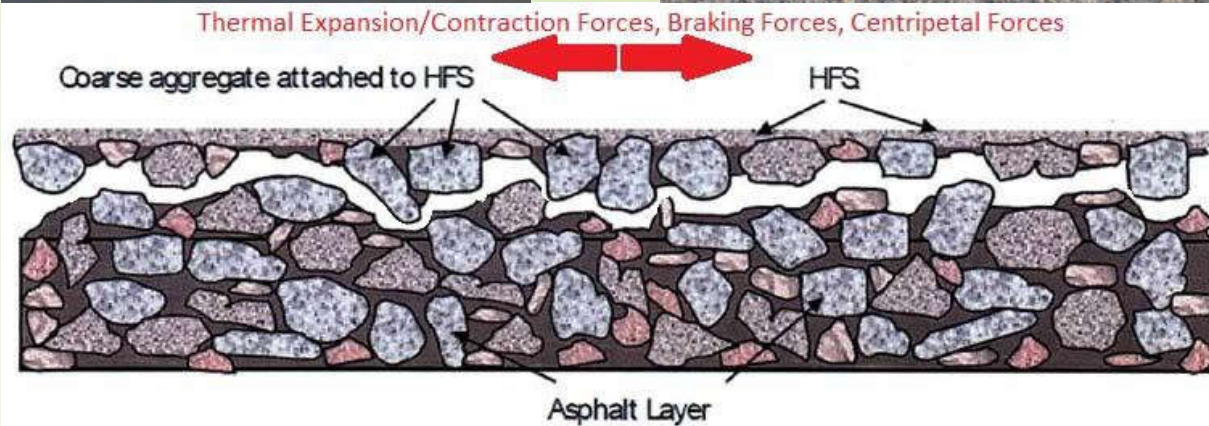
Pavement Condition & Proper HFST Equipment Matters

HFST Failure Forensic Investigation - Conclusions

- ↴ Asphalt pavement was significantly aged or contained high amounts of RAP when placed in 2014
- ↴ Areas within the project showed excessive amounts of epoxy binder thickness and high variability of thickness
- ↴ Combination of poor asphalt and excessive epoxy binder caused accelerated delamination failures in the asphalt substrate

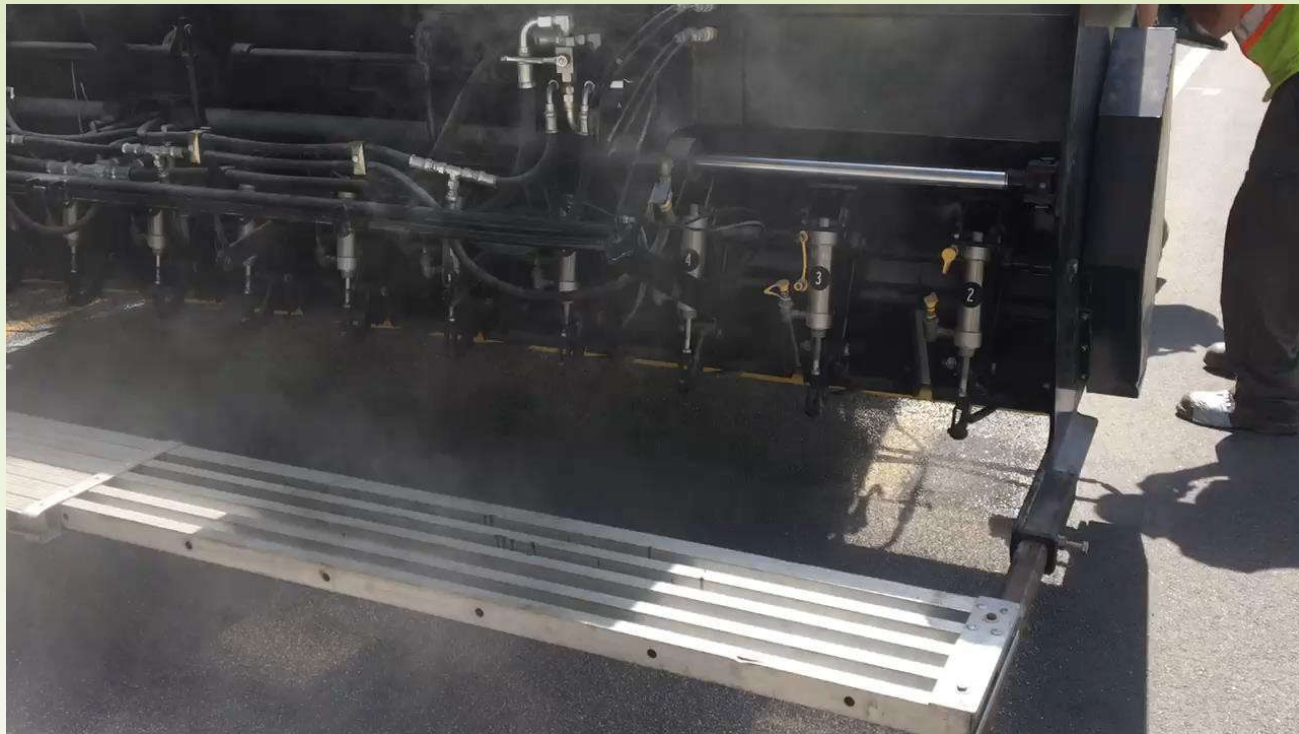
Improper Automated Equipment – Video Variability of Binder Thickness

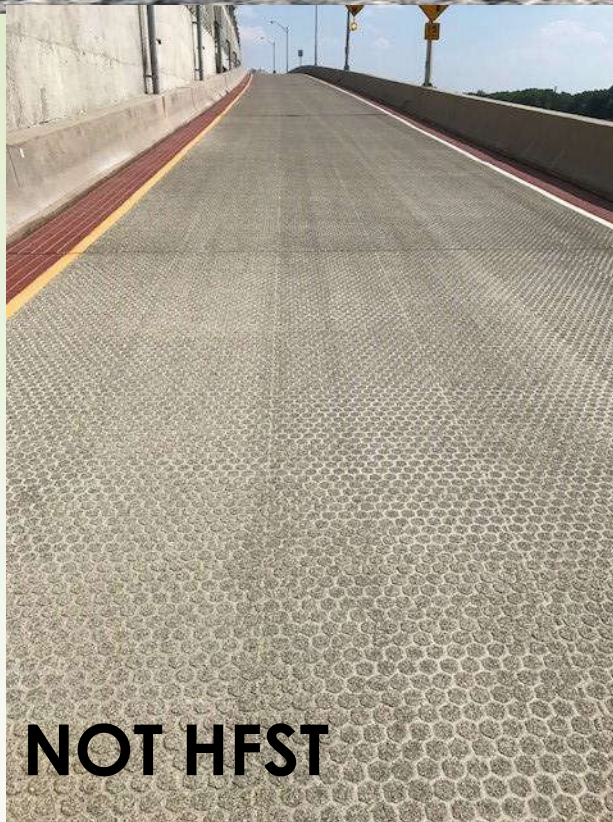
Products Advertised as HFST, but Not HFST = Inadequate Skid Resistance

Route 29 Southbound to Lalor St. Ramp						
Pass 1		Pass 2		Pass 3		Average
MP	SN40	MP	SN40	MP	SN40	SN40
0.000	40.5	0.000	37.4	0.000	36.7	38.2
0.036	37.2	0.024	32.9	0.035	36.4	35.5
0.071	34.1	0.054	31.4	0.073	32.7	32.7
0.109	52.2	0.085	50.0	0.111	46.5	49.6
0.144	51.4	0.119	50.1	0.141	50.4	50.6
0.174	48.2	0.142	49.7	0.163	48.4	48.8
0.203	49.5	0.168	45.4	0.186	51.8	48.9
0.229	54.4	0.200	54.2	0.206	50.7	53.1

Route 29 Southbound to Lalor St. Ramp						
Pass 1		Pass 2		Pass 3		Average
MP	SN40	MP	SN40	MP	SN40	SN40
0.000	66.4	0.000	66.3	0.000	66.7	66.5
0.013	64.2	0.011	56.5	0.011	61.5	60.7
0.026	63.0	0.022	56.8	0.022	55.9	58.6
0.039	52.2	0.034	63.1	0.036	49.9	55.1
0.053	58.8	0.048	65.9	0.058	59.9	61.5
0.067	64.0	0.064	59.9	0.086	55.9	59.9
0.082	55.6	0.081	55.8	0.100	60.0	57.1
0.099	58.3	0.098	56.1	0.113	61.5	58.6
0.115	60.8	0.115	57.5	0.125	59.4	59.2
0.13	52.7	0.131	52.9	0.138	65.1	56.9

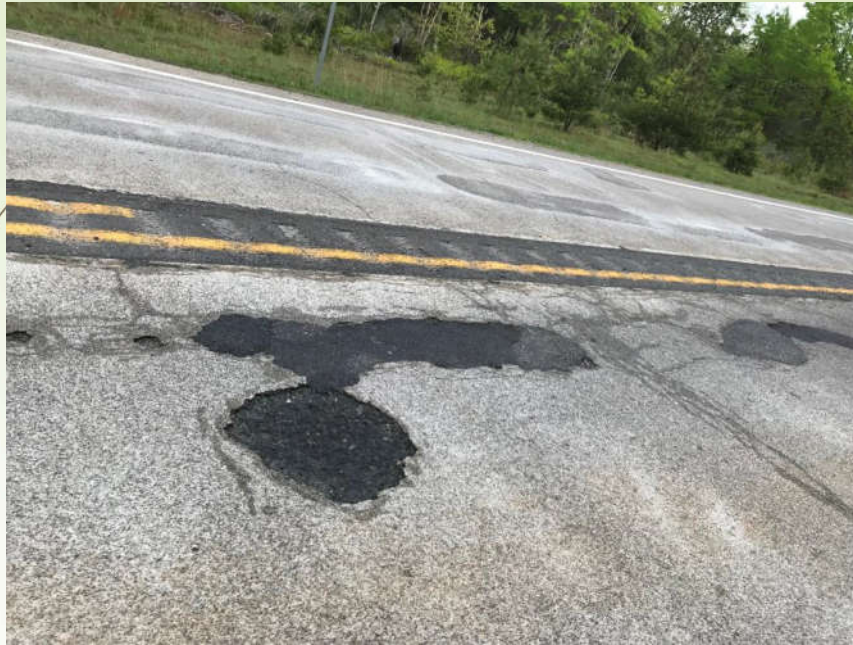
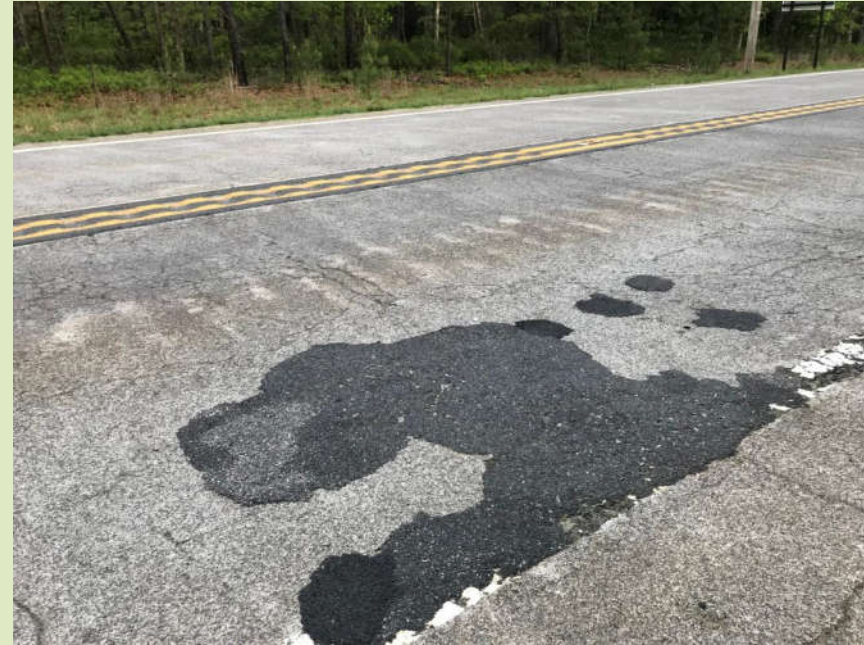
Products Advertised as HFST, but Not
HFST = Premature Failure

NOT HFST

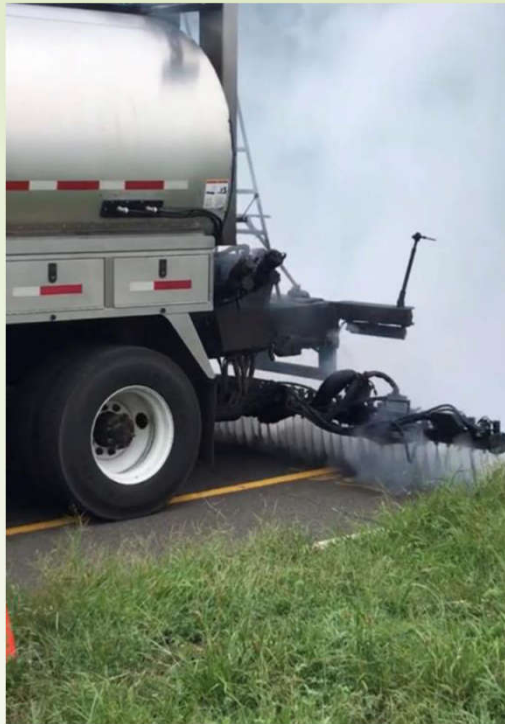
PG82-22 FR Binder Appl.

- ↳ What if we tried high friction aggregate with a highly modified asphalt binder?
 - ↳ Stellarflex PG82-22 FR
 - ↳ True Grade PG88-22
 - ↳ 7.5% Polymer
- ↳ Try some other aggregates?
Locally sourced
 - ↳ TRI Diabase (NJ)
 - ↳ Calcined Bauxite (Great Lakes Minerals)
 - ↳ Flint Rock (Oklahoma)

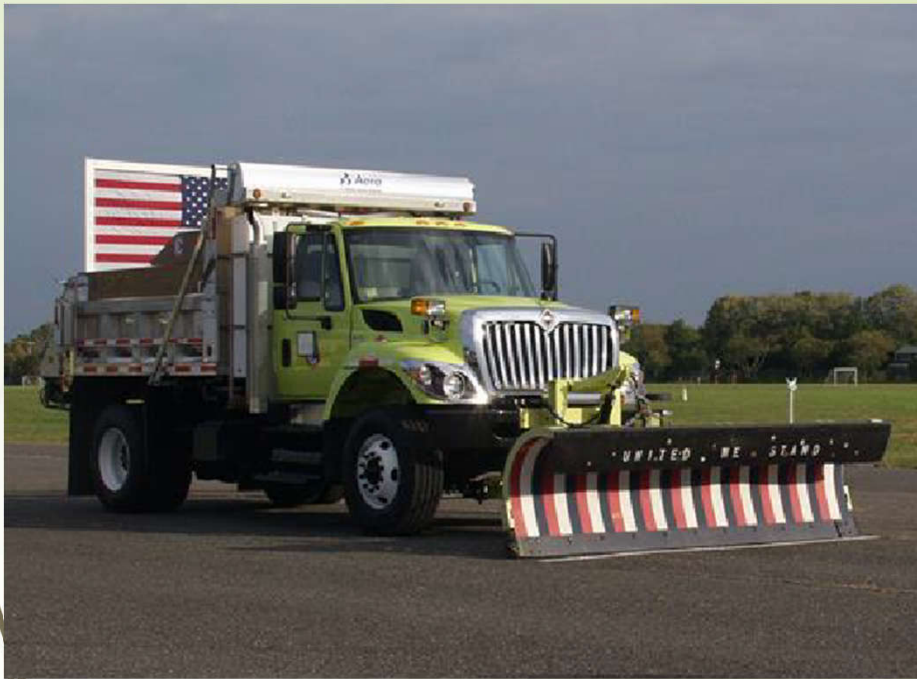
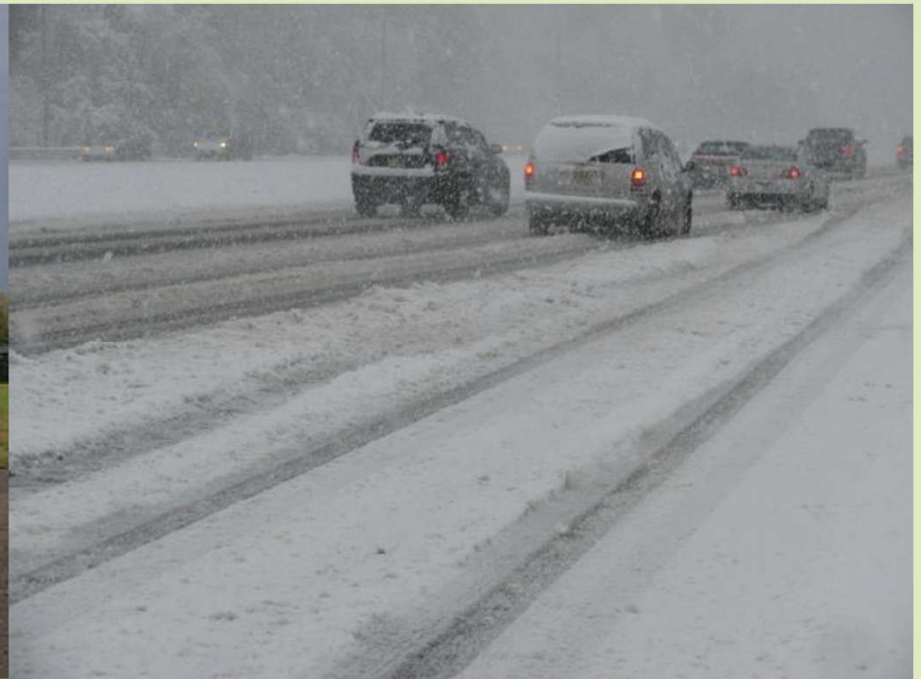
Challenges – Aggressive Snow Operations

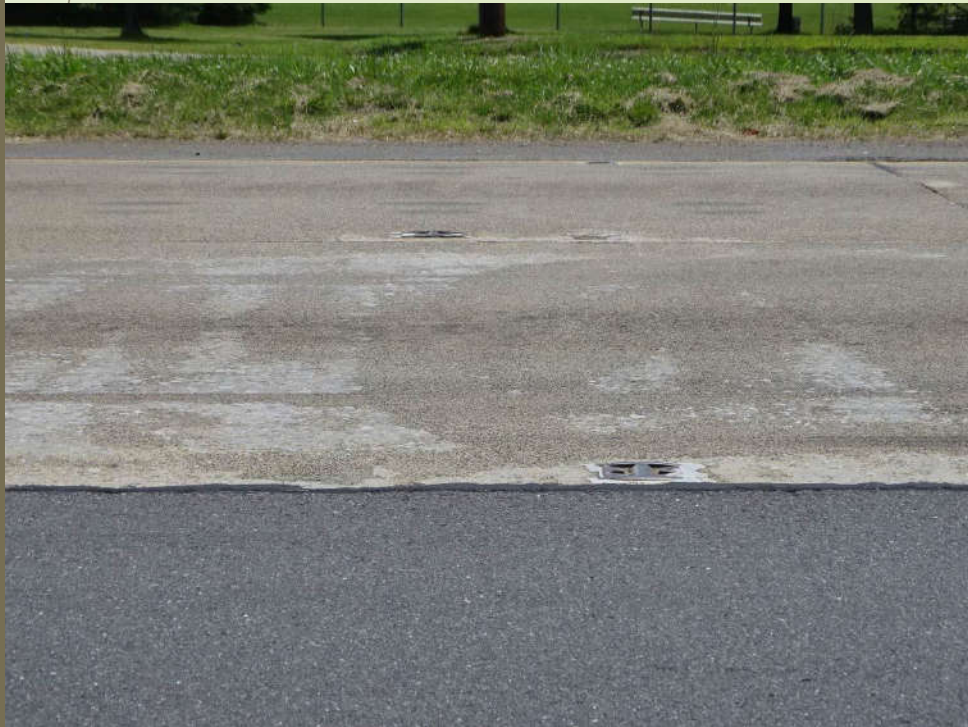
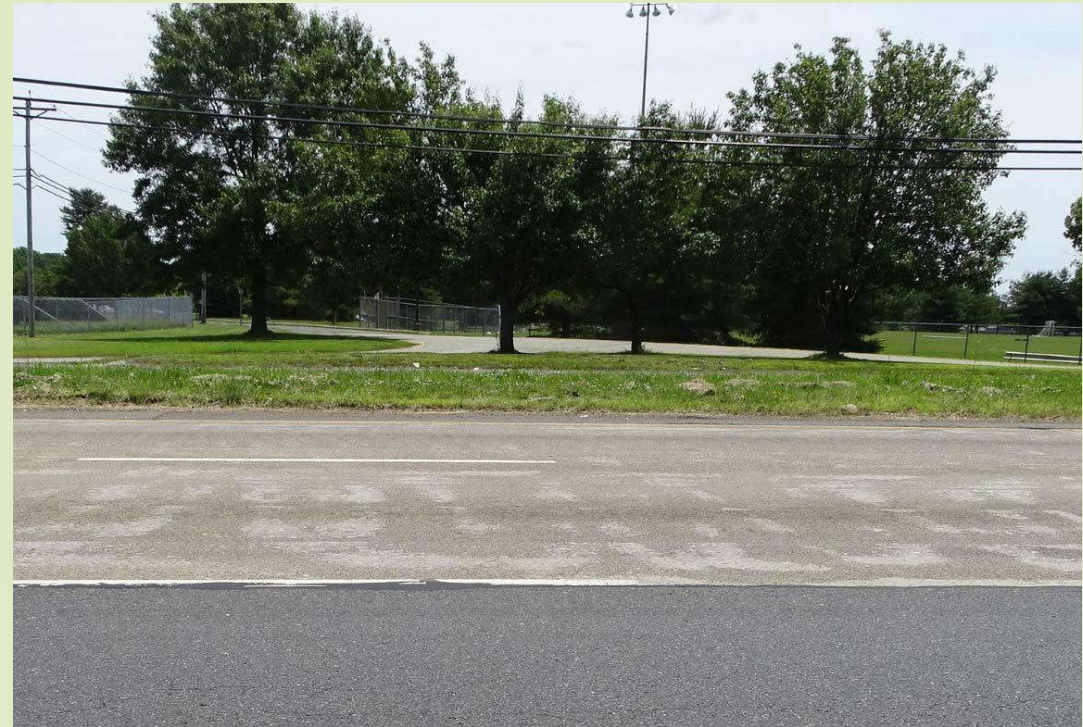
Challenges – Aggressive Snow Operations + Improper HFST Equipment
