INFLUENCE OF CRACKING AND CHLORIDE CONCENTRATION ON CORROSION TESTING

Aaron J. Strand, Matthew P. Adams, Matthew J. Bandelt
J.A. Reif, Jr., Department of Civil and Environmental Engineering
New Jersey Institute of Technology

21st Annual NJDOT Research Showcase
Innovation Breakout Session #2
Conference Center at Mercer
23rd October 2019

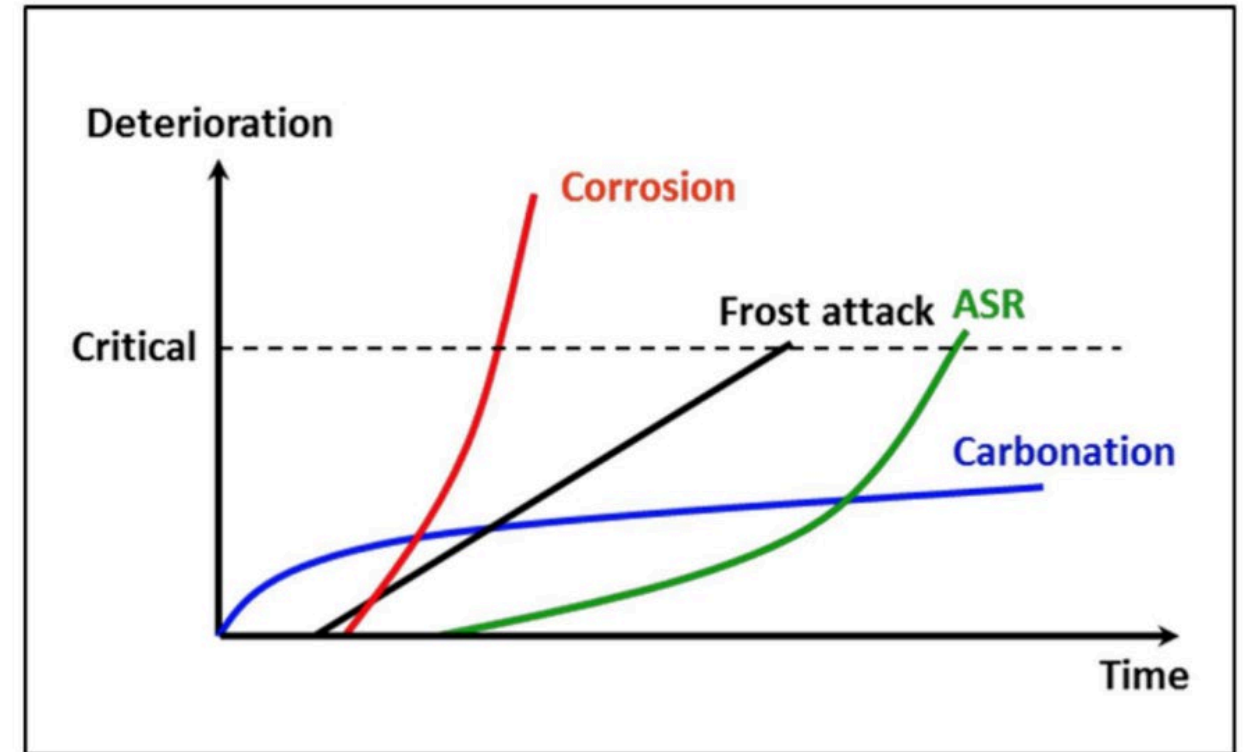
Simplified deterioration mechanism (Aboutaha, 2004)

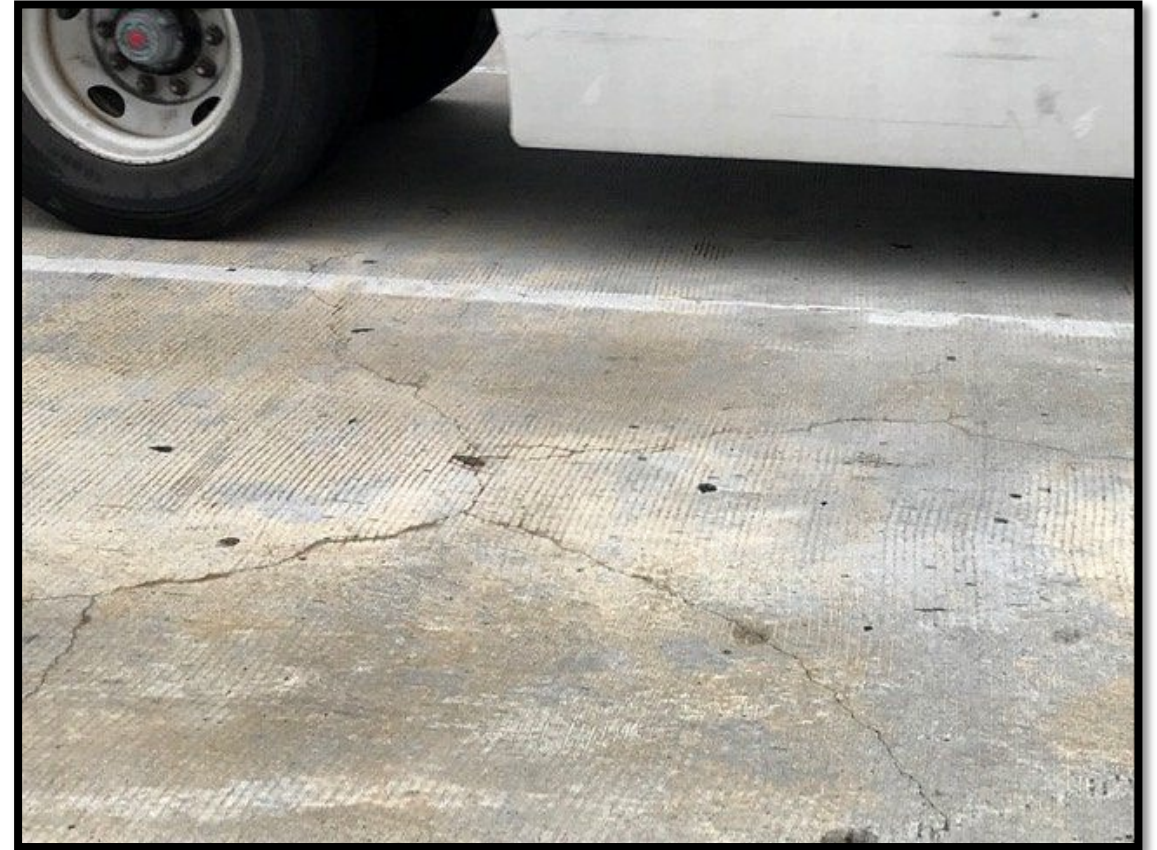
SOURCES OF BRIDGE DECK CRACKING

- Plastic Shrinkage
- Drying Shrinkage
- Surface Tears (Finishing)
- Flexure/Deflection of the Deck
- Reflection of Underlying Cracks and Joints
- Temperature Related Mechanisms

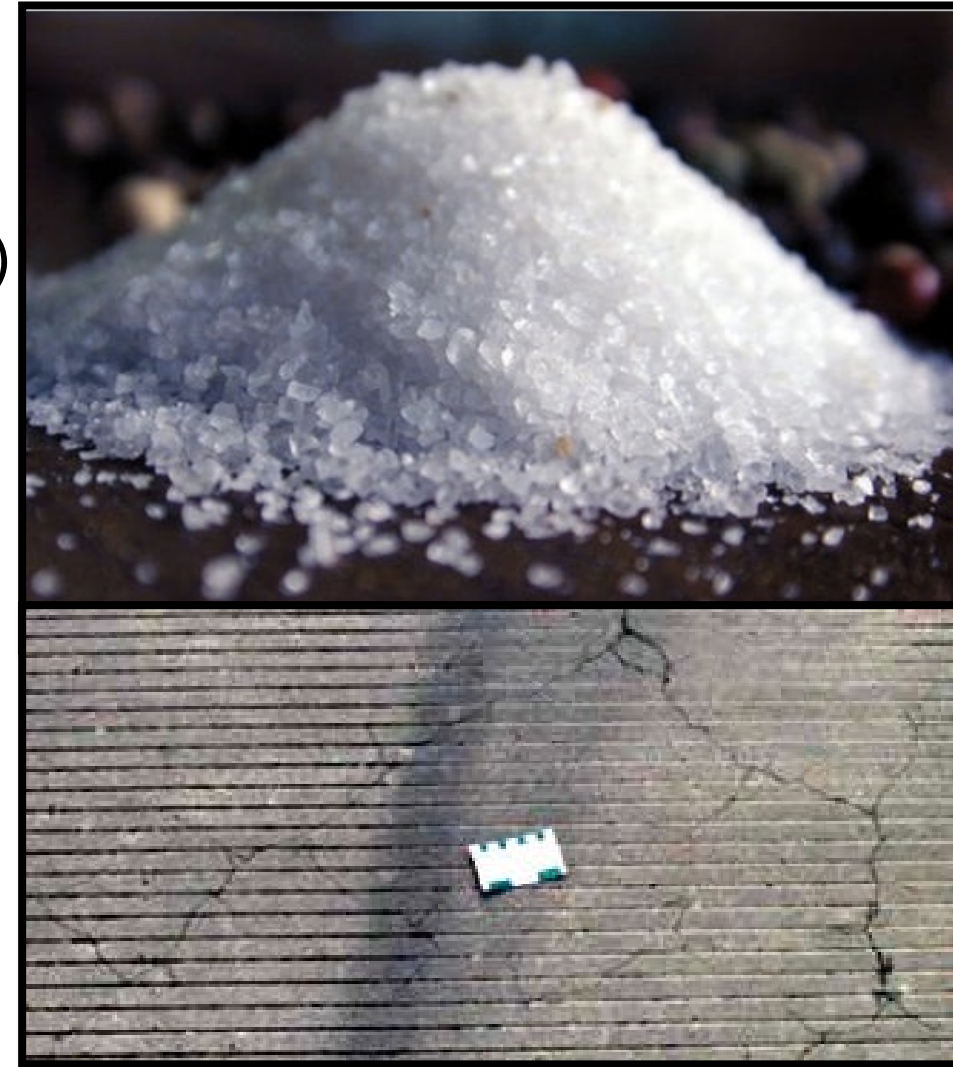
MATERIAL SPECIMEN CONDITIONS

- Five brine solutions were used
 - 1.5% NaCl solution
 - 3.0% NaCl solution (specified in ASTM G109)
 - 4.5% NaCl solution
 - 6.0% NaCl solution
 - 9.0% NaCl solution
- Pre-cracking per salt level
 - One uncracked specimen
 - One flexure pre-cracked specimen

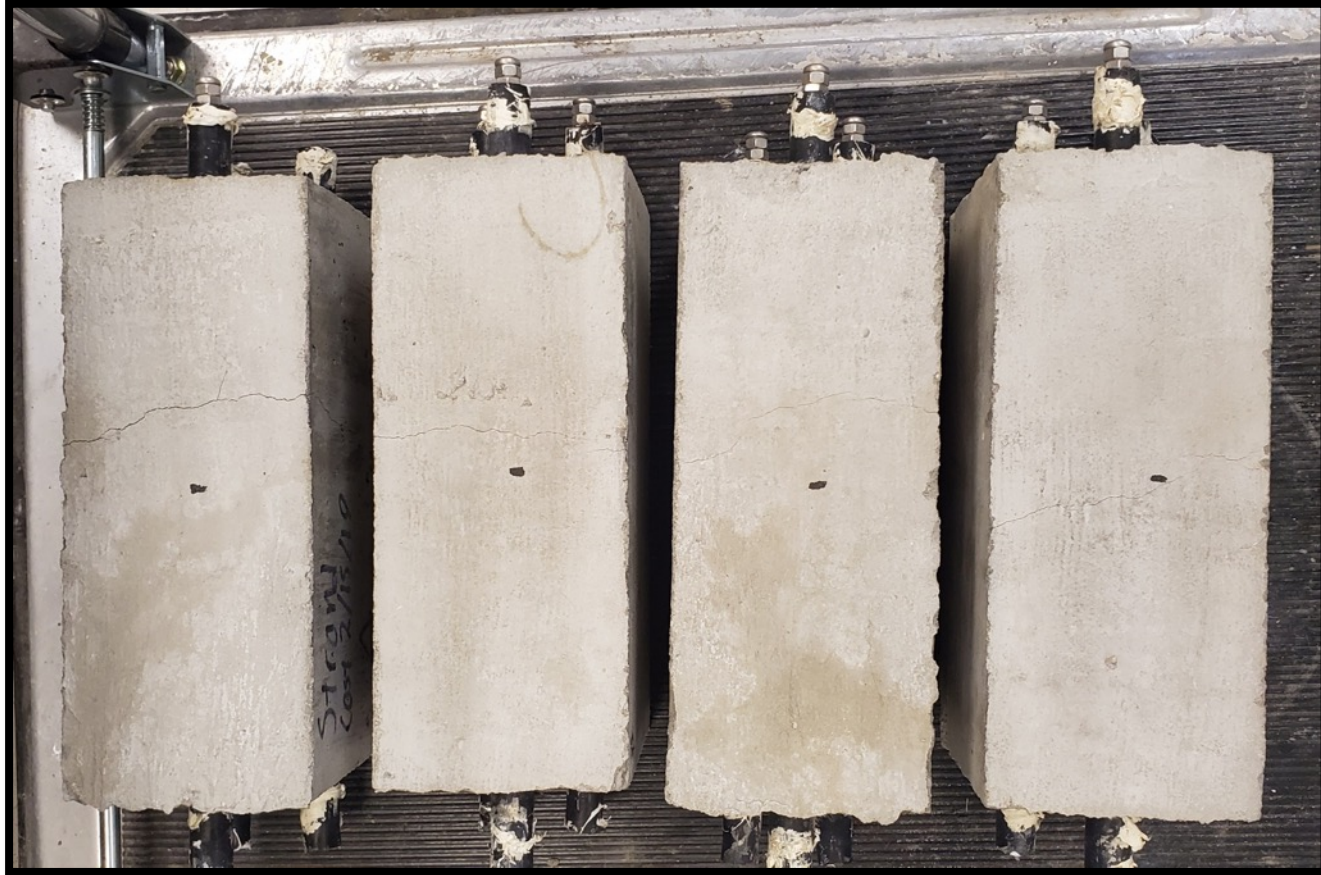
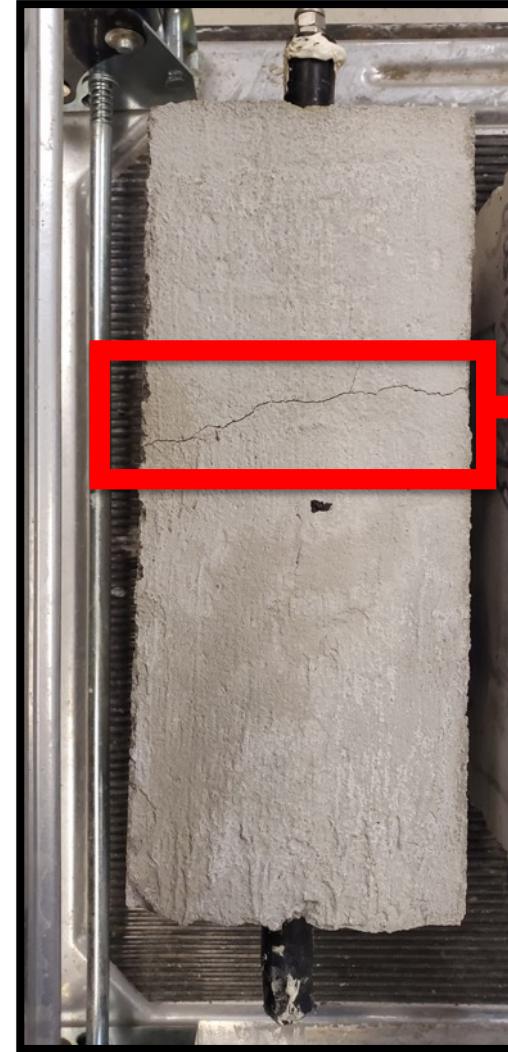
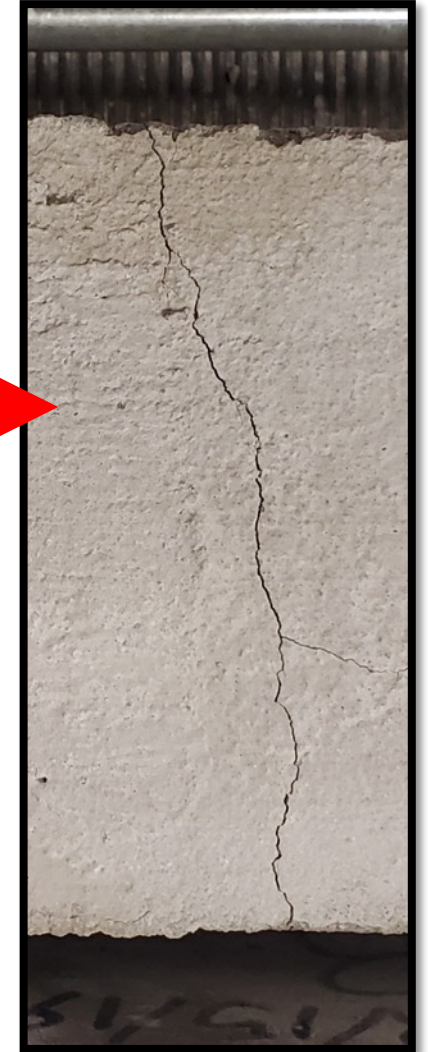
PHOTOS OF CRACKED SPECIMENS

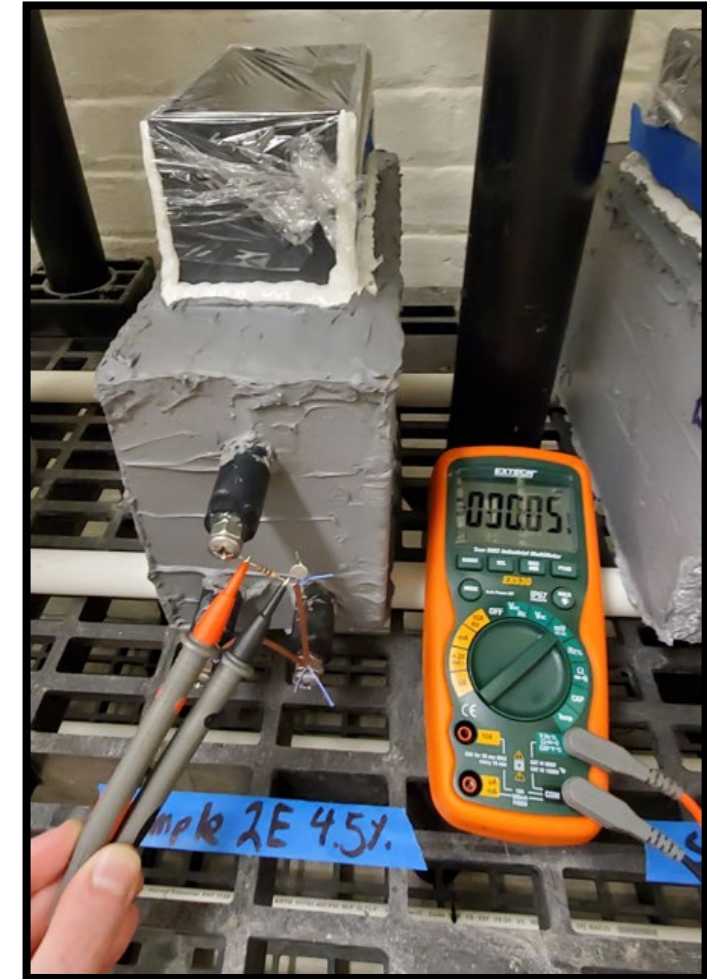
DATA COLLECTION TIMING

- ASTM G109
 - Every month, one week into ponding
- This project
 - Every third day and on biweekly salt solution addition or removal

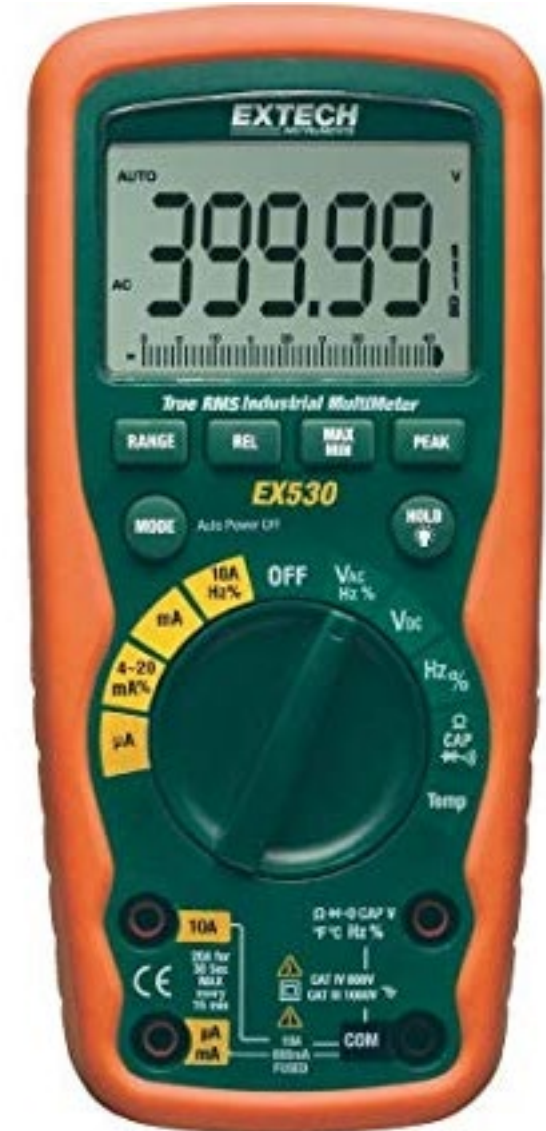
MATERIAL SPECIMEN TESTING

- Measure voltage across resistor and calculate macrocell current
 - A macrocell current value above 10 μA is indication of chlorides reaching reinforcement steel (from ASTM G109)

$$I_j = V_j/100$$

I_j is macrocell current,
 V_j is measured voltage across 100 Ω resistor in volts

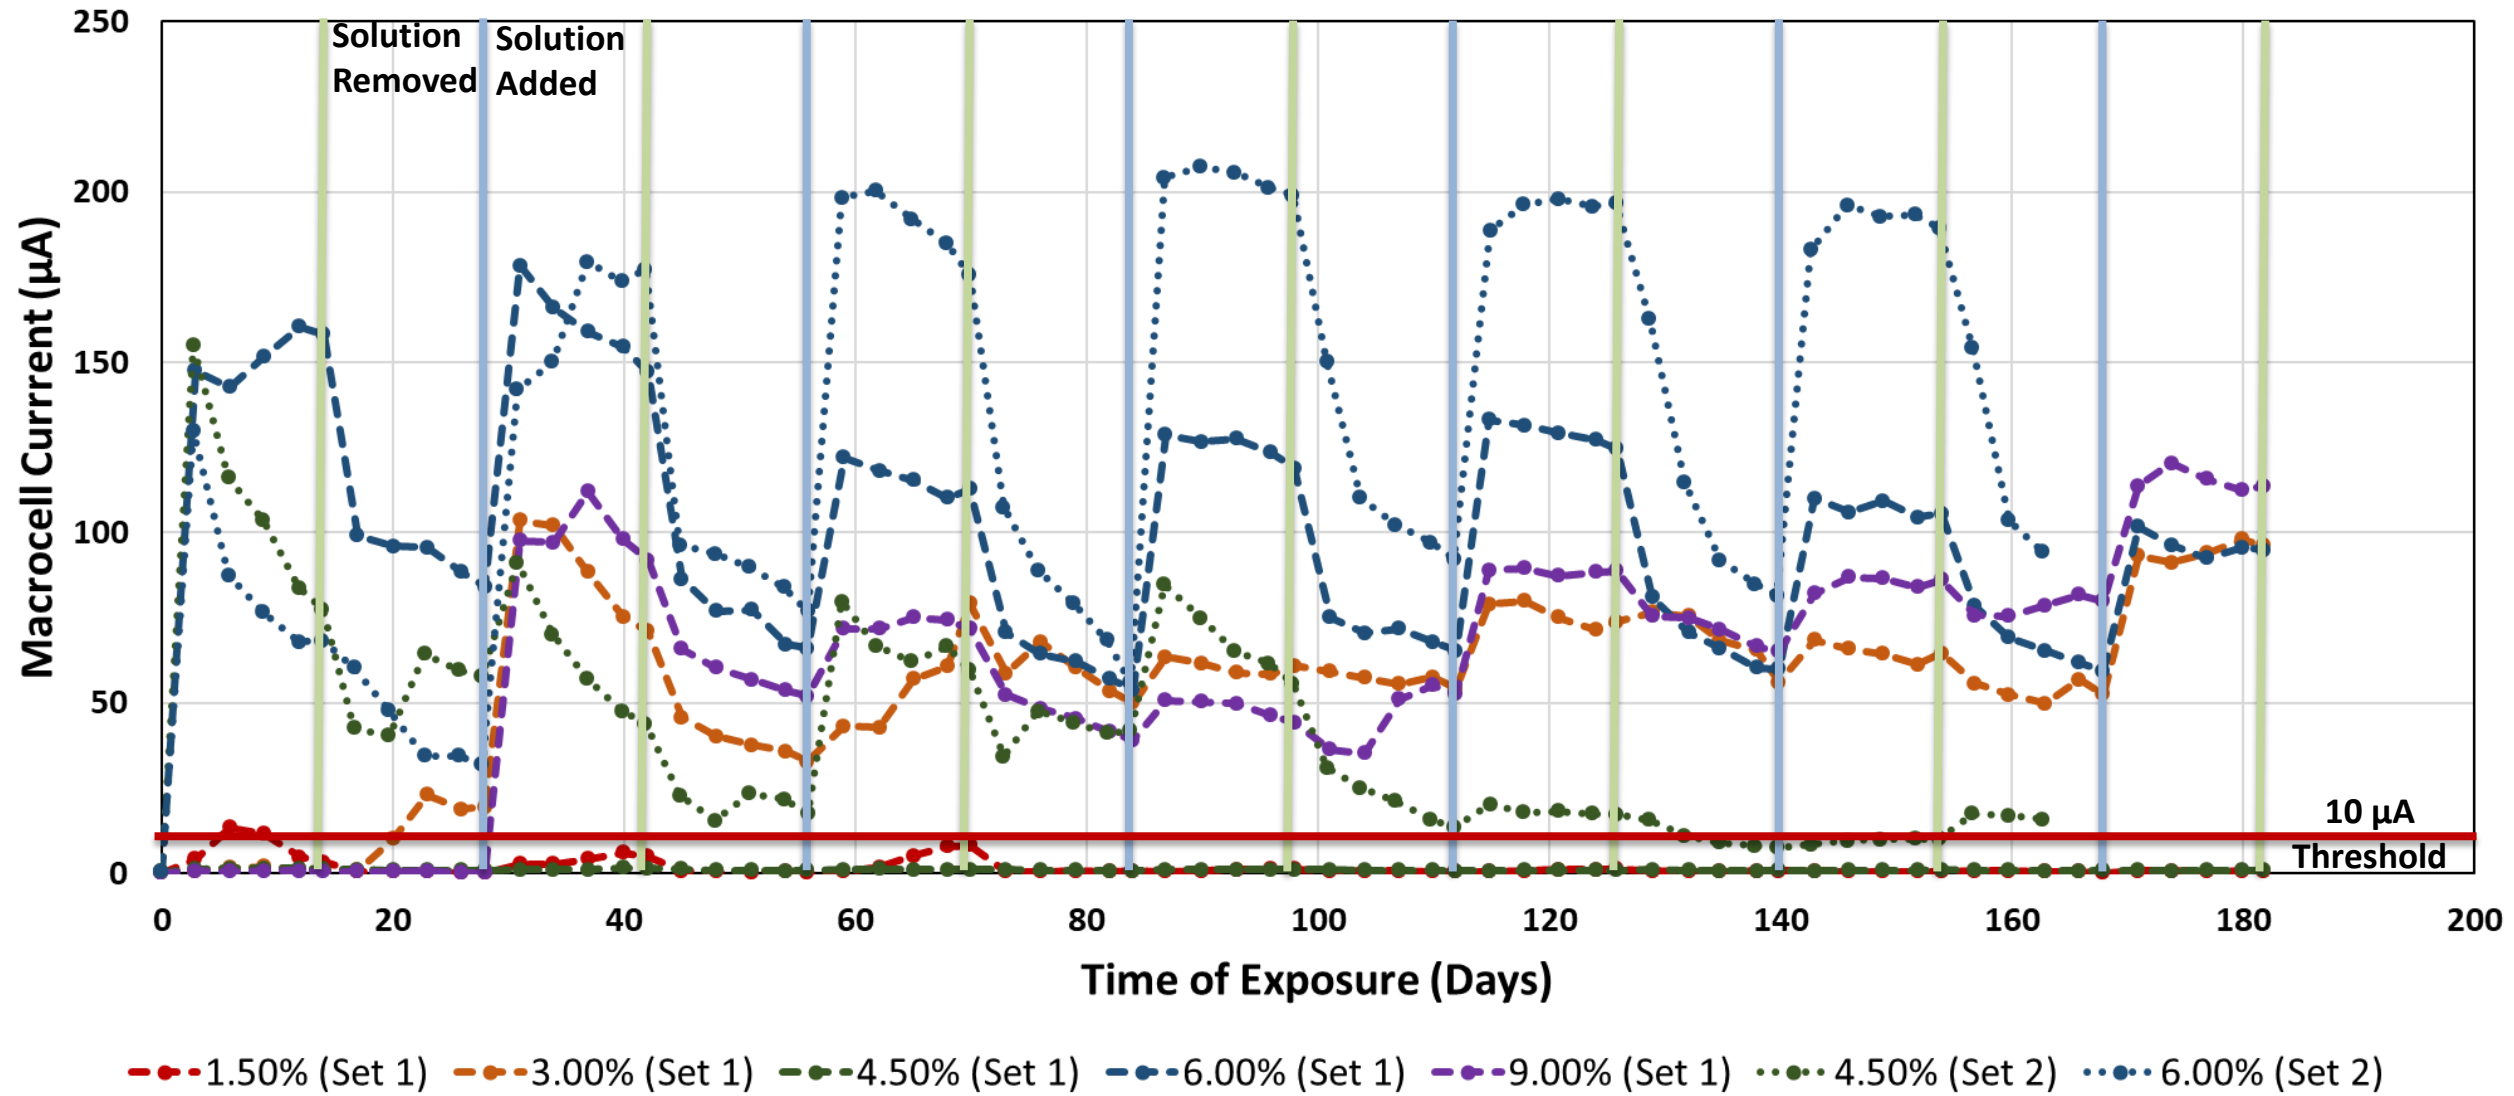
CRACKED SPECIMENS MACROCELL CURRENT RESULTS

- For **cracked** specimens:
 - Threshold met for solutions **greater than 3%**.
 - Reached at a **greatly accelerated rate**
- For **un-cracked** specimens:
 - At **all** chloride levels no corrosion appears to have initialized

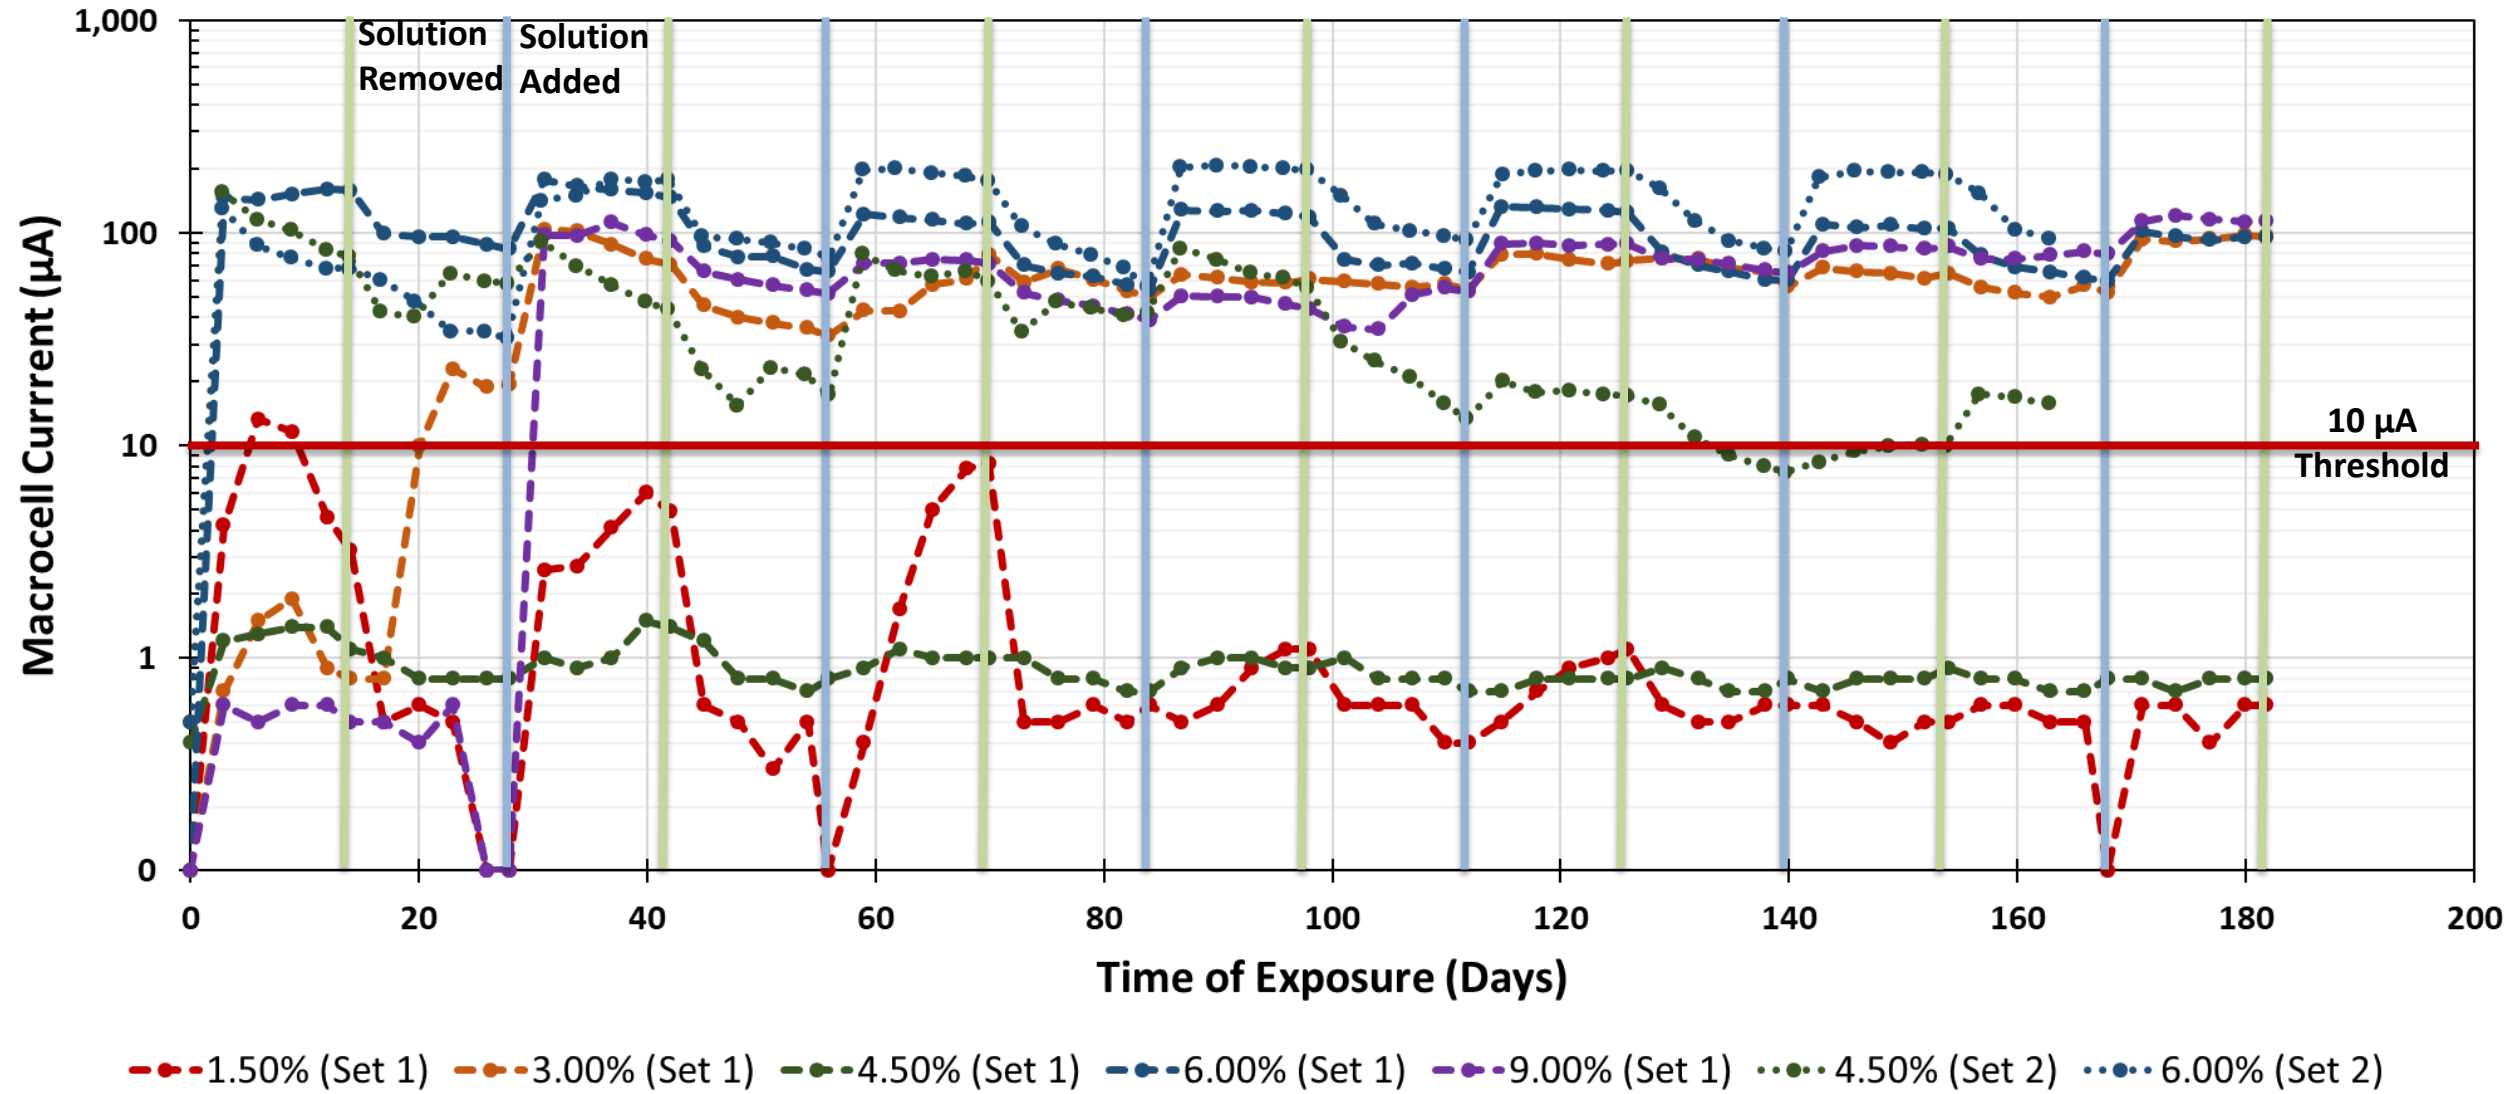
CRACKED SPECIMENS MACROCELL CURRENT RESULTS

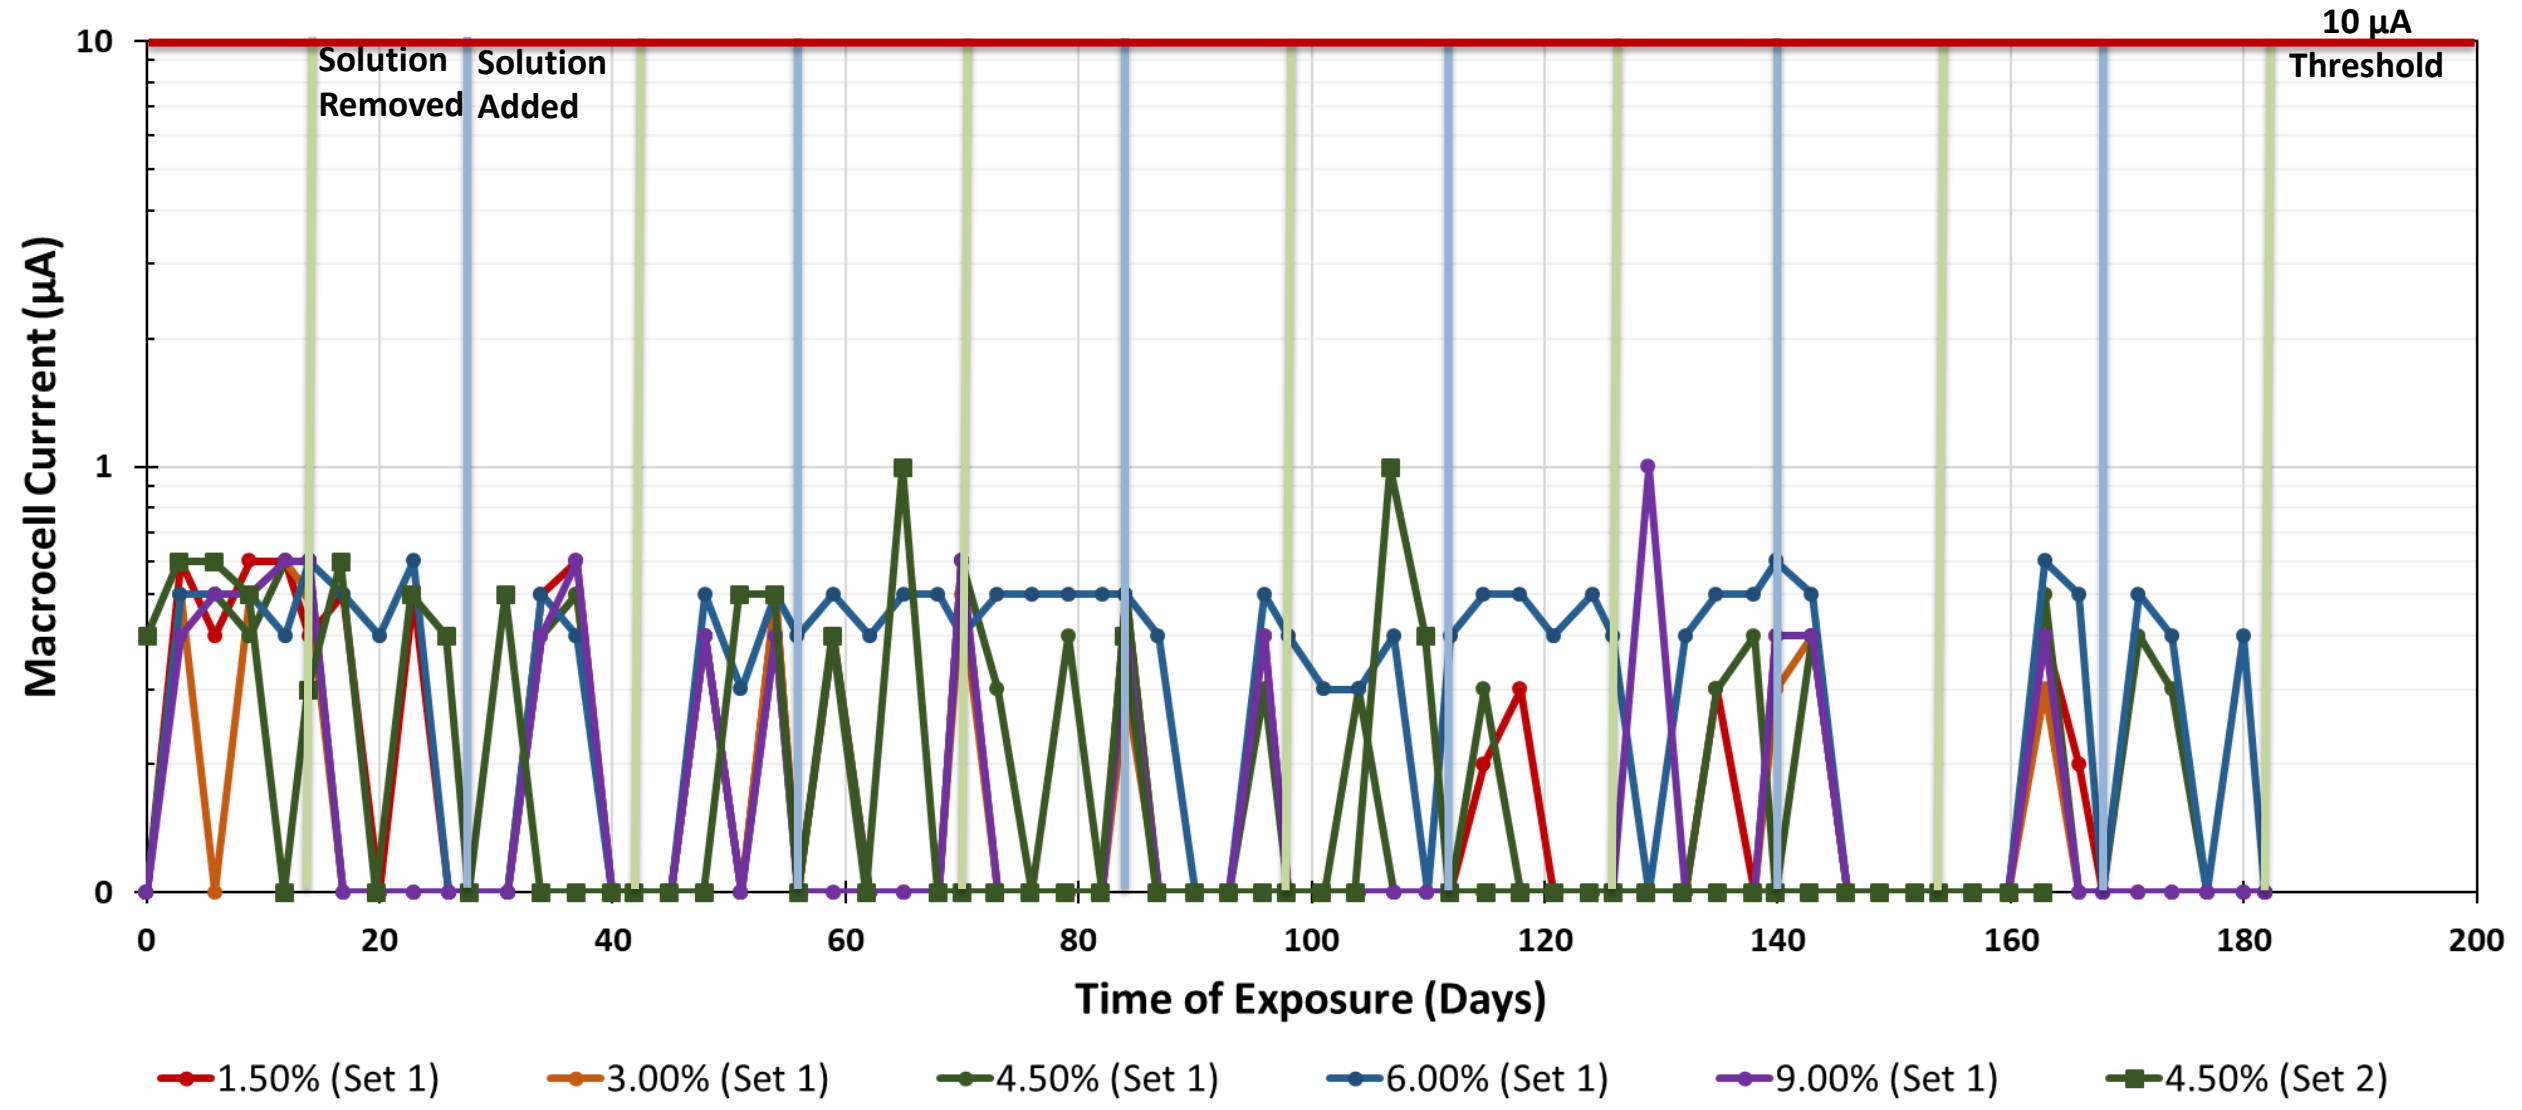
UNCRACKED SPECIMENS MACROCELL CURRENT

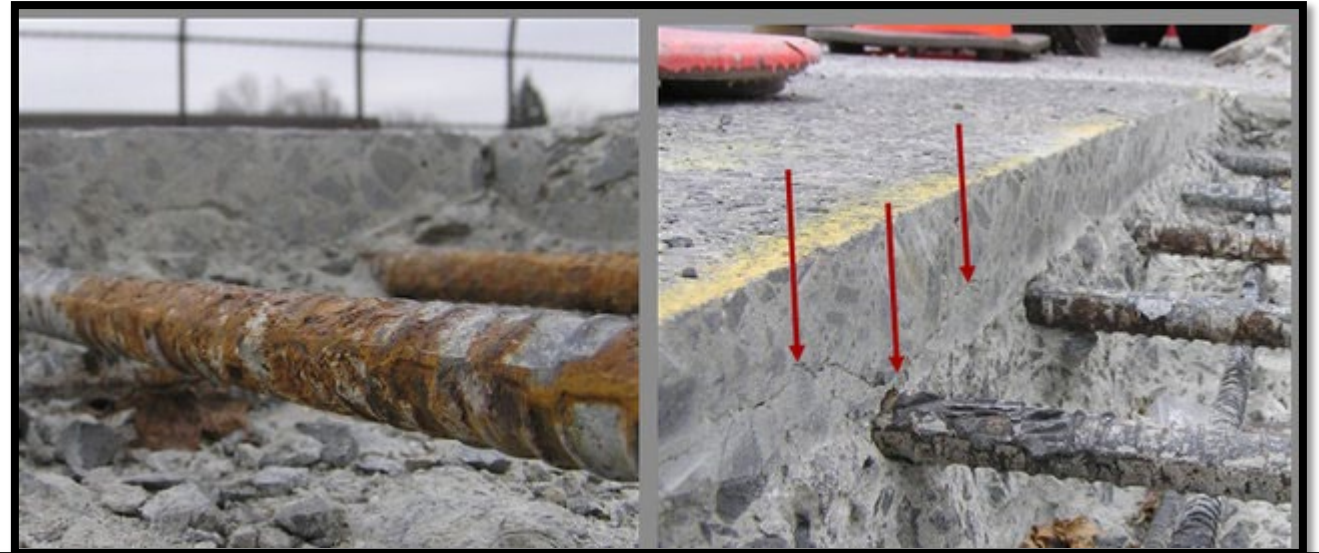
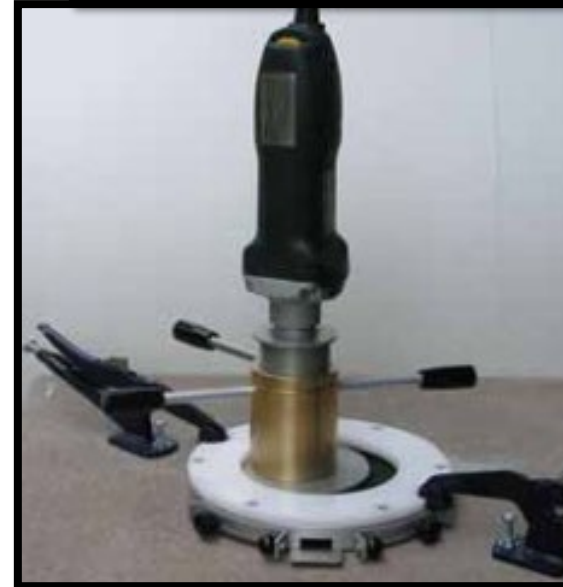
FUTURE PLANS

- Continue ponding cycles until uncracked (diffusion) specimens reach threshold
- Use specimens for chloride profile analysis
