## HIGH FRICTION SURFACE TREATMENT - LESSONS LEARNED

# NJDOT High Friction Surface Treatment Update

# NJDOT HIGH FRICTION SURFACE TREATMENT (HFST)

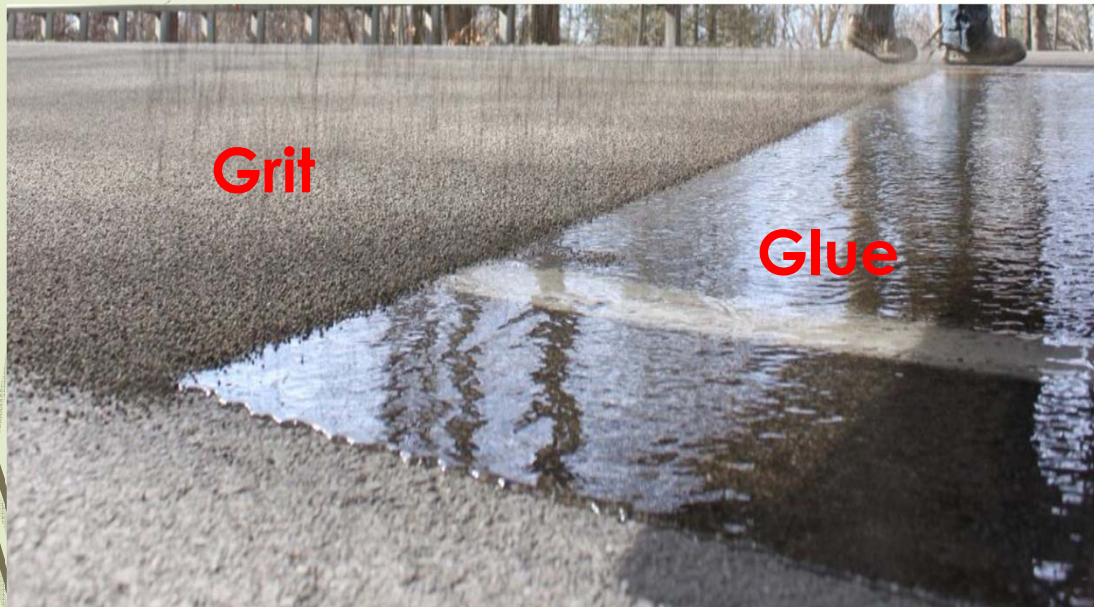
- ▶ HFST is a safety countermeasure
  - ▶ polish-resistant calcined bauxite aggregate (**grit**)
  - ▶ bonded to the pavement surface using a polymer resin binder (**glue**)

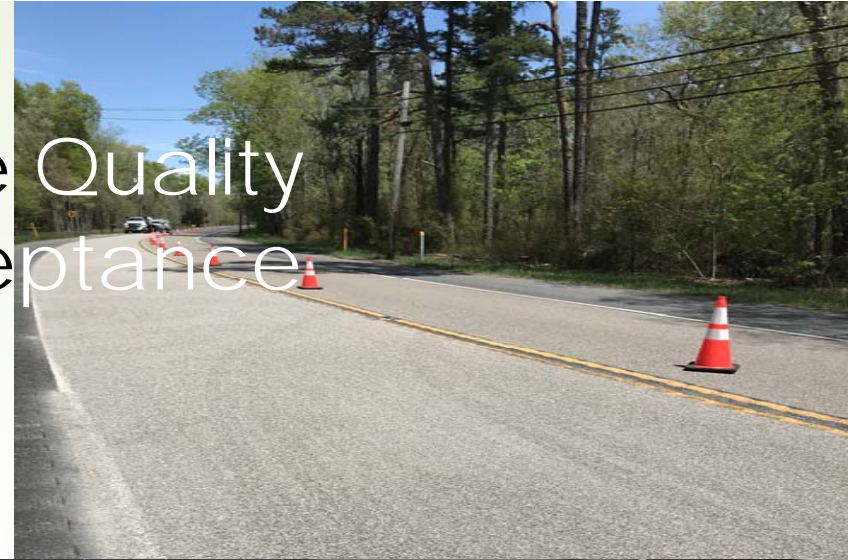
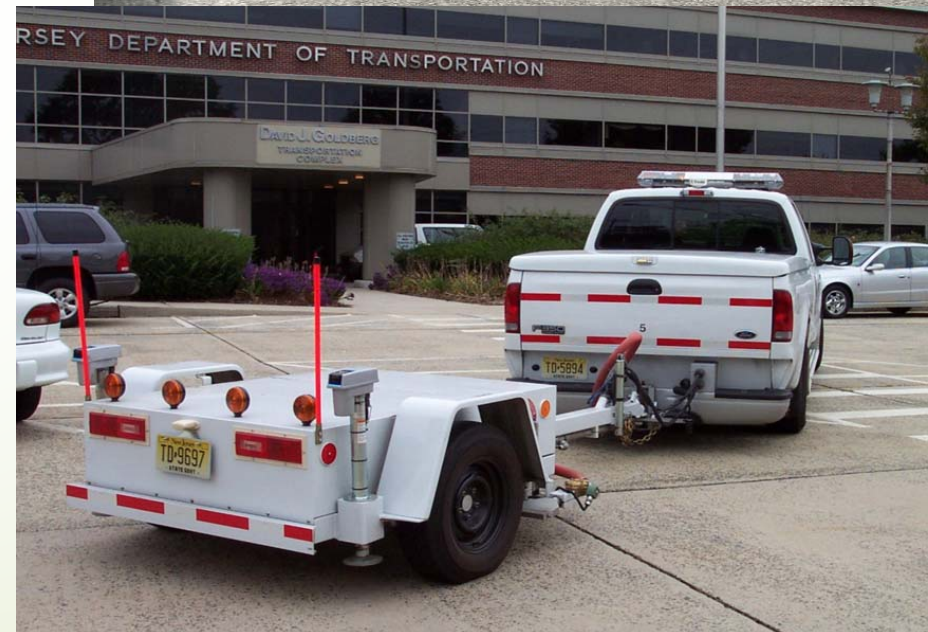
# NJDOT SPEC. Surface Quality Skid Resistance Acceptance

- RE performs visual inspection of HFST
- RE can reject HFST based on visual assessment and require corrective action
- If RE visually approves HFST, then NJDOT Pavement Management performs Skid Resistance Testing using ASTM Test Method E 274 for Initial Acceptance
  - Average Minimum SN  $\geq 65$**

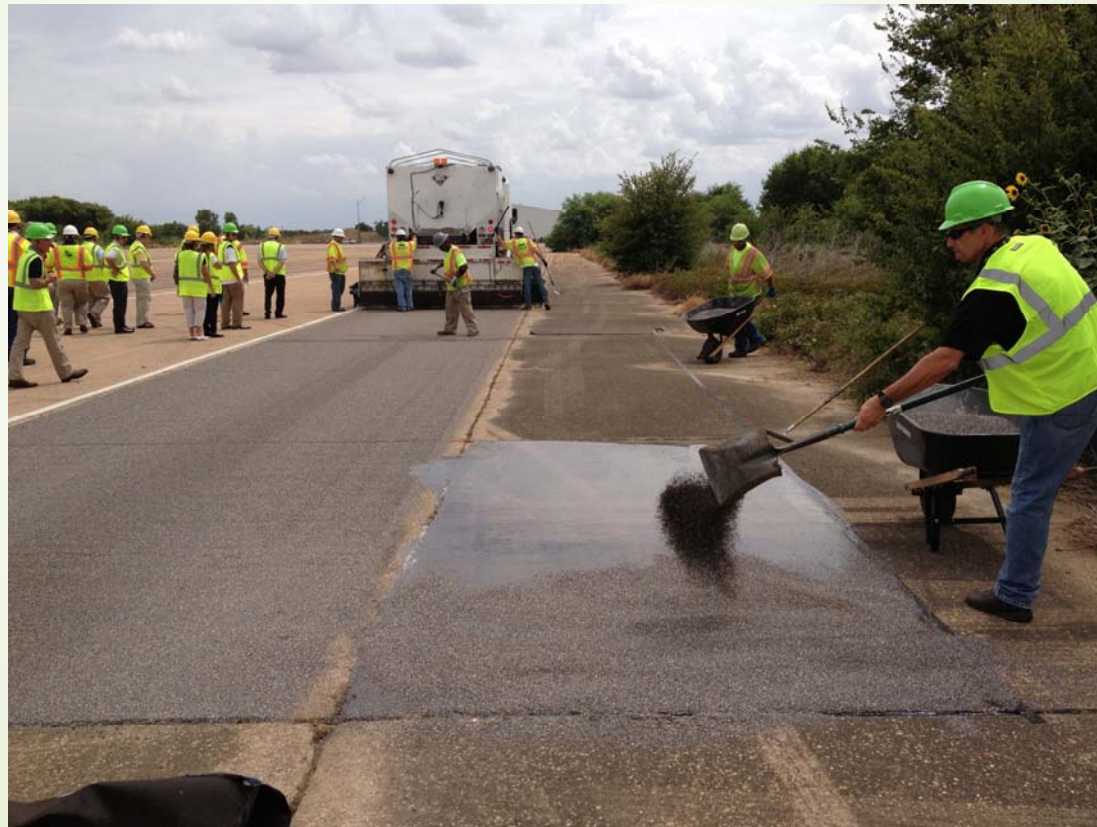
# **TRUCK MOUNTED HFST APPLICATION EQUIPMENT VS. MANUAL APPLICATION**

## Manual HFST Placement or Mechanically Assisted Installation = Premature Failure

- **Automated equipment matters** - properly functioning and calibrated
  - Consistent binder thickness
- Make sure **pavement condition is GOOD!**
  - Visual condition assessment NOT ADEQUATE!
- Not all products advertised as HFST meet NJDOT specification or FHWA/AASHTO requirements
- Experience and workmanship matters
- NJDOT still in the pilot phase with HFST
- Researching HFCS. Stay Tuned!

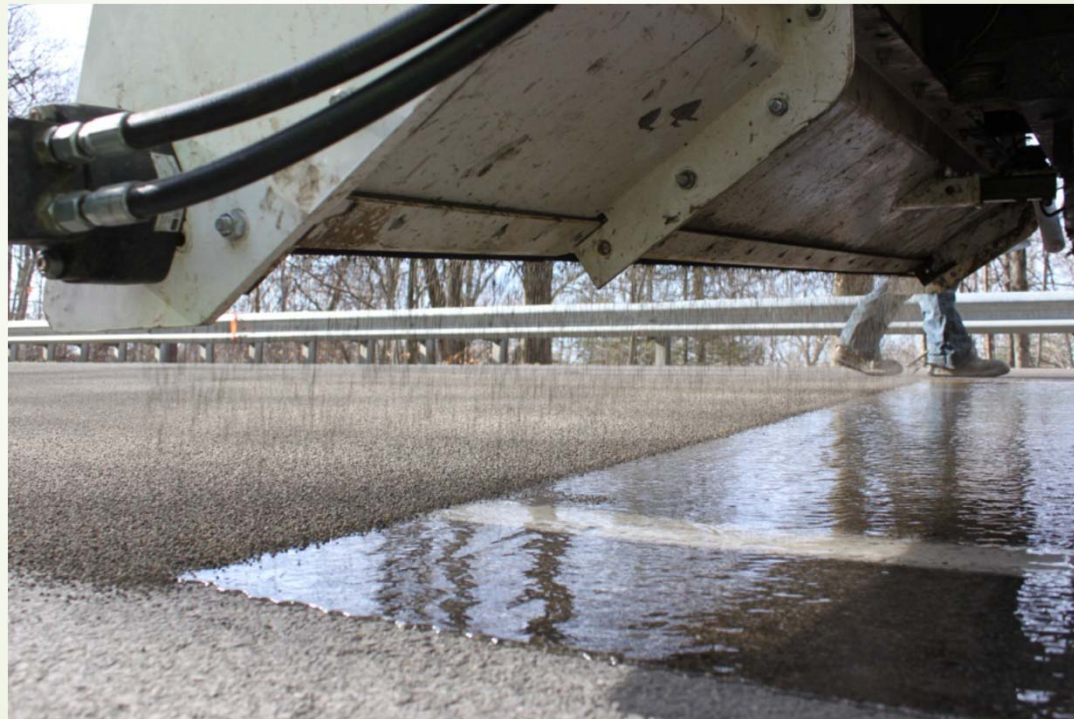
# Automated Equipment Installation = Best Opportunity for Success

Automated Equipment = Binder + Aggregate placed by machine without manual spreading or leveling

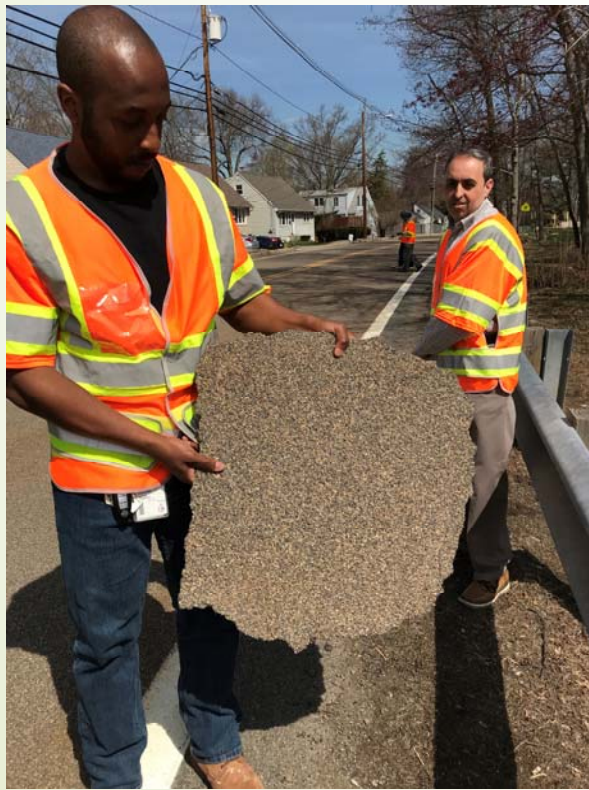
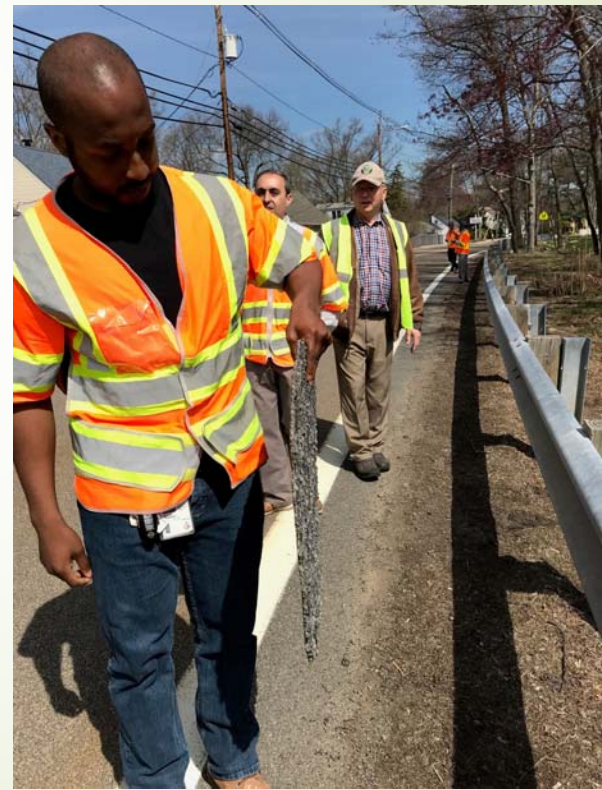
# Pavement Condition Matters

# HFST Failure Forensic Investigation - Conclusions

- Asphalt pavement was significantly aged or contained high amounts of RAP when placed in 2014
- Areas within the project showed excessive amounts of epoxy binder thickness and high variability of thickness
- Combination of poor asphalt and excessive epoxy binder caused accelerated delamination failures in the asphalt substrate

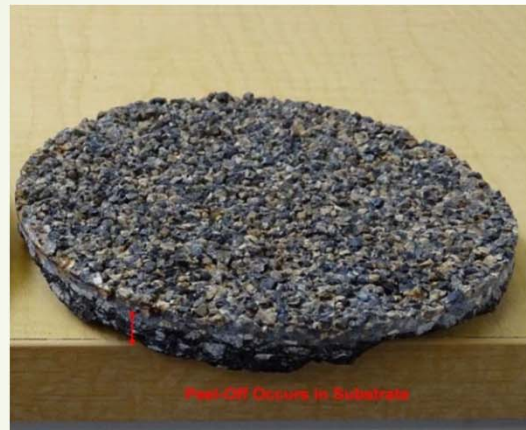
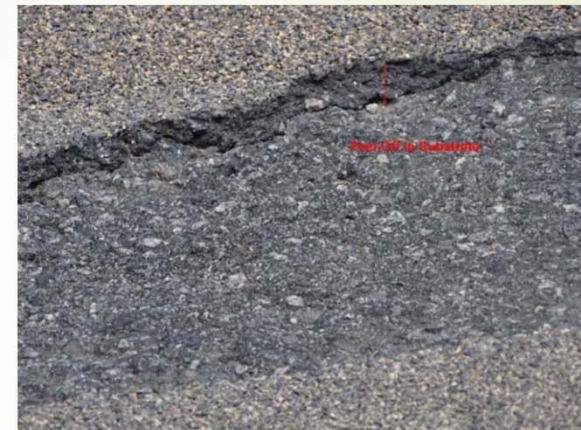
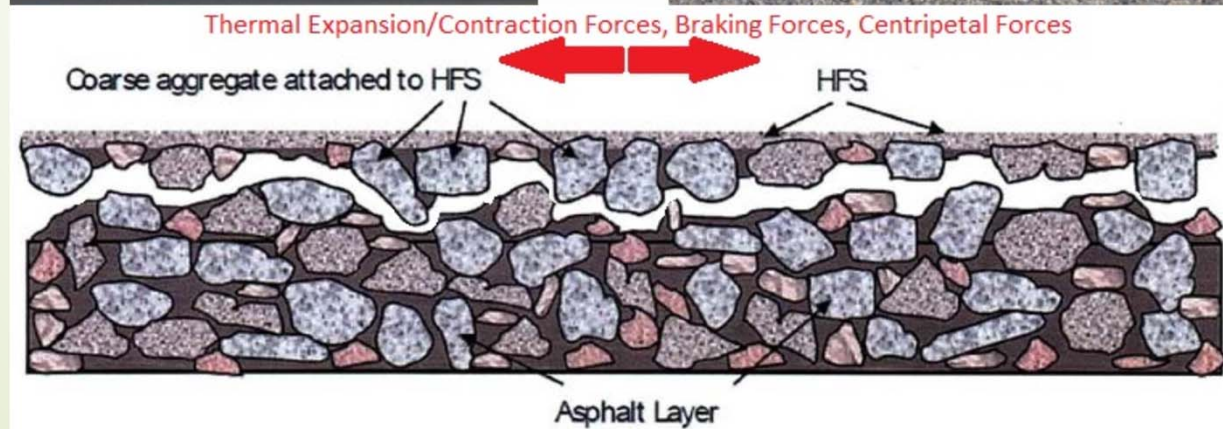
# Pavement Condition Matters

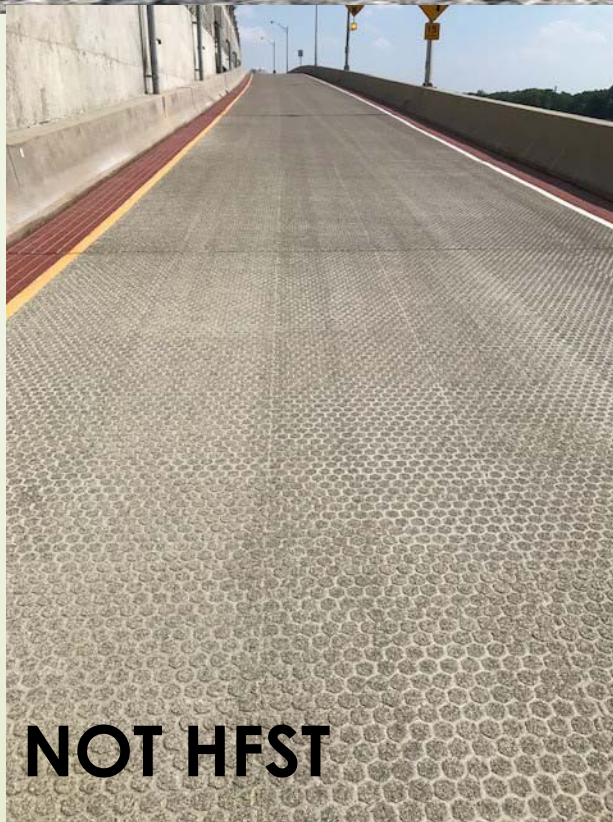
# Products Advertised as HFST, but Not HFST = Inadequate Skid Resistance

Route 29 Southbound to Lalor St. Ramp						
Pass 1		Pass 2		Pass 3		Average
MP	SN40	MP	SN40	MP	SN40	SN40
0.000	40.5	0.000	37.4	0.000	36.7	38.2
0.036	37.2	0.024	32.9	0.035	36.4	35.5
0.071	34.1	0.054	31.4	0.073	32.7	32.7
0.109	52.2	0.085	50.0	0.111	46.5	49.6
0.144	51.4	0.119	50.1	0.141	50.4	50.6
0.174	48.2	0.142	49.7	0.163	48.4	48.8
0.203	49.5	0.168	45.4	0.186	51.8	48.9
0.229	54.4	0.200	54.2	0.206	50.7	53.1

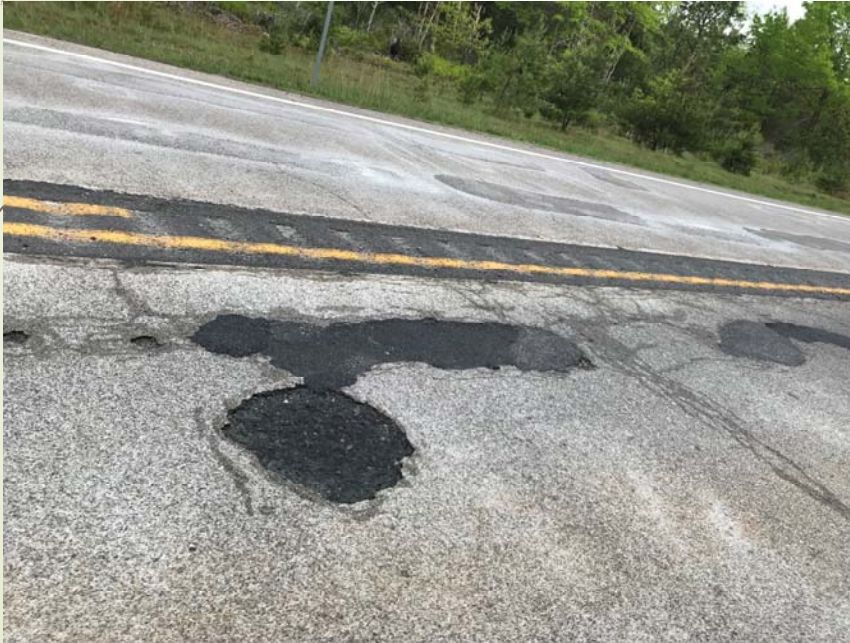
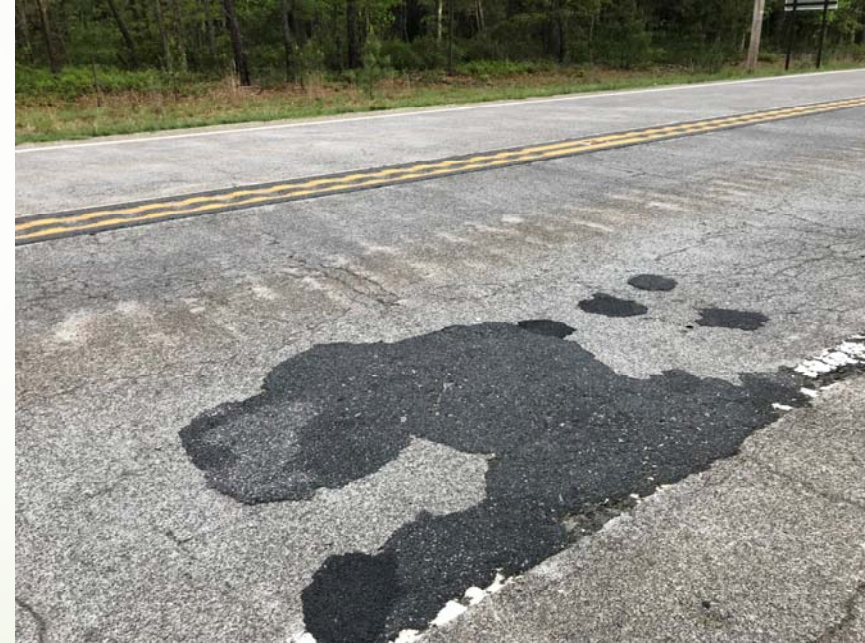
## Products Advertised as HFST

**NOT HFST (as per NJDOT specification)**

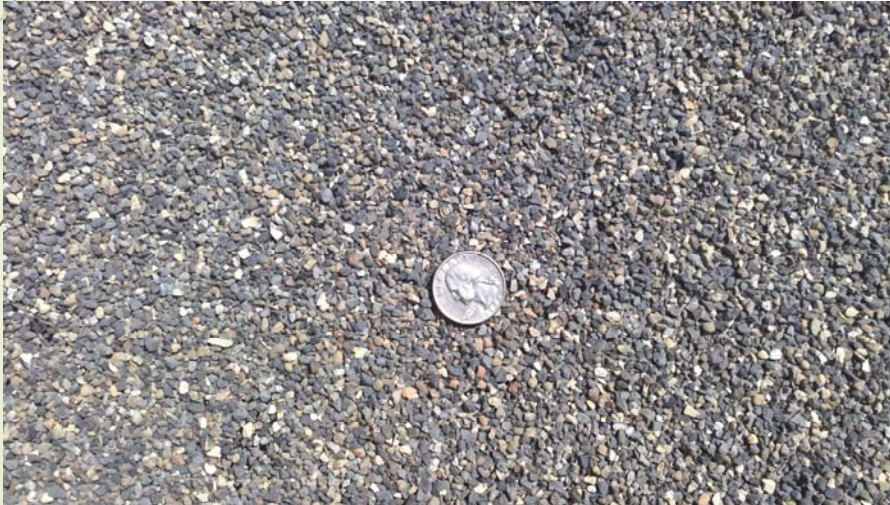
# Route 68 High Friction Chip Seal (HFCS) Case Study

- What if we tried high friction aggregate with a highly modified asphalt binder?
  - Stellarflex PG82-22 FR
    - True Grade PG88-22
    - 7.5% Polymer
- Try some other aggregates?  
Locally sourced
  - TRI Diabase (NJ)
  - Calcined Bauxite (Great Lakes Minerals)
  - Flint Rock (Oklahoma)

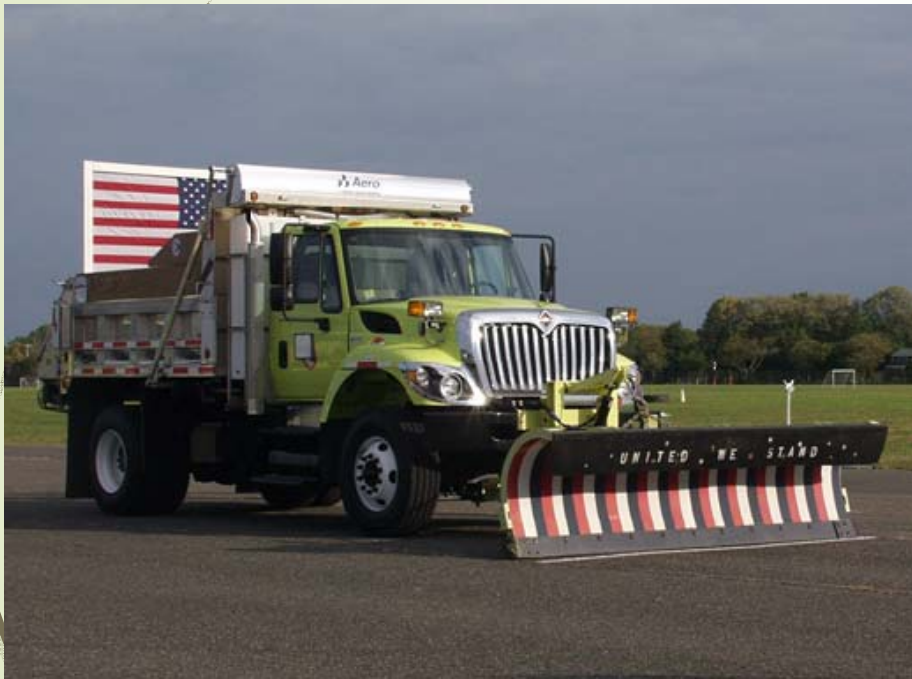
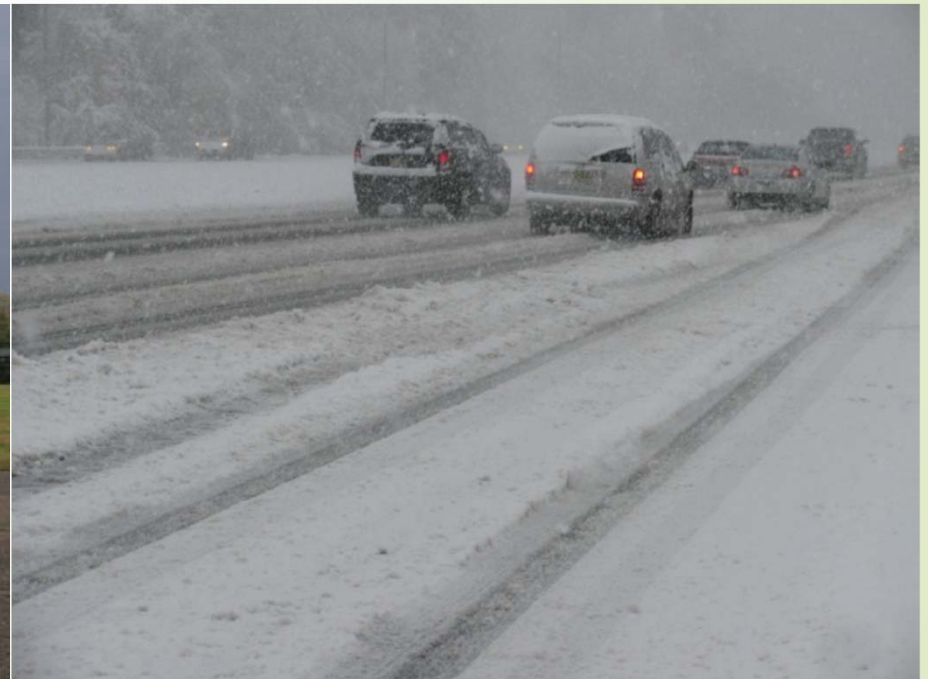
# Challenges – Aggressive Snow Operations

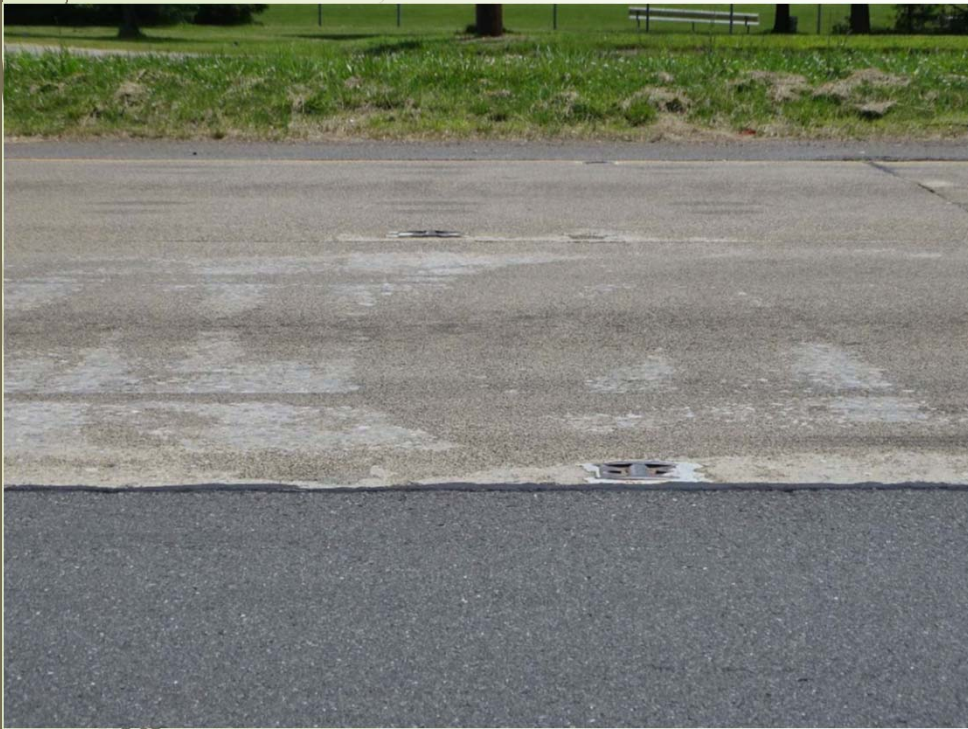
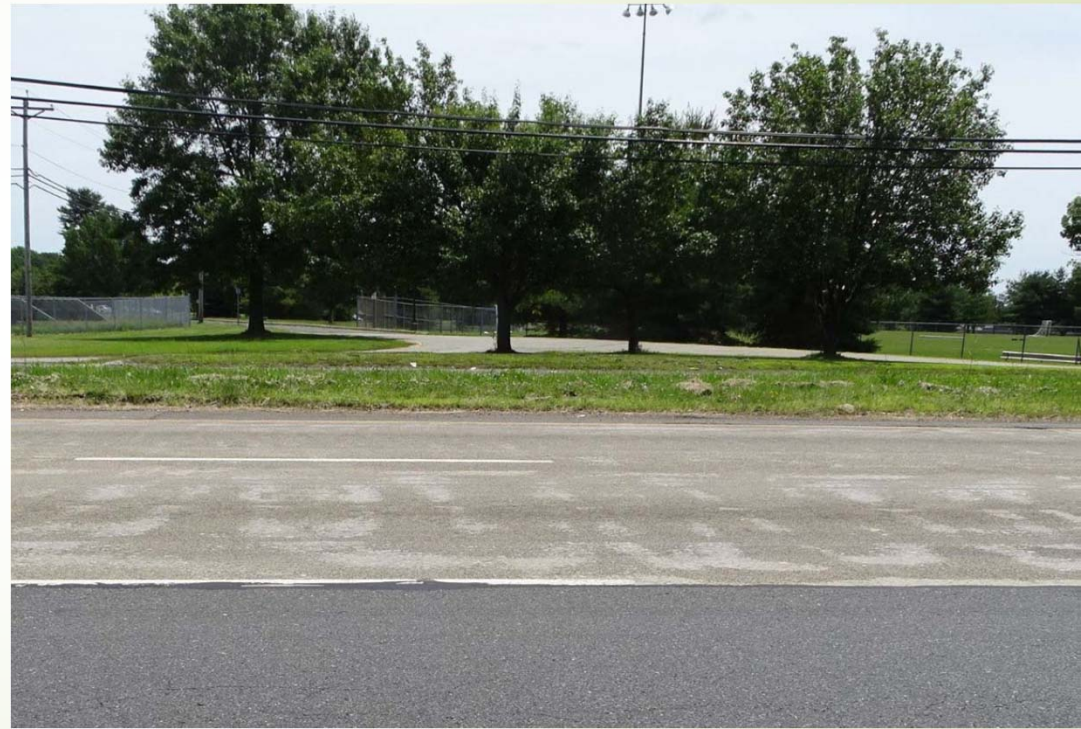
## Challenges – Aggressive Snow Operations + Improper HFST Equipment
