Weather-Savvy Roads Pilot Program

Final Report

June 13, 2022

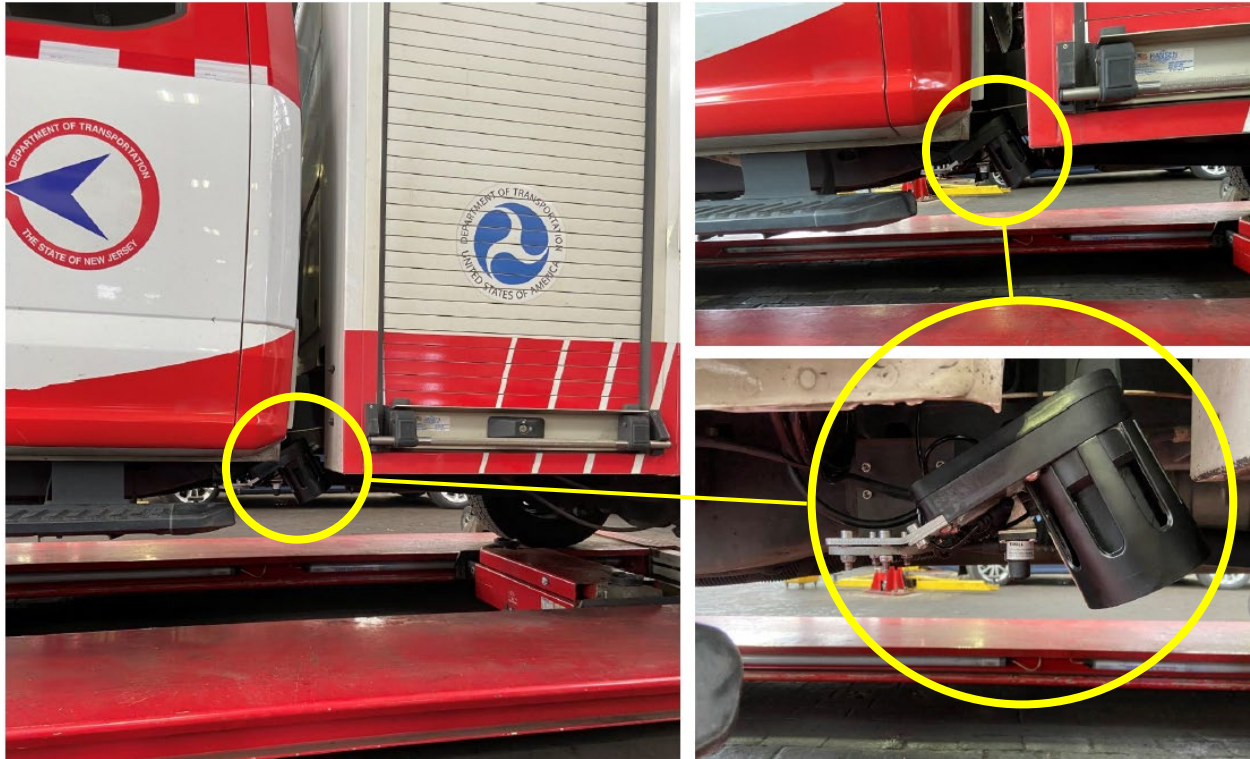
Figure 6. Vaisala MD30 base sensor installed on the SSP truck (Source: NJIT)

- On the SSP trucks (modified Ford F-350) the sensor was installed on the vehicle undercarriage on the driver's side using a specialized bracket and facing downward in the wheel track. The air temperature and humidity sensor was detached and installed on the frame of the overhead DMS sign mounted on the vehicle's rooftop. The air temperature and humidity sensor was mounted on a magnetic bracket and was connected to the MD30 sensor base with an appropriate cable. See Figure 6 and Figure 7 for illustration.

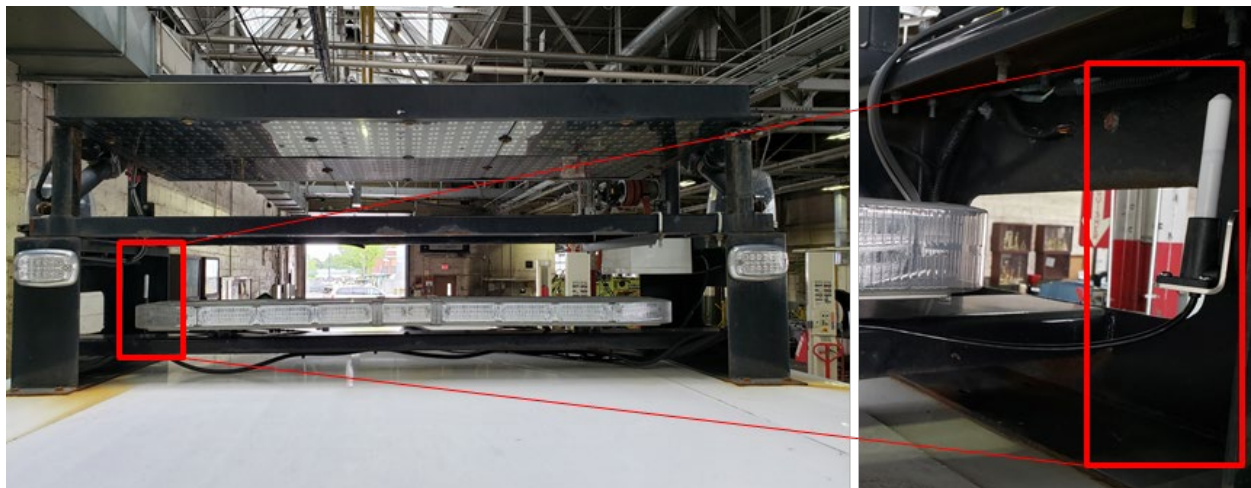
Figure 7. Air temperature and humidity sensor installed on the SSP truck (Source: NJIT)

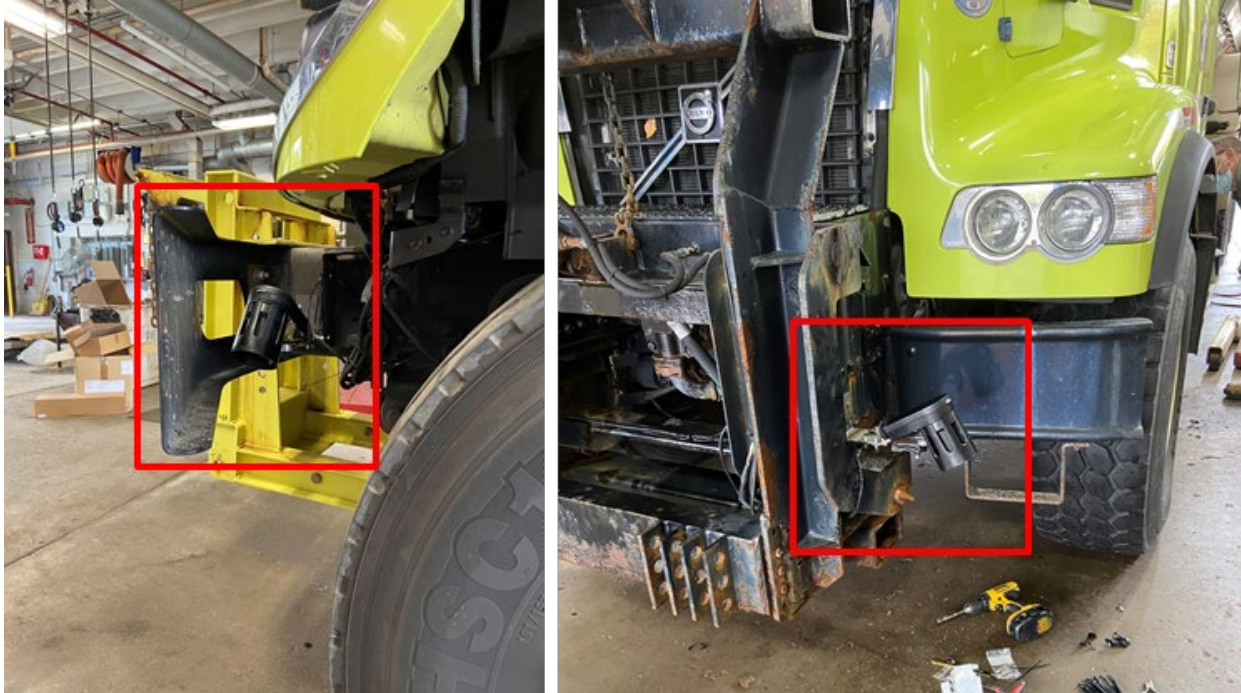
Figure 8. Vaisala MD30 base sensor installed on the plow dump trucks (Source: NJIT)

- On the plow dump trucks, the MD30 sensor base was installed in the front of the vehicle using a specialized bracket and facing downward in the wheel track. On the International trucks the sensor was installed just behind the front bumper, and on the Volvo trucks it was installed on the plow lift frame in front of the front bumper. The air temperature and humidity sensor was detached and installed at the back of the cab, mounted on a magnetic

bracket. As in the case of the SSP trucks, the air temperature and humidity sensor was connected to the MD30 sensor base using the appropriate cable provided by the vendor. See Figure 8 and Figure 9 for illustration.

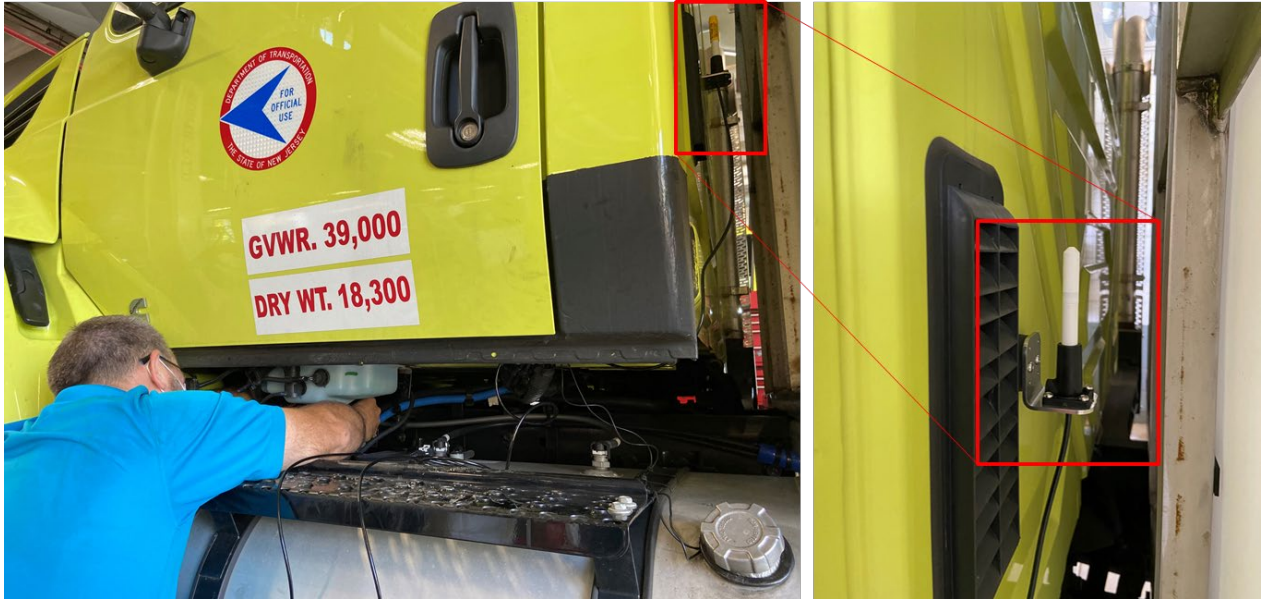
Figure 9. Air temperature and humidity sensor installed on a plow dump truck (Source: NJIT)

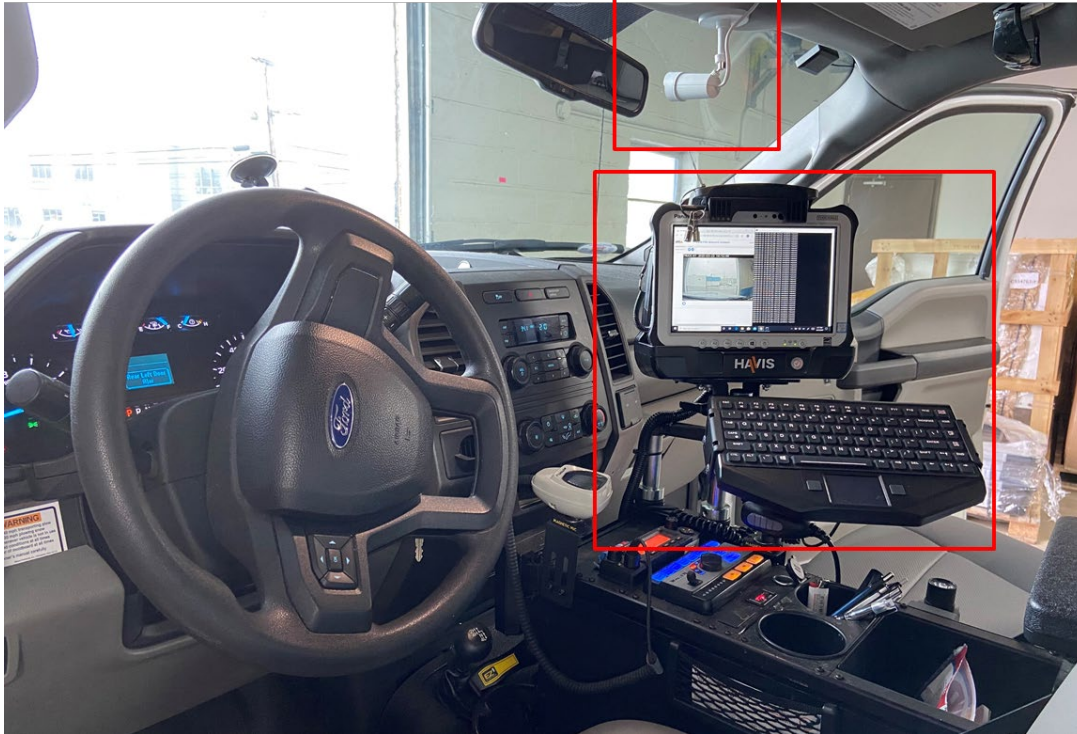
Figure 10. The camera and the computer system installed in an SSP (F-350) truck (Source: NJIT)

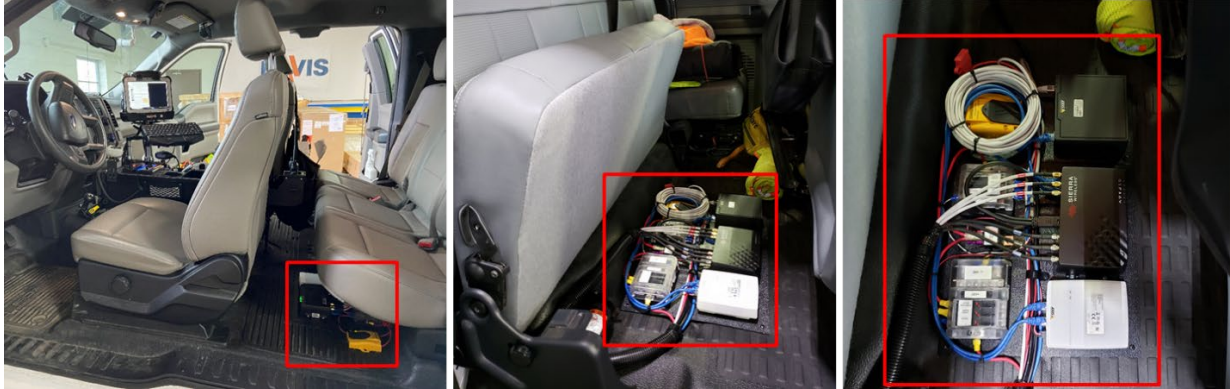
Figure 12. The camera main unit (Axis F41), PoE injector, cellular LTE modem, and the power distribution unit installed under the back seat of an IMRT (F-250) and SSP (F-350) trucks (Source: NJIT)

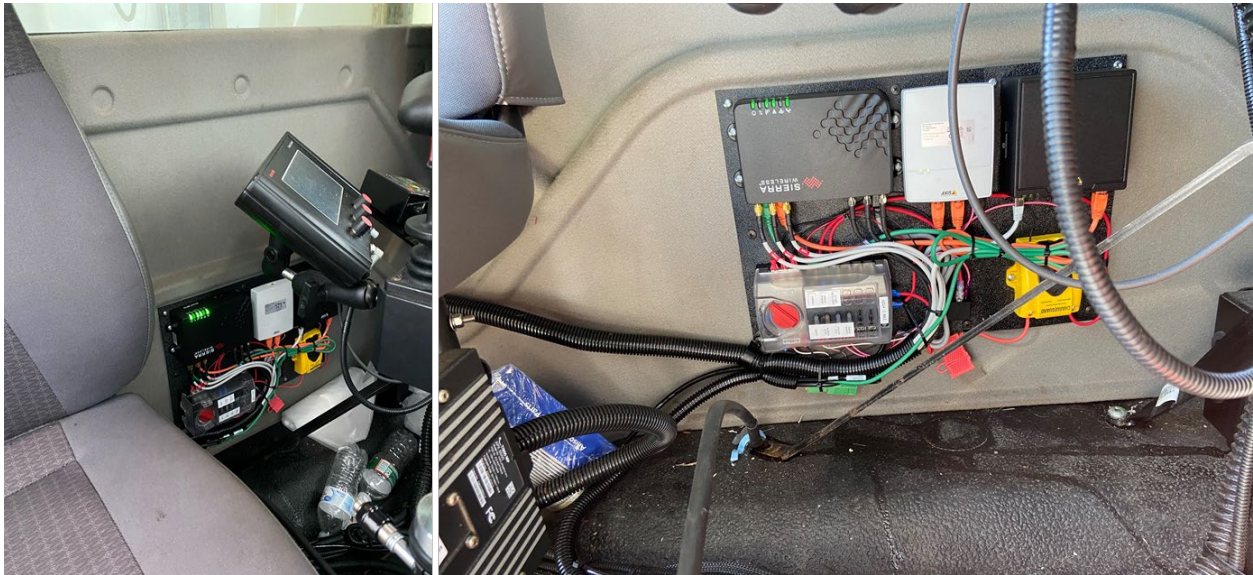
Figure 13. The camera main unit (Axis F41), PoE injector, cellular LTE modem, and the power distribution unit installed against the back wall of the cab interior in a plow dump truck (Source: NJIT)

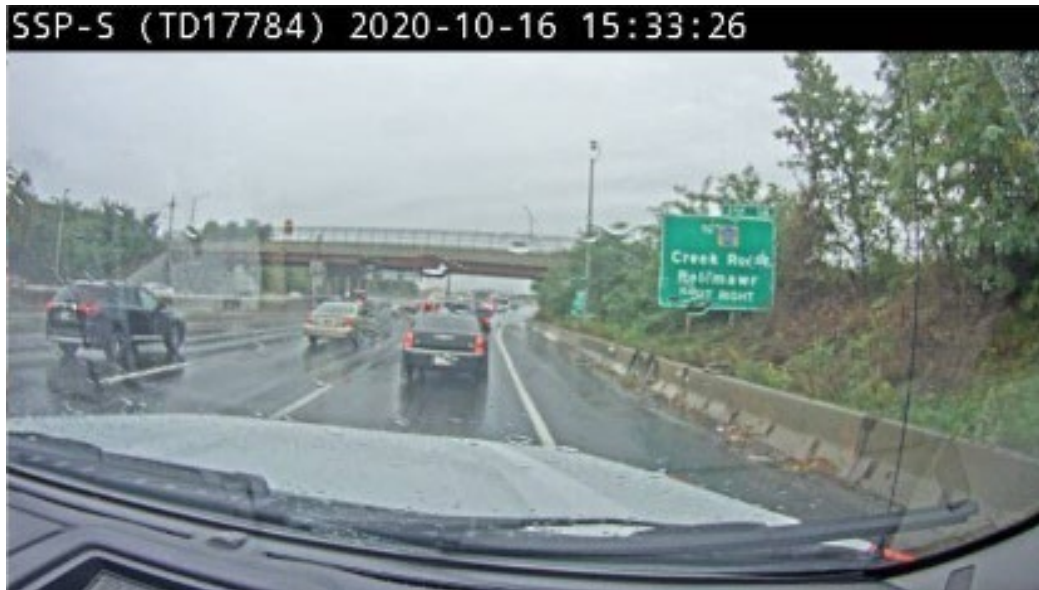
Figure 14. The video snapshot from one of the vehicle cameras showing the video overlay with the vehicle ID, license plate number, date and time of the screen capture (Source: NJIT)

- The video stream is set up to display an overlay with the vehicle ID, license plate number, date and time (See Figure 14 for illustration).
- The access to camera settings and the video stream was controlled through the router’s LAN and required user authentication (username and password).

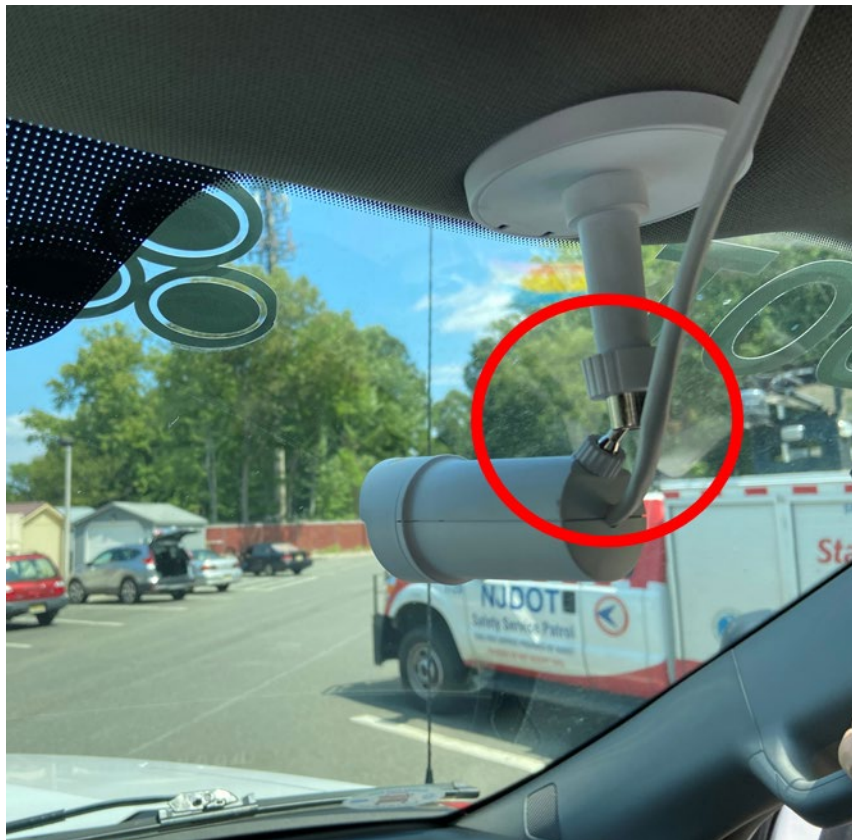
Figure 15. Position of the camera and the camera mount with the tightening bolts circled
(Source: NJIT)

Following the initial installations of the bullet-type cameras, it was observed that in some vehicles the cameras would tilt out of position during vehicle operation. It was reported by some vehicle operators that this was happening due to vehicle vibration. The operators were asked to manually adjust the camera position and tighten the two nuts that hold the camera housing attached to the camera mount (see Figure 15). However, this was thought to be quite inefficient, and over time it could lead to permanent damage of the camera mount requiring the replacement of the mount. NJIT had researched and identified two potential solutions for this problem: (1) use a glue, such as Loctite, to fix the bolts in place after putting the camera in the optimal position – this solution would likely require a new mount and camera housing in case the camera must be moved out of the position for any reason; or (2) replace the bullet cameras with dome cameras.

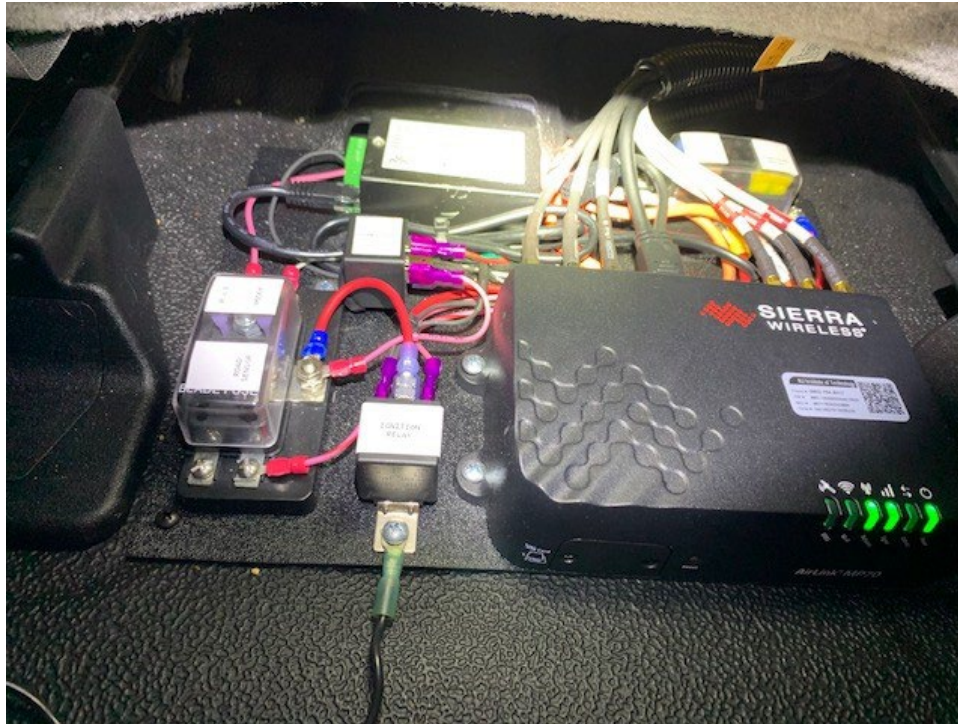
Figure 16. The electronics board without the video processing unit (not required for the dome camera models), installed under the passenger seat in F350 SSP vehicle (Source: NJIT)

As already noted, the setup with the dome camera required a smaller footprint on the electronics board for Weather-Savvy instrumentation as it eliminated a need for the video processing unit. The setup of the electronics board for the system with dome camera Axis P3925-R is shown in Figure 16. The illustrations of the installation of Axis P3925-R dome camera in NJDOT vehicle are shown

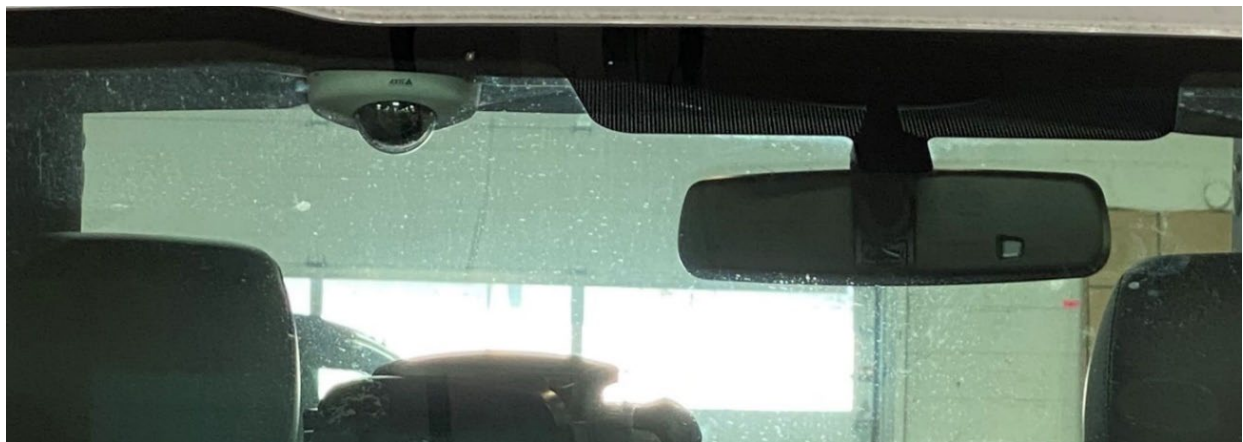
Figure 17. Dome camera (Axis P39 Series) installed in an NJDOT fleet pick-up truck – front view (Source: NJIT)

in Figure 17 and Figure 18. A snapshot of the video image broadcasted from the camera via cellular communication is shown in Figure 19.

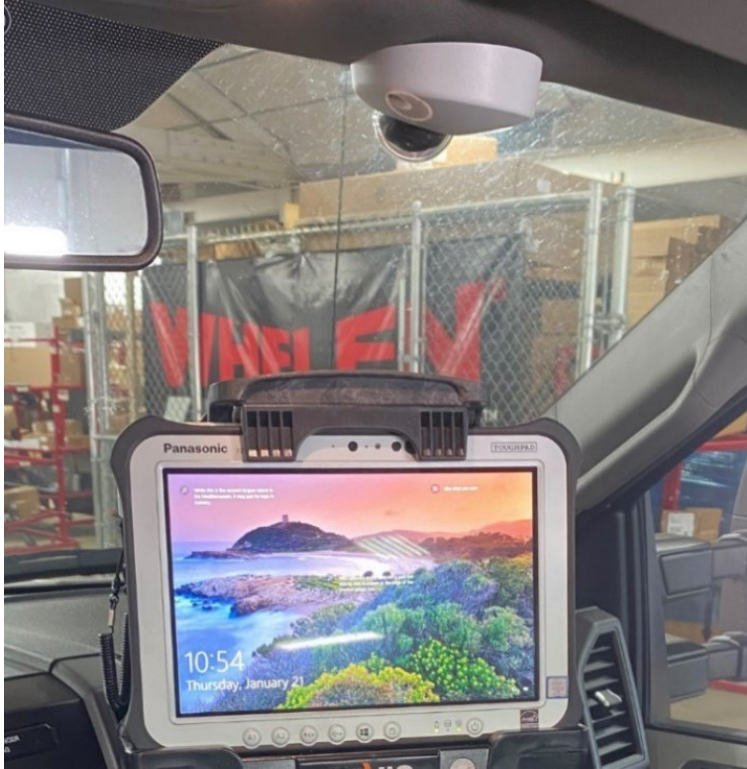
Figure 18. Dome camera (Axis P39 Series) installed in an NJDOT fleet pick-up truck – side view (Source: NJIT)

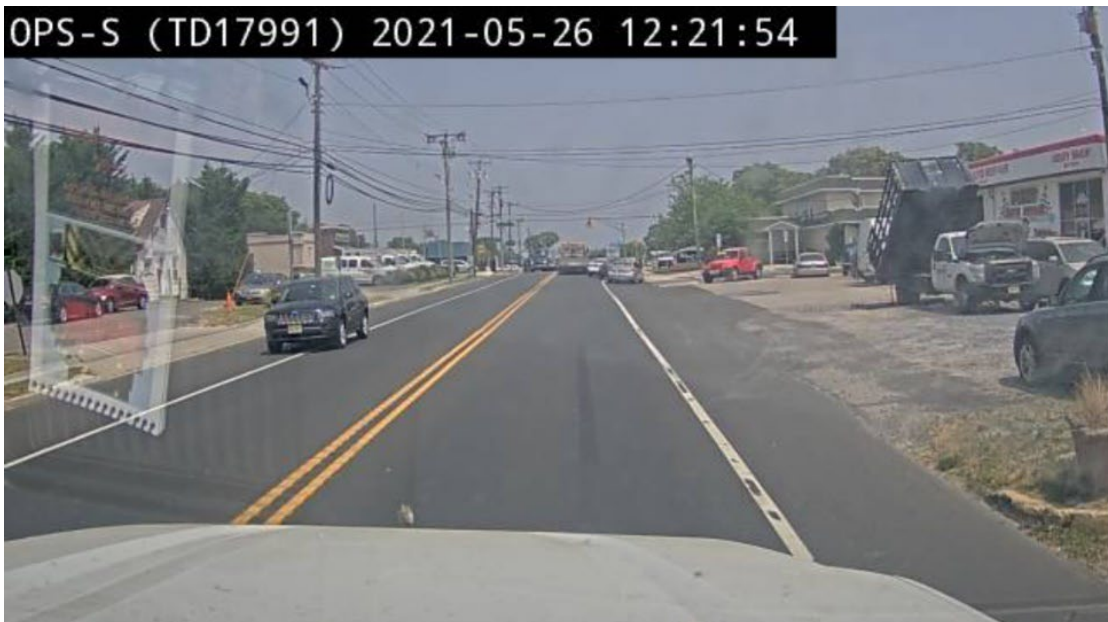
Figure 19. A video image broadcasted from the dome-type dashboard camera via cellular communication (Source: NJIT)

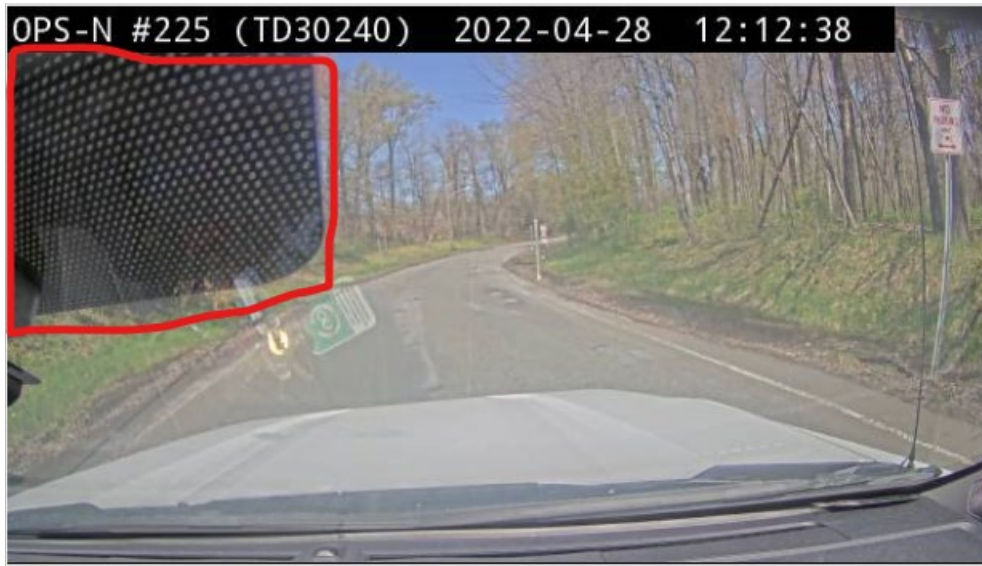
Figure 20. Screenshot of a video stream from windshield camera showing the partial occlusion from the windshield frit (Source: NJIT)

One aspect to be careful about is the camera positioning relative to the ceramic frit in the rearview mirror area of the front windshield. As shown in Figure 20, the windshield frit can present an occlusion in the camera view, and once the dome camera is mounted the viewing angle is fixed. Thus, it is important to check the camera view prior to affixing it to the vehicle headliner.

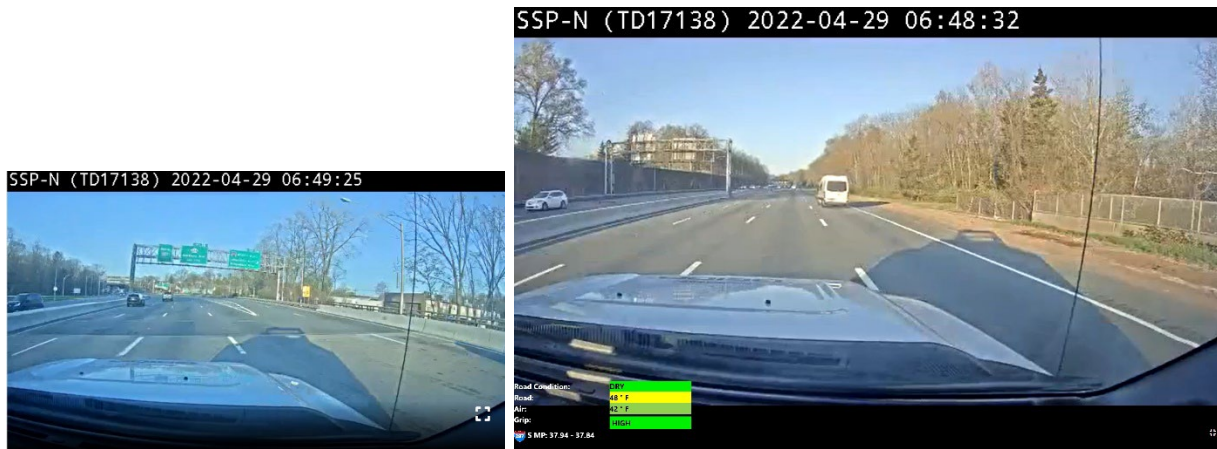
Figure 27. Toggling between the dashboard view and full-screen view of the video using the toggle overlay button in the lower right corner of the view (Source: NJIT)

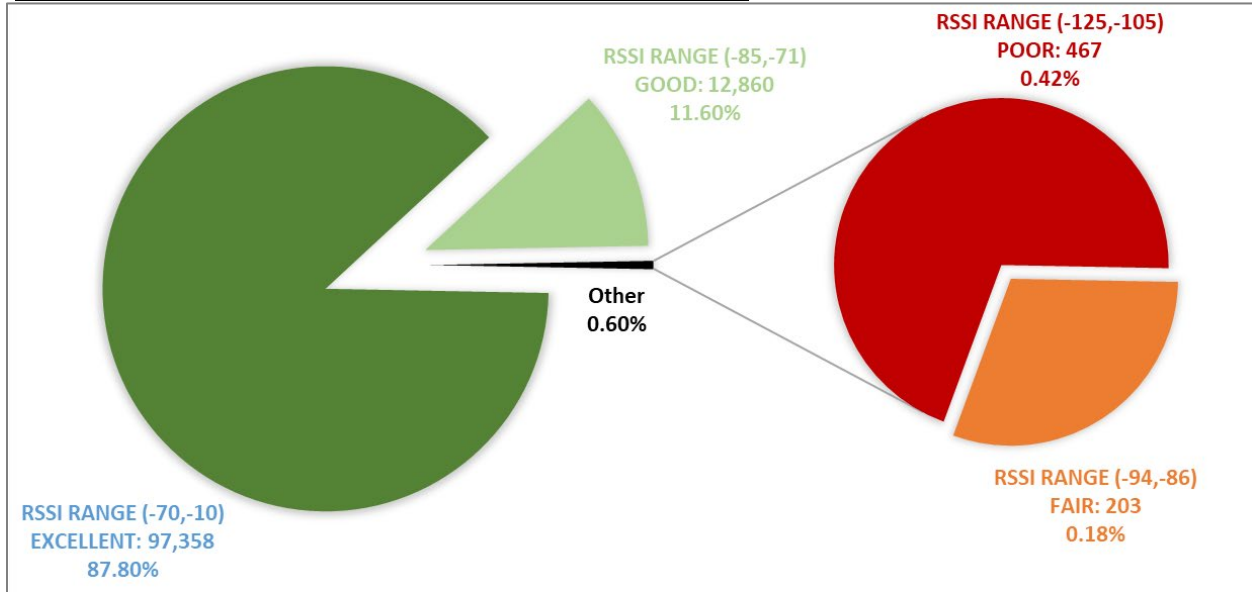
Figure 34. RSSI signal quality breakdown (Source: NJIT)

Based on the collected data, the majority of status records indicated acceptable signal quality, as shown in Figure 34, with 99.5% indicating EXCELLENT or GOOD RSSI levels (overall, 88% had EXCELLENT RSSI). Only about 0.6% of the recorded status reports had FAIR or POOR signal quality measured by RSSI. Plotting the RSSI values for each status report on a map (Figure 35), reveals areas where more attention should be given to signal quality, such as roadway sections along NJ 29 where POOR and FAIR signal quality has been consistently observed.

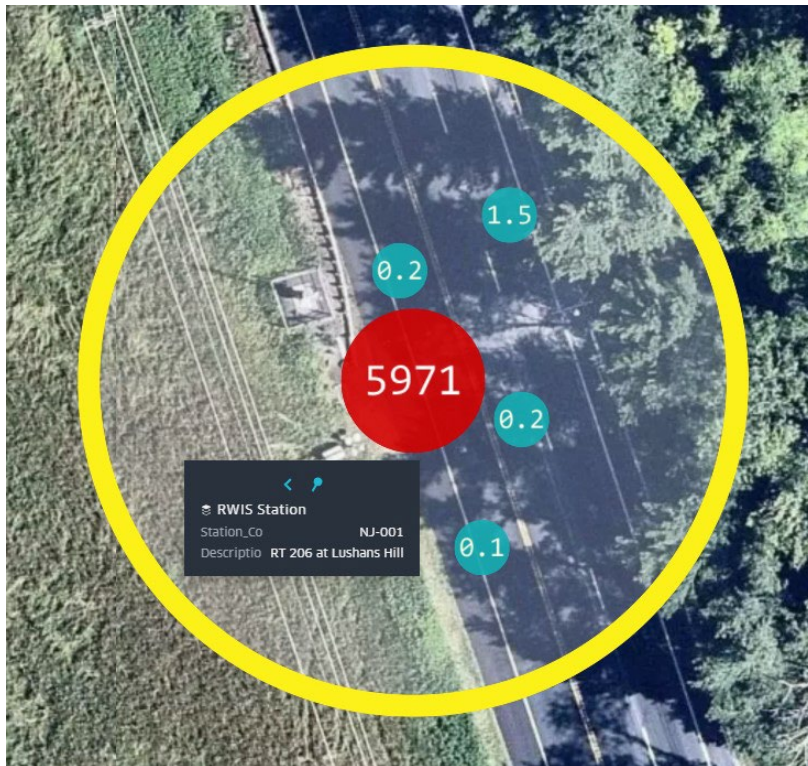
Figure 44. An example of matched MRWIS and RWIS records using a 100 ft buffer and 5-minute data record interval (Source: NJIT)

Figure 44 shows a sample of MRWIS records that are matched to an RWIS station using a 100 ft buffer and 5-minute interval (within 2.5 minutes before or after the data recording at the stationary RWIS). The red dot represents the RWIS station, with the station ID label. The blue dots represent MRWIS records, with the numbers inside the dots representing the difference in measured road surface temperature from the adjacent stationary RWIS.

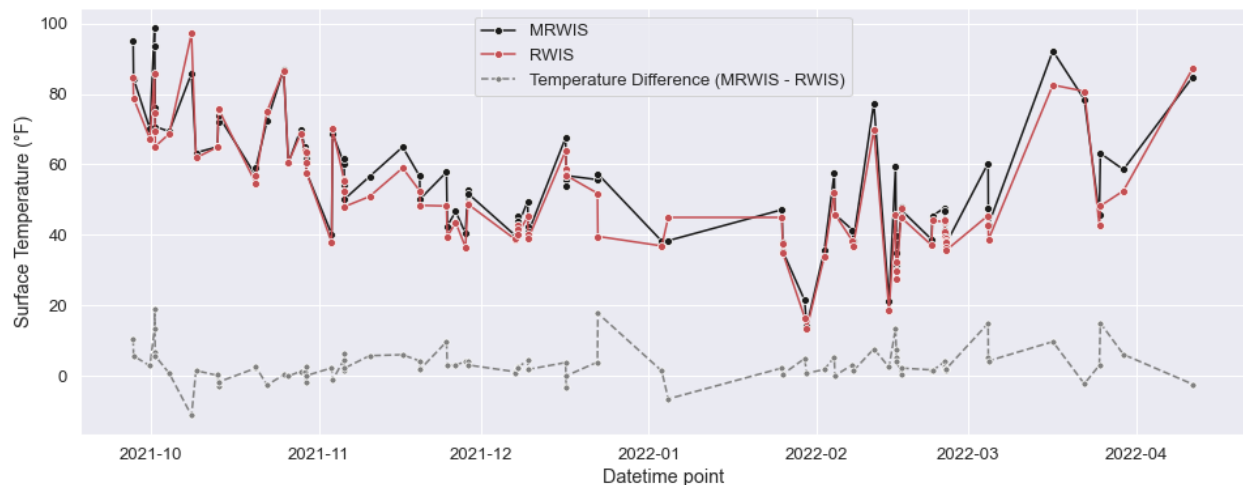
Figure 45. Graphed comparison between the matched MRWIS and RWIS RST measurements (Source: NJIT)

When applying the 100-ft buffer, a total of 94 unique matching MRWIS and RWIS records were identified. The corresponding RST measurements for the matched MRWIS and RWIS records and the date/time of the recorded data are shown in Figure 45. It can be observed that most of the MRWIS RST measurements deviate slightly from the corresponding (matched) RWIS RST measurements, although for some timepoints large discrepancies were identified, as high as 19 degrees Fahrenheit.

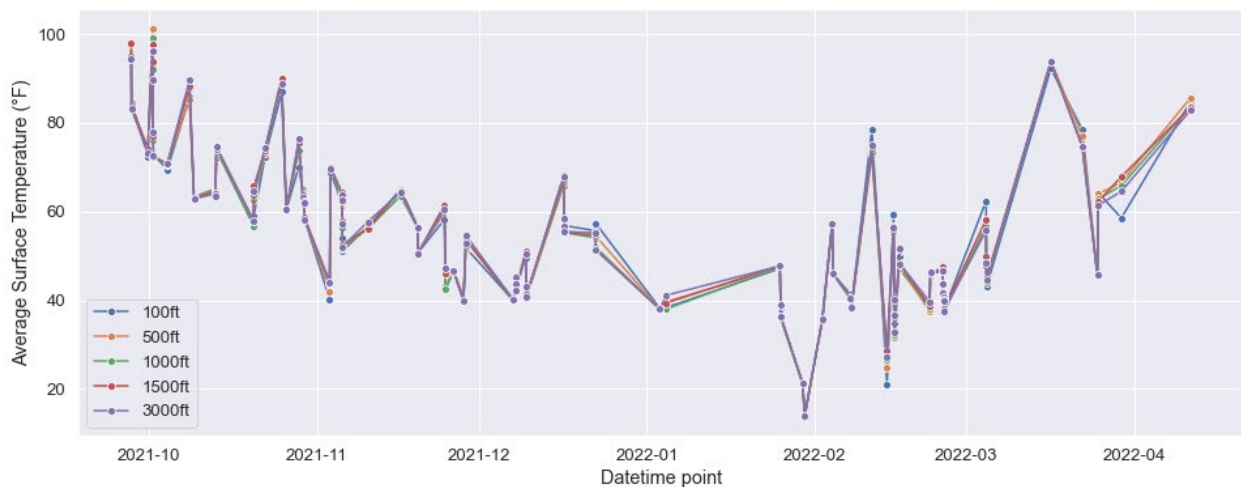
Figure 46. Average MRWIS temperature per time point with different buffer sizes (Source: NJIT)

To answer these questions, the average of the MRWIS RST measurements is calculated for all records matched to the corresponding RWIS considering five different buffer sizes. The average RST values are then plotted for each buffer size and date/time of the matching RWIS record, as shown in Figure 46. In general, the average MRWIS measurements are similar among the varying buffer sizes. When compared, the average difference of the RST measurements between different buffer sizes is less than 0.5 degrees, with the maximum difference of 9 degrees found between the average measurements with 100 ft and 1500 ft buffers. In most cases the differences are less than one degree.
