Route 71 over Shark River

Road Diet & Safety Improvements

Gerald P. Oliveto, P.E.
September 2023

Span Lock Failure

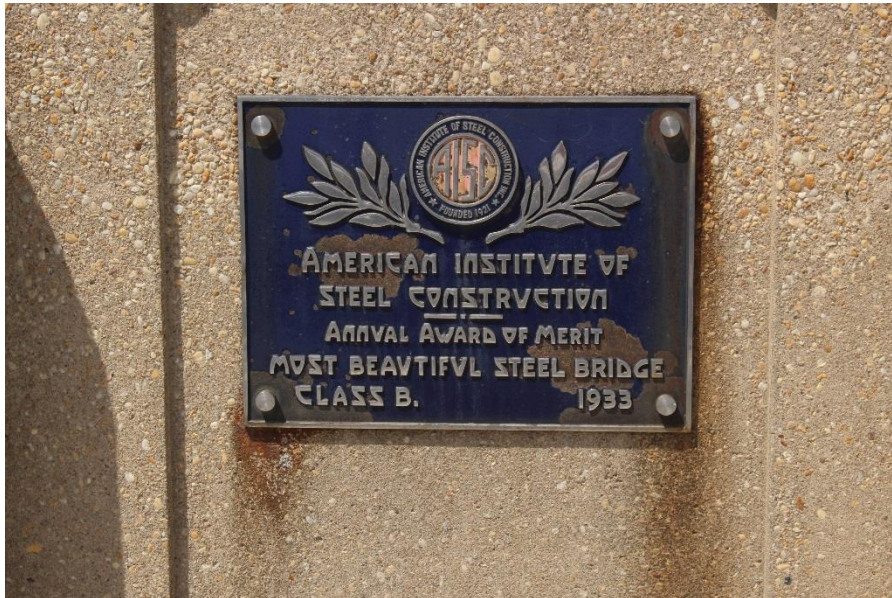
SHARK RIVER BRIDGE—Between F St., Belmar, and Main St., Avon, N. J.; Total Cost, \$413,320.45; Engineer, Morris Goodkind. Bridge Engineer, State of New Jersey, State Highway Commission; Fabricators, American Bridge Company; Owner, State of New Jersey Highway Commission; Completed October 12, 1933; Spans: 9 spans, 83 ft., plus 1 bascule span, 110 ft.—total length, 853 ft.

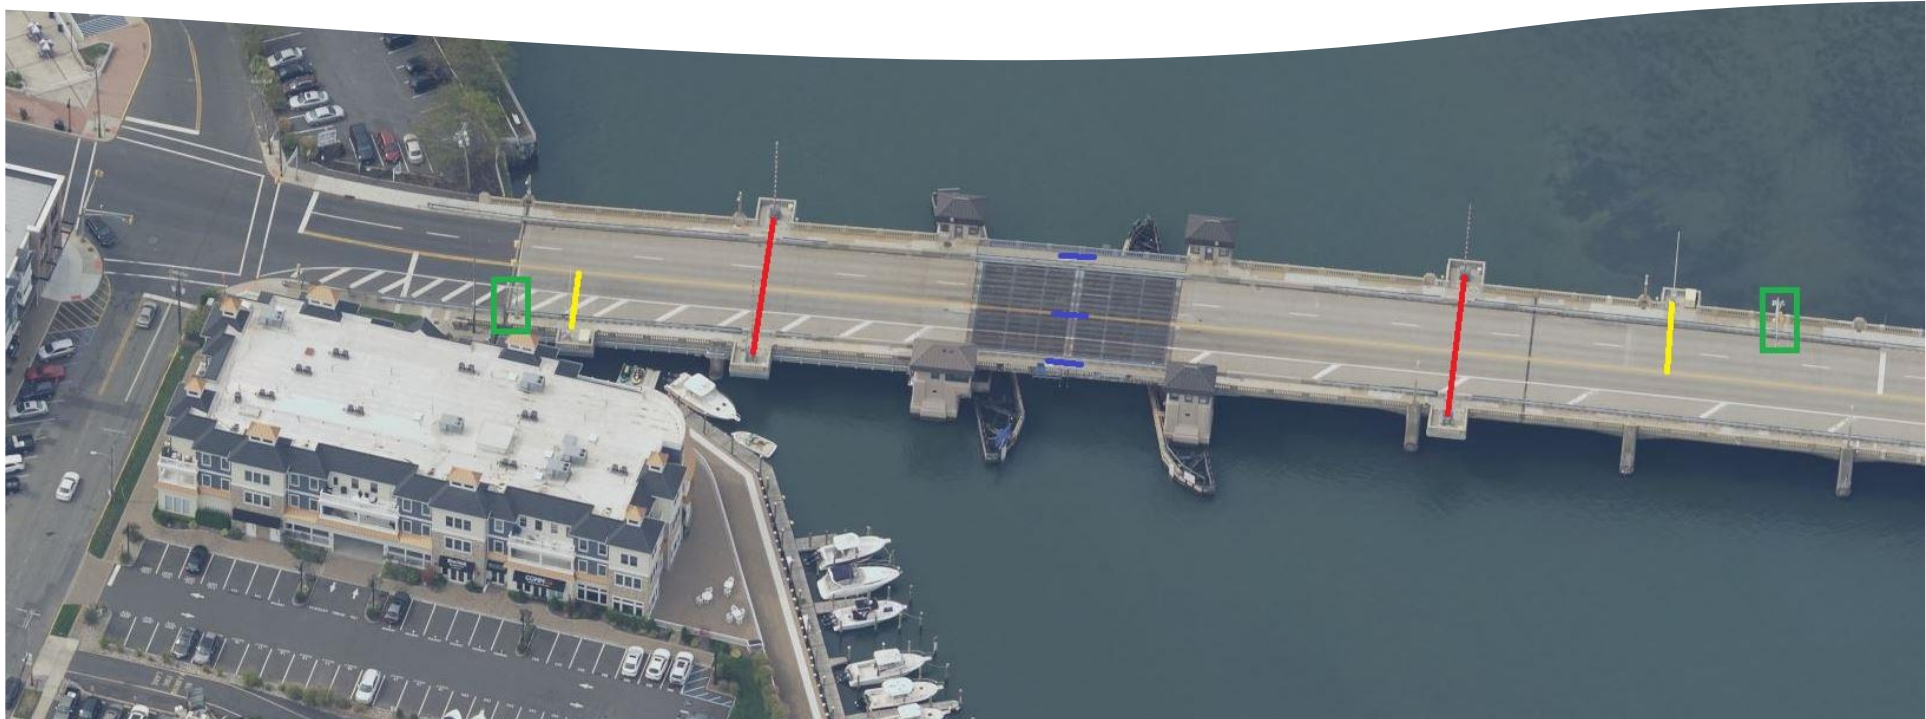
- **Green square = bridge traffic signal, warning gongs**
- **Yellow = warning gates**
- **Red = barrier gates**
- **Blue = span locks**

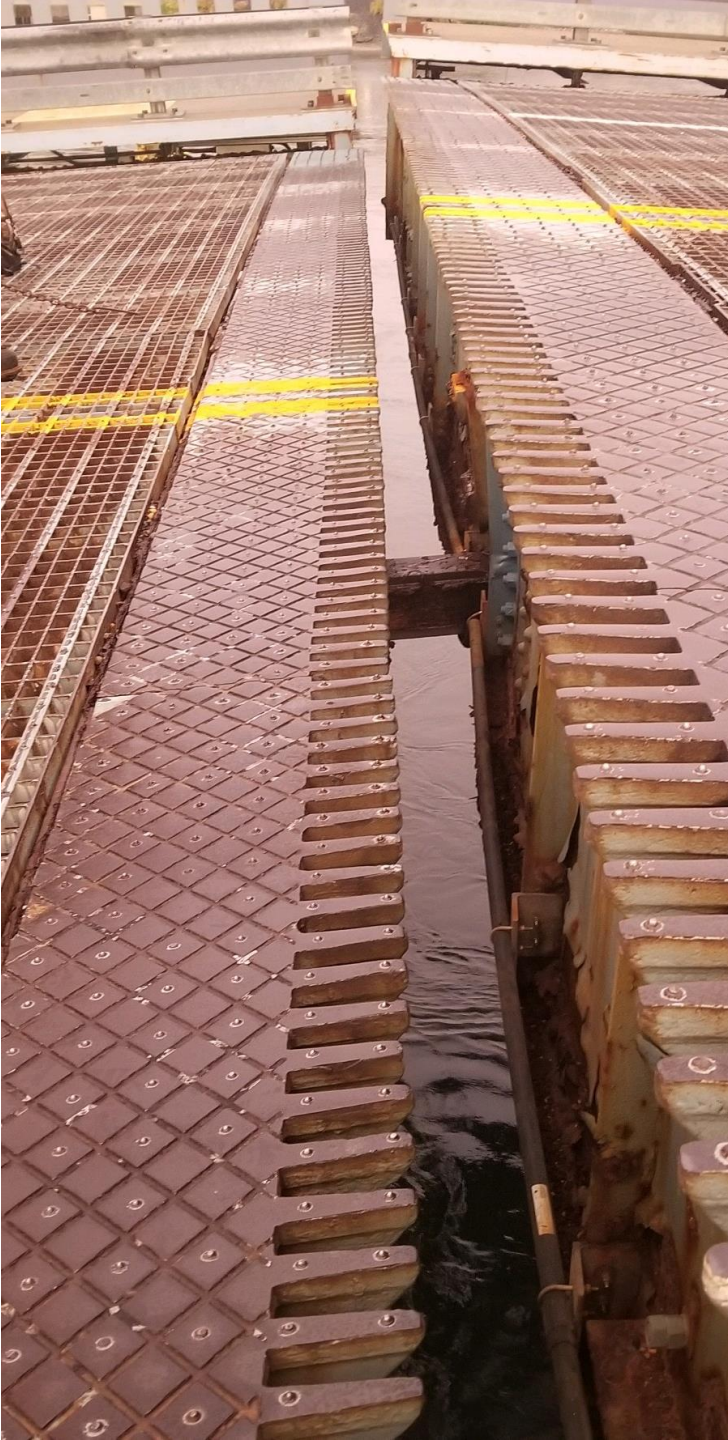
- **Vessel captain notifies bridge house that vessel is clear of bridge**
- **Operator ensures marine traffic is clear of bridge**
- **Horn sounded (5 short)**
- **Bridge lowered**
- **Span locks engaged**
- **Barrier gates raised (offgoing, oncoming)**
- **Warning gates raised**
- **Operator turns traffic signals to green**
- **Sequence takes 7 minutes (red light to green light)**

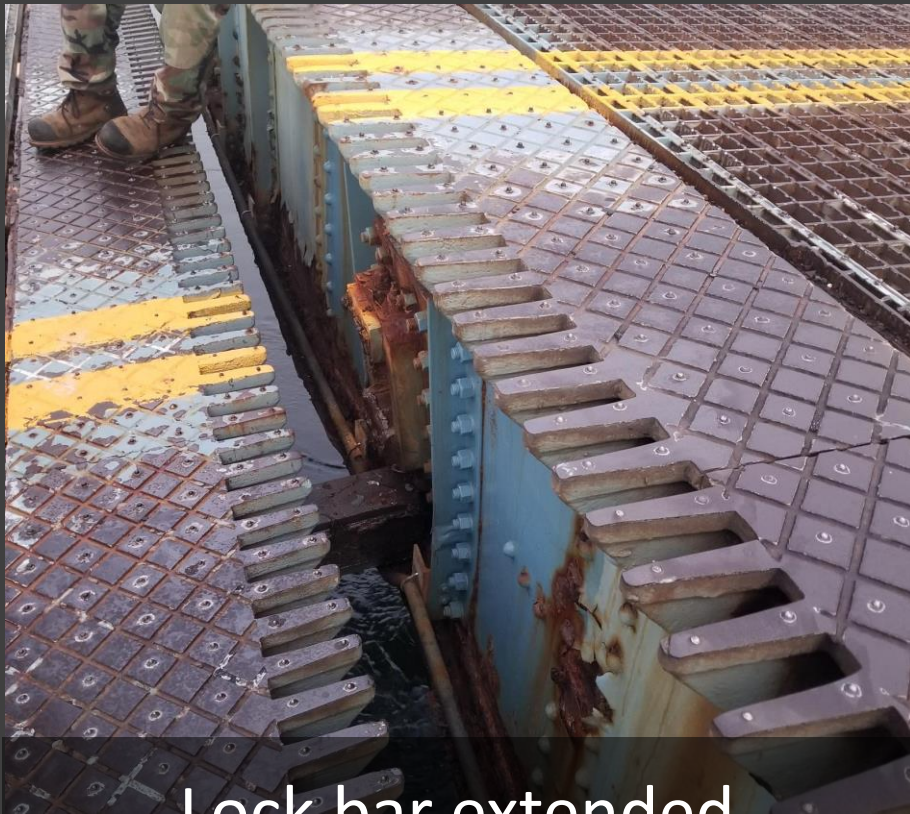
- **Center span lock bar engaged while bridge was raised**
- **No indications on Operator's control panel**
- **Operator initiated closing sequence as usual**
- **Bridge could not close with lock bar engaged**

Lock bar extended

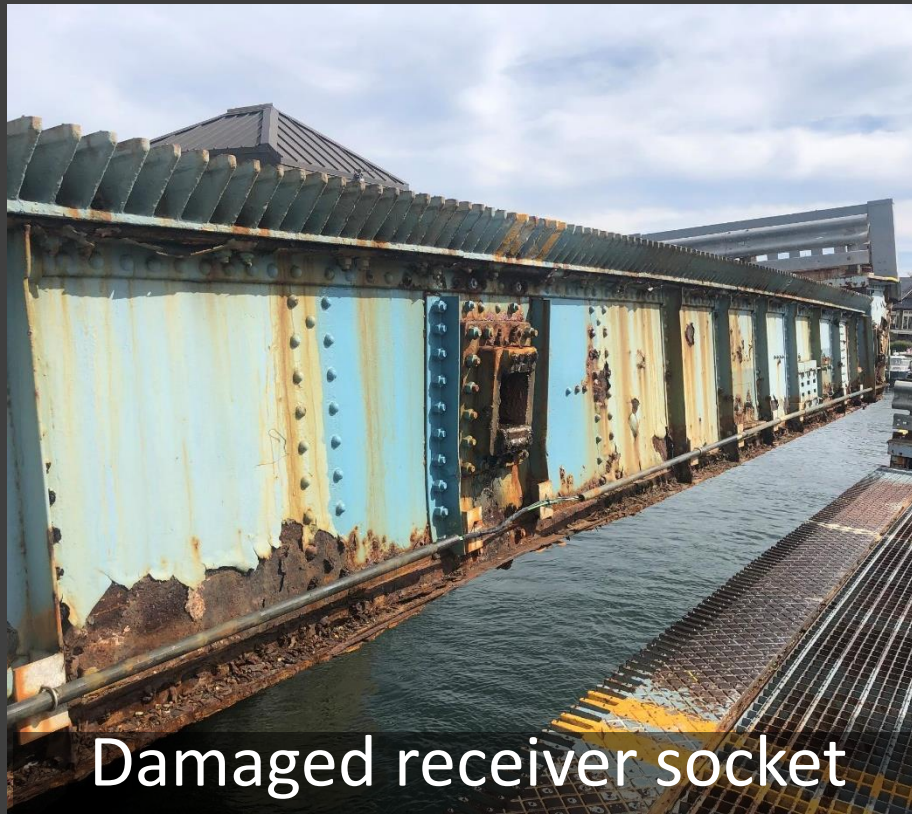
Damaged receiver socket
and bent south floor beam

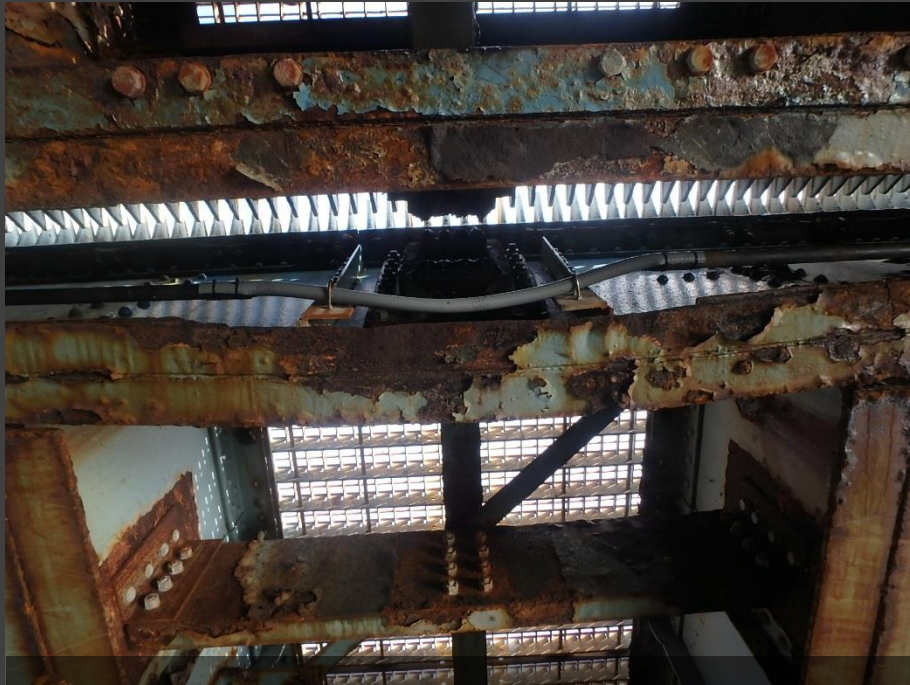
Bent toe (south) floor beam

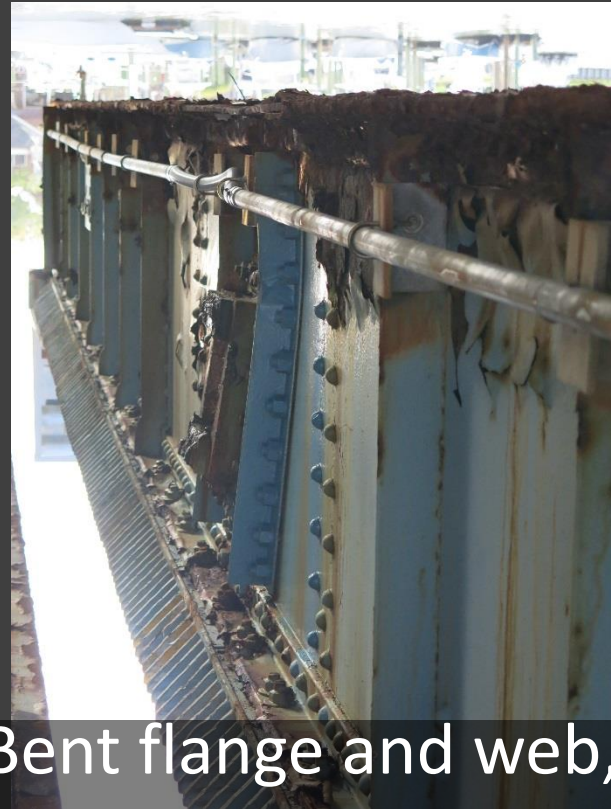
Bent flange and web,
misaligned receiver

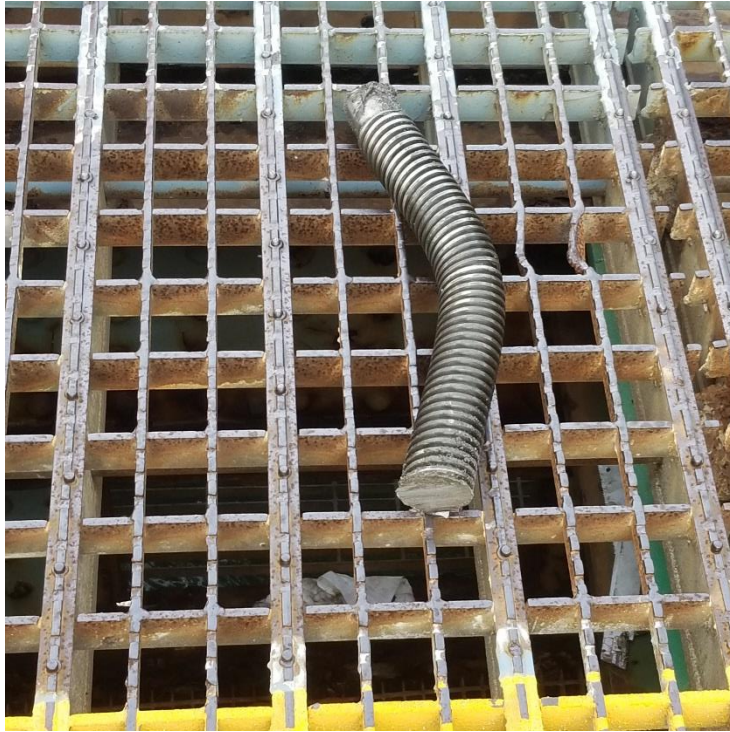
Damaged span lock driving gear

- **On-Call Contractor on-scene**
- **Center span lock not reusable**
- **Damaged span lock hardware cut and removed**
- **Center span lock electric bypassed**
- **Allowed NJDOT to raise bridge to remove all damaged components**

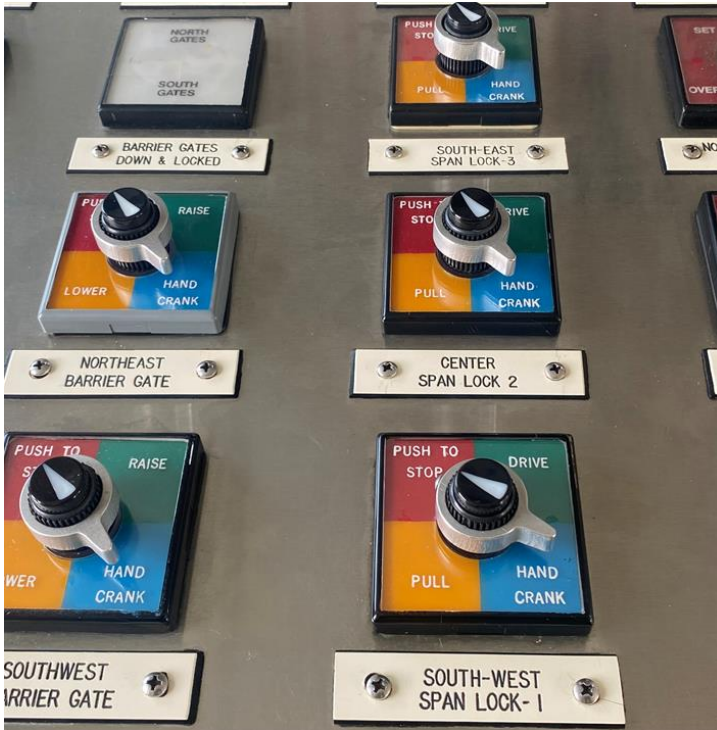
Control Console

- **Movable Bridge Engineering & DOT's On-call electrical contractor on-scene**
- **Operator's panel configured to allow operation with remaining two span locks**
- **Programming revised to prevent similar malfunction**

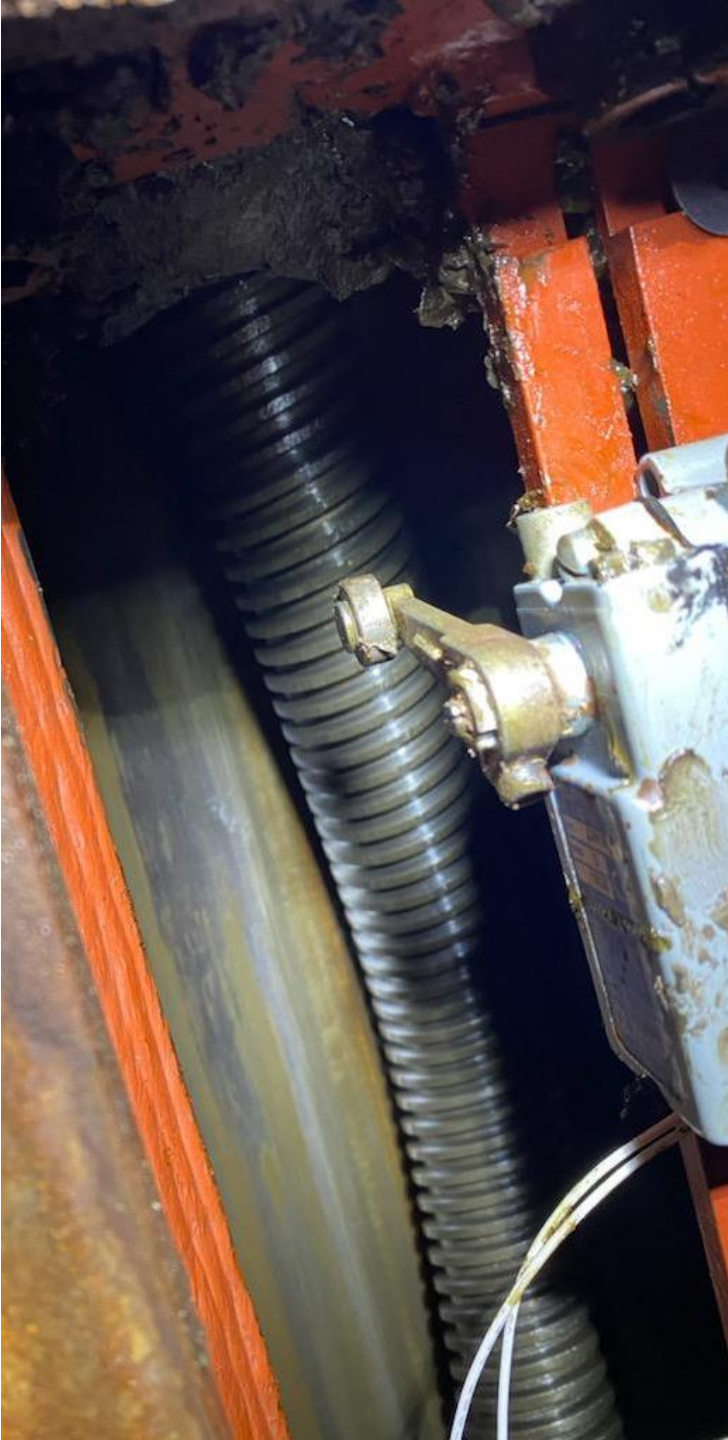
- **Failed proximity switch quickly identified**
- **False indication that span was lowered when it was not**
- **Span lock engaged improperly**
- **All proximity switches from that batch replaced statewide**
- **Bridge evaluated for operation with remaining two span locks**

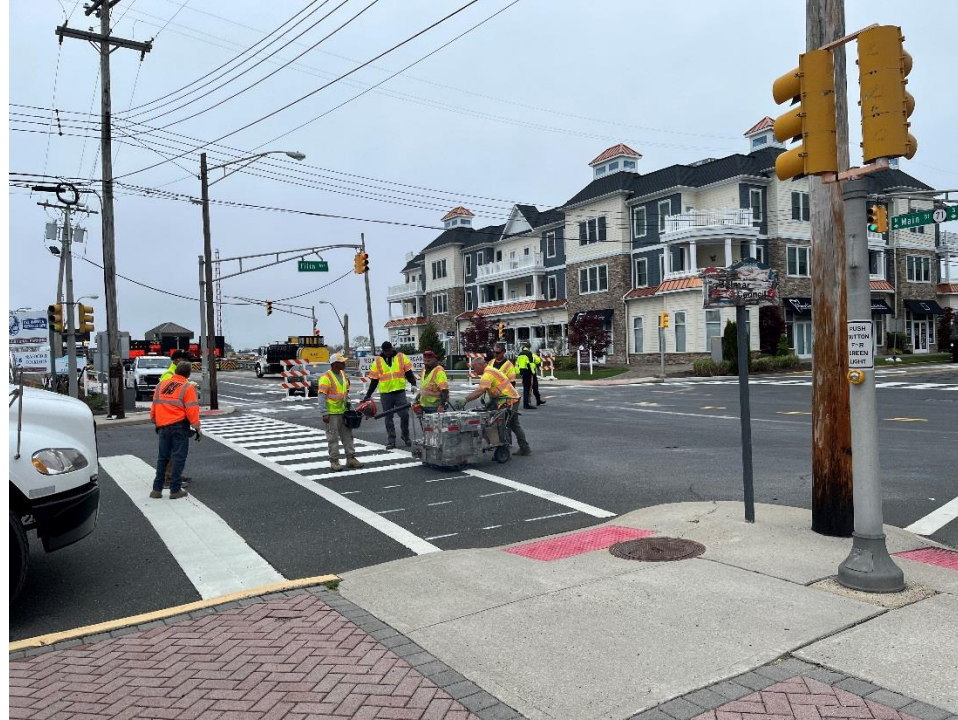
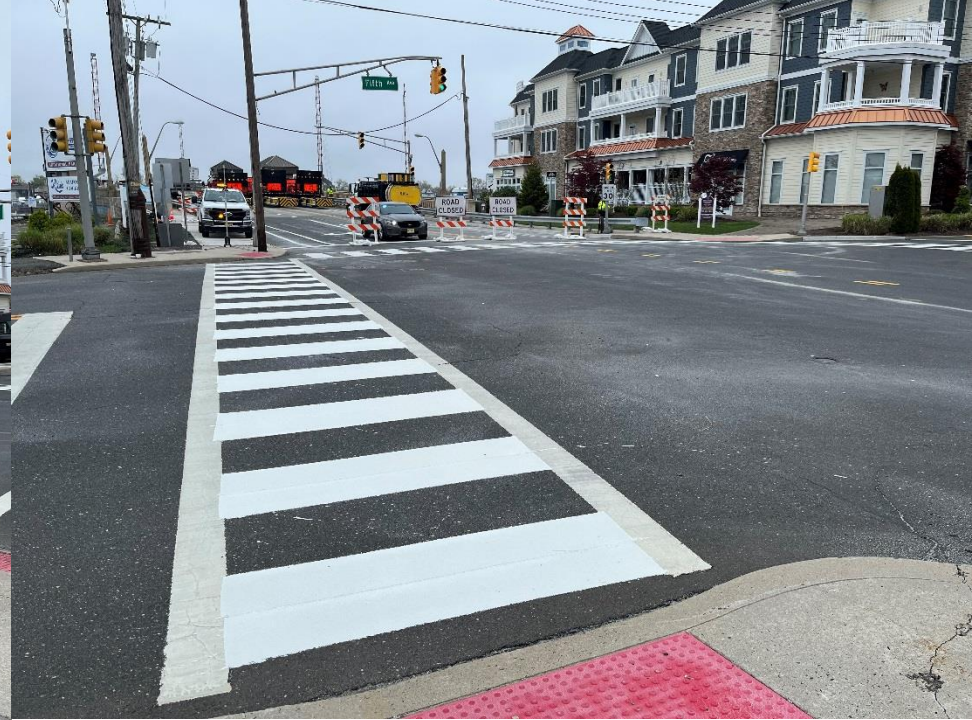
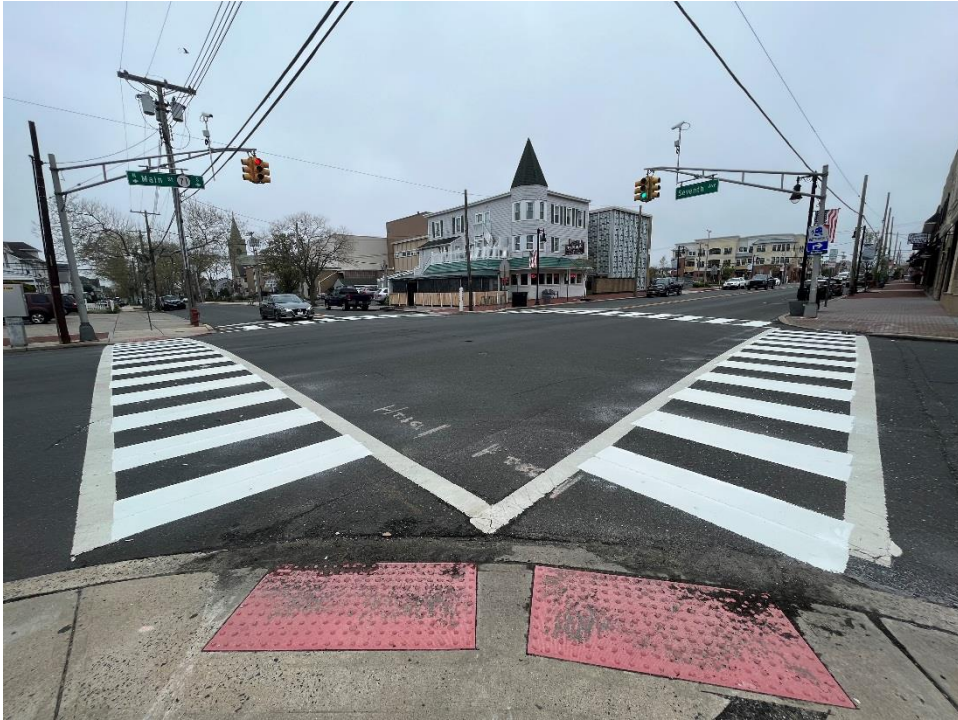
- 18 intersections received crosswalk hatching
- 15 in Avon-By-The-Sea
- 3 in Belmar

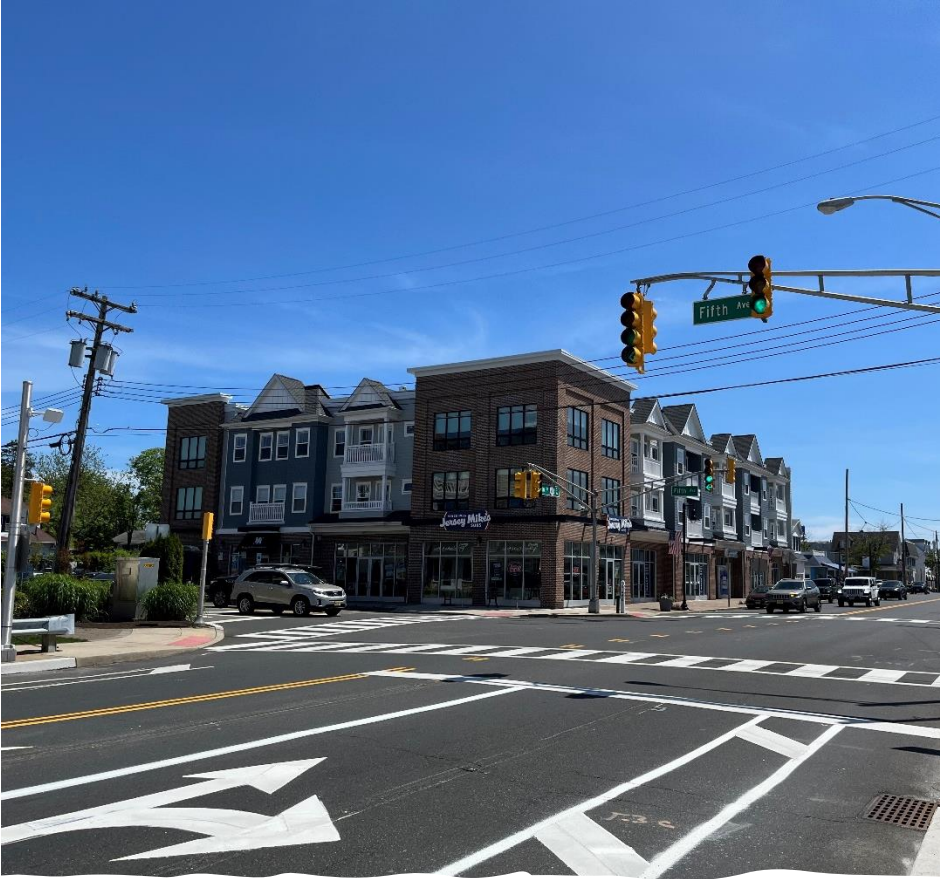
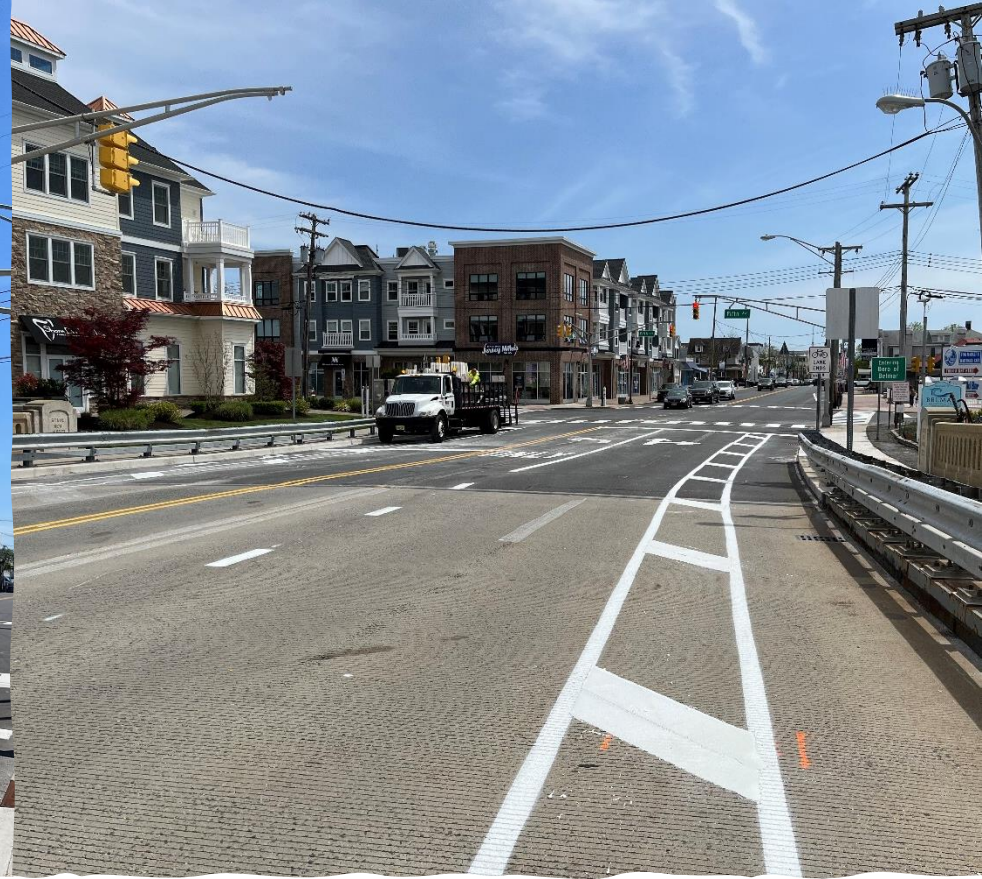
- **Eight vehicle queueing capacity**
- **Safely removes left turning vehicles from through traffic**
- **Protected/Permitted left turn signal**
- **Pre-Empted with bridge operation**

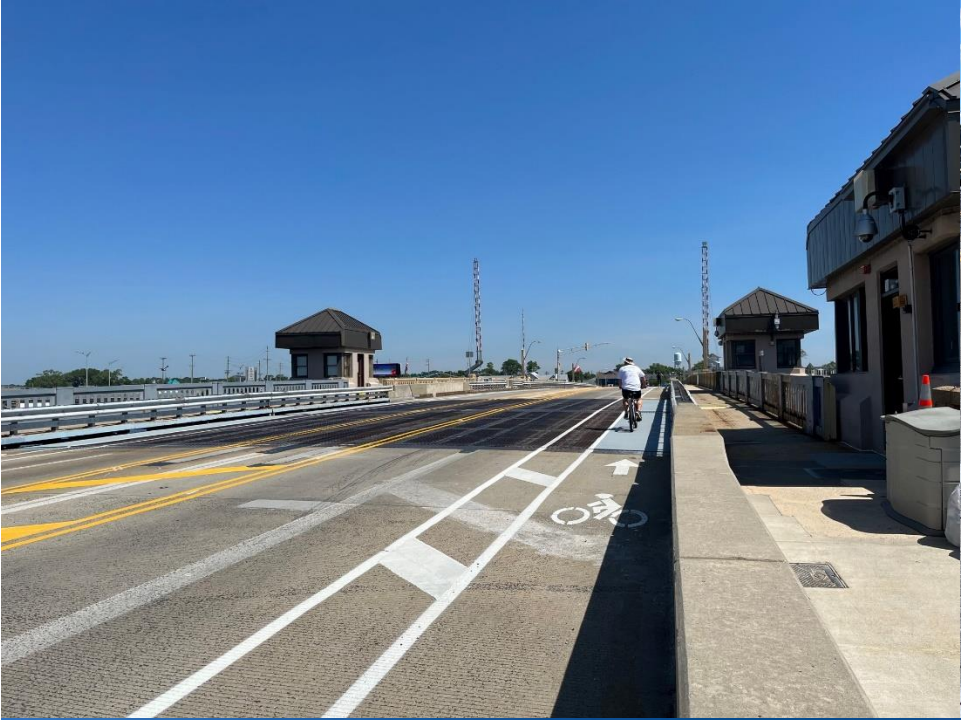
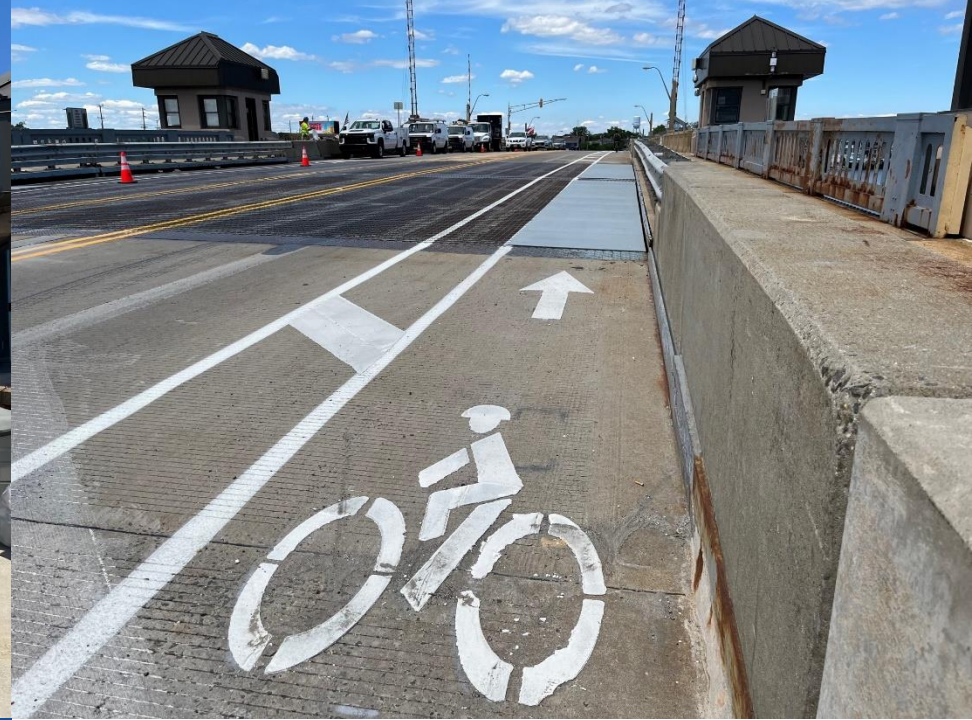
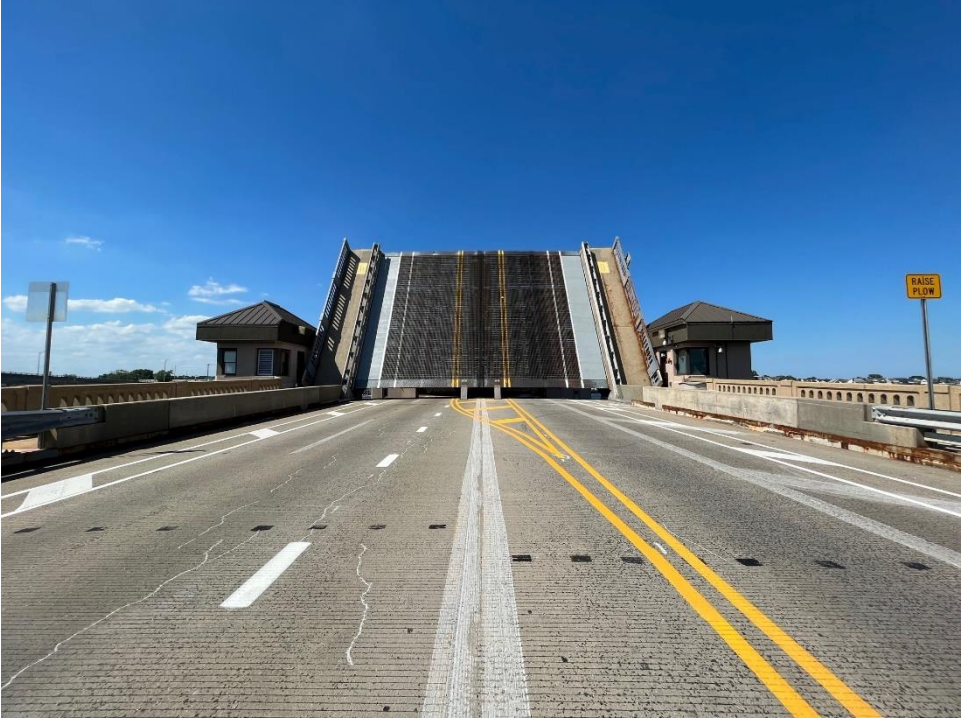
- **Bike Lanes extended $\frac{1}{4}$ mile over bridge from Avon-By-The-Sea to Belmar**
- **Required barge for installation**
- **Required balancing of span to accommodate FRP panels**

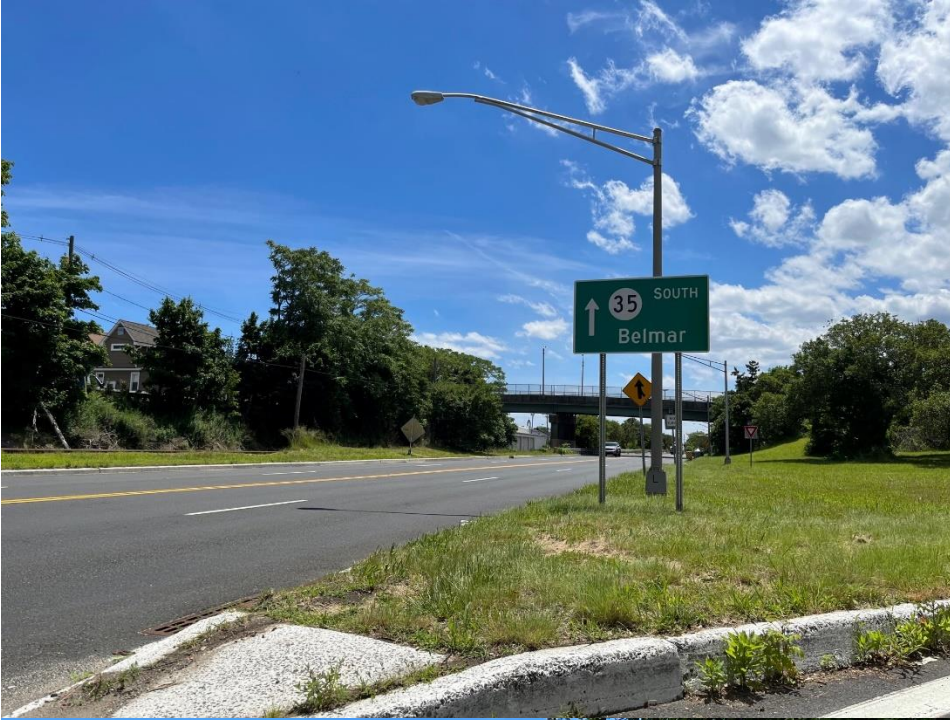
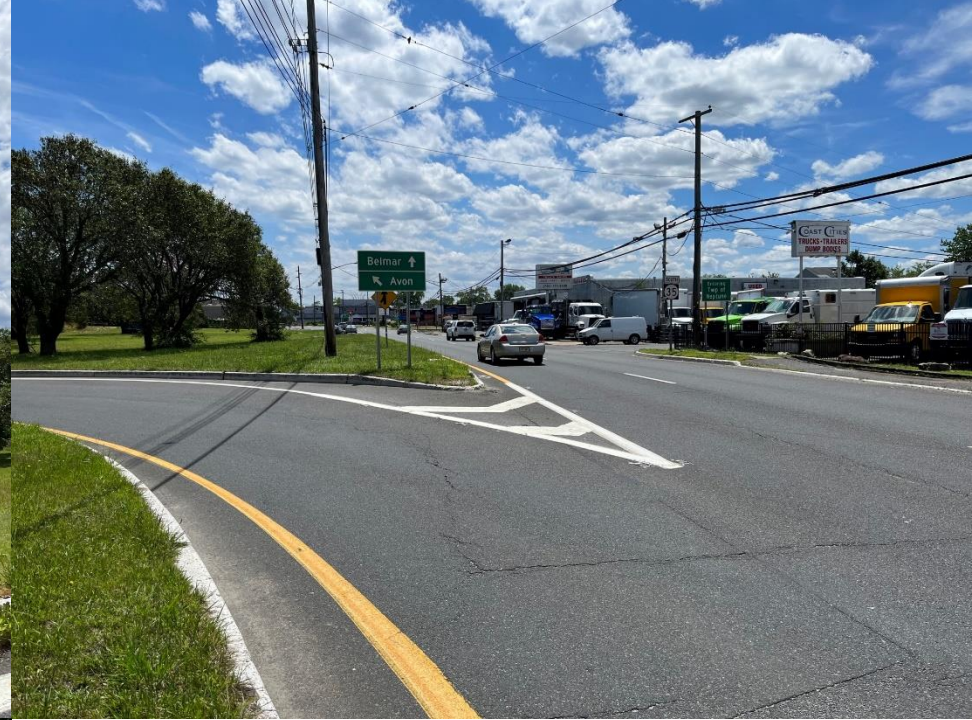
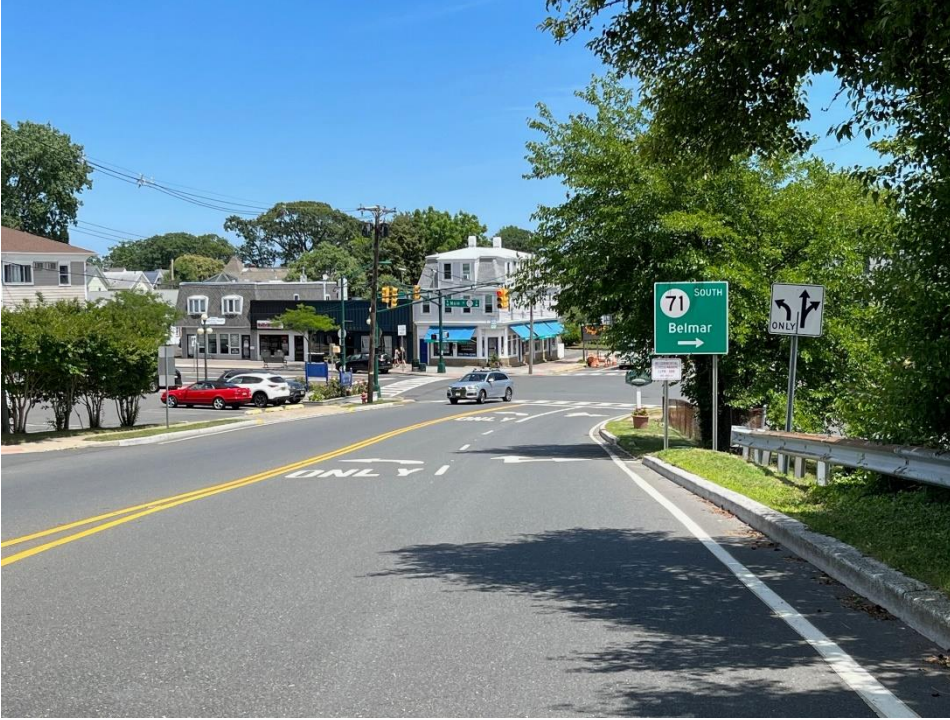
Enhanced
Highway Guide
Signage

- **New signs installed:**
 - **Route 35 Seaview Circle**
 - **Route 35 and Memorial Drive**
 - **Route 35 and Sylvania Avenue**
 - **Route 71 and Sylvania Avenue**

- **More directly route motorists to proper beach destinations**
- **Intended to keep motorists on state highway system**

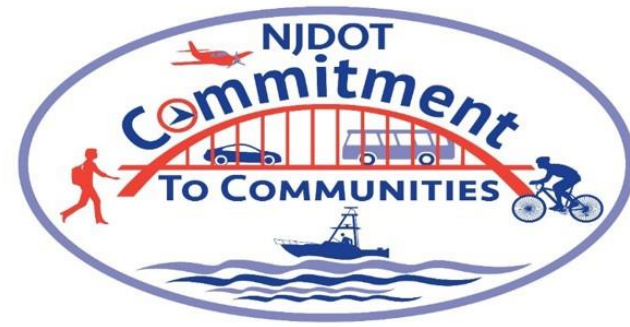
Route 71 Road Diet GPS Company Coordination

- **NJDOT Office of Mobility coordinated with GPS Companies for routing changes**
- **Avon-By-The-Sea voiced concerns regarding GPS usage of residential streets**
- **Algorithms changed to better utilize state highways**
- **Belmar bound traffic from points north directed to utilize Route 35**
- **Belmar bound traffic on shore roads directed to utilize Route 71**

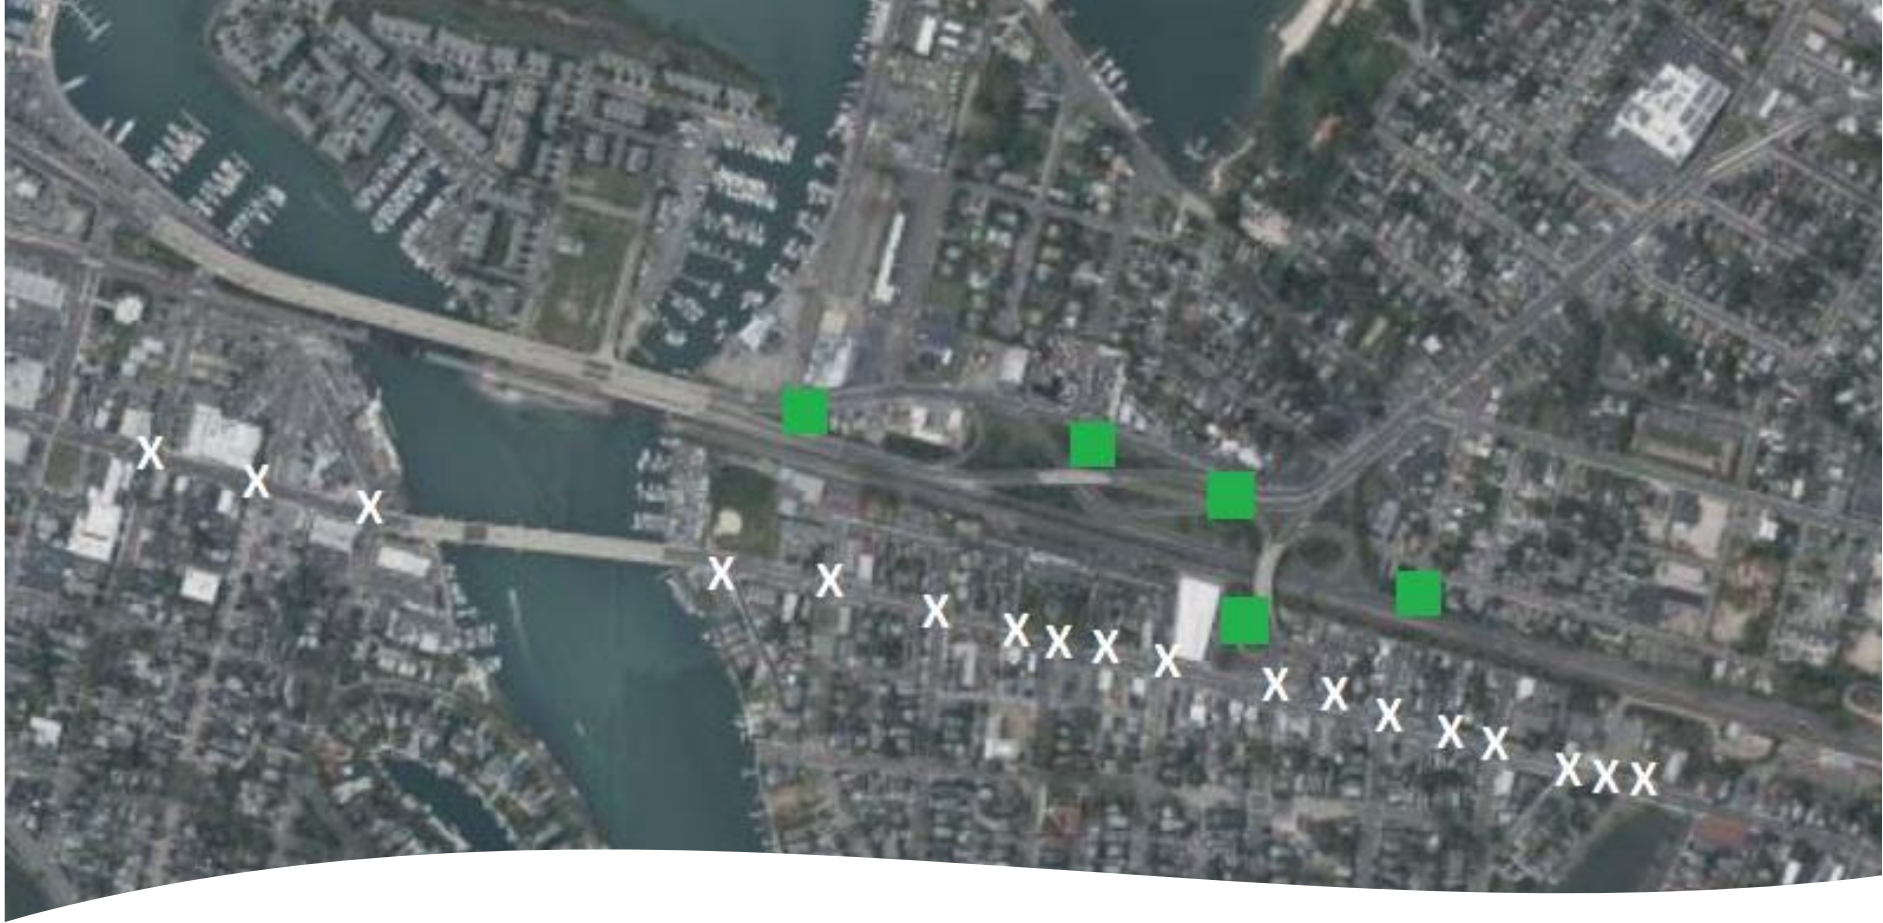
Route 71
Road Diet
Project Map

- **White X denotes high visibility crosswalk location**
- **Green square denotes enhanced highway guide signage**

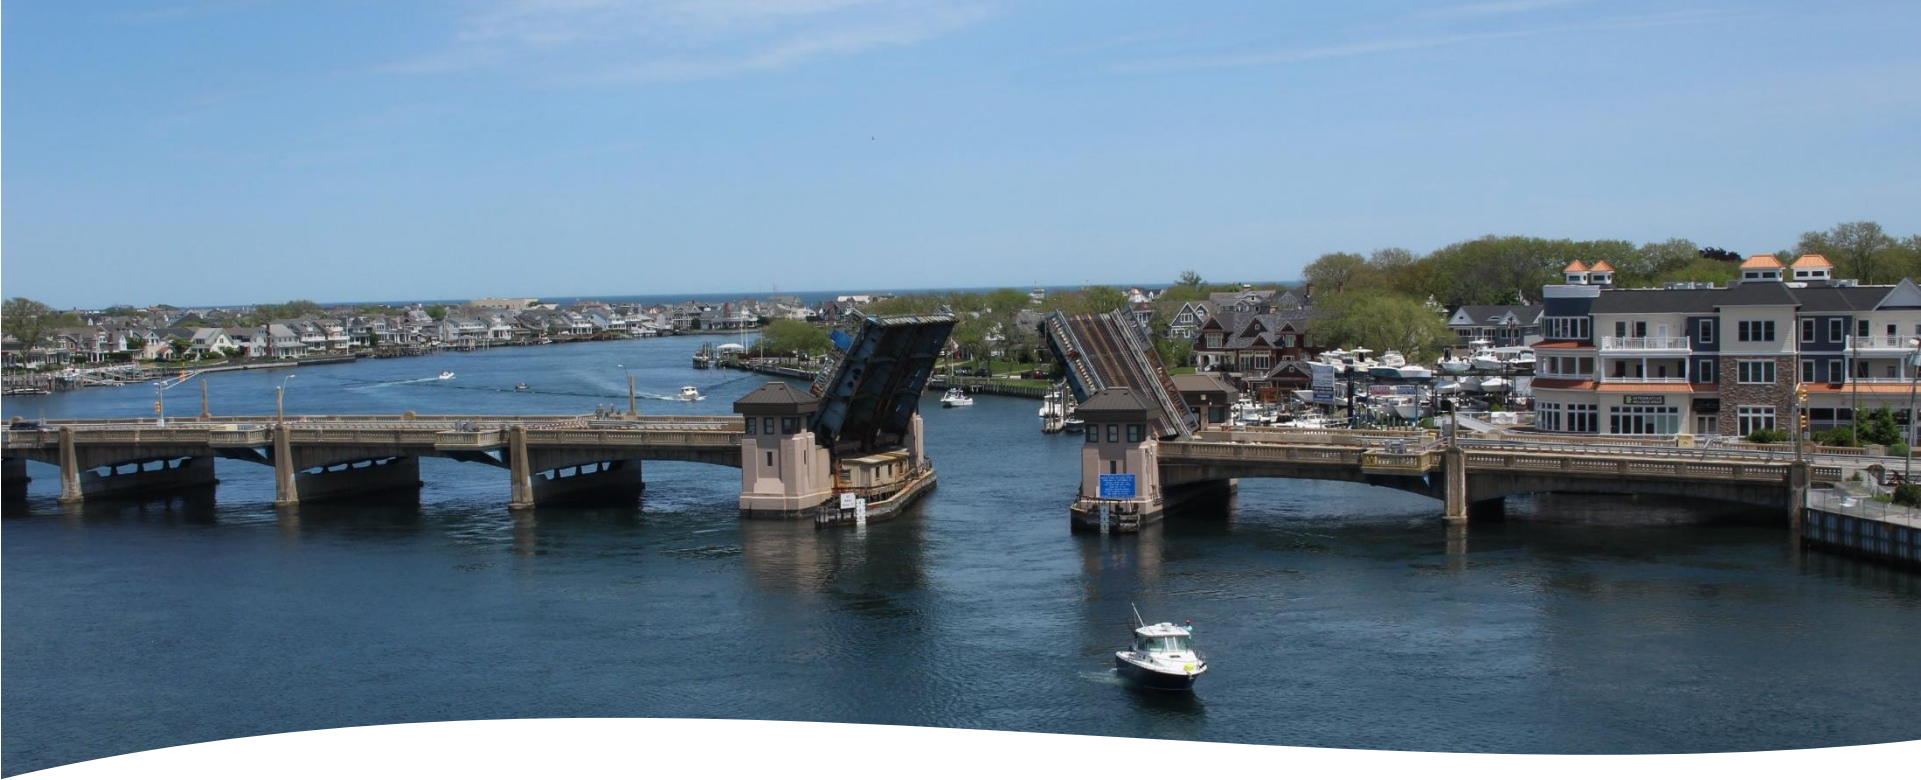
Monitoring & Evaluation

- Operations continues to monitor highway
- Drastic increase in bicycle traffic over bridge
- Signal timings effectively manage traffic
- Backups from bridge openings cleared within three traffic light cycles at Fifth Avenue
 - Measured at busiest lift times, 7:30AM & 2:30PM
- Overwhelming support from community
