Forensic evaluation of pavement failure Using GPR and UAV technology

Vahid Ganji, Ph.D., P.E.

Pavement Department Manager, Michael Baker International

NJDOT Research Showcase 2019

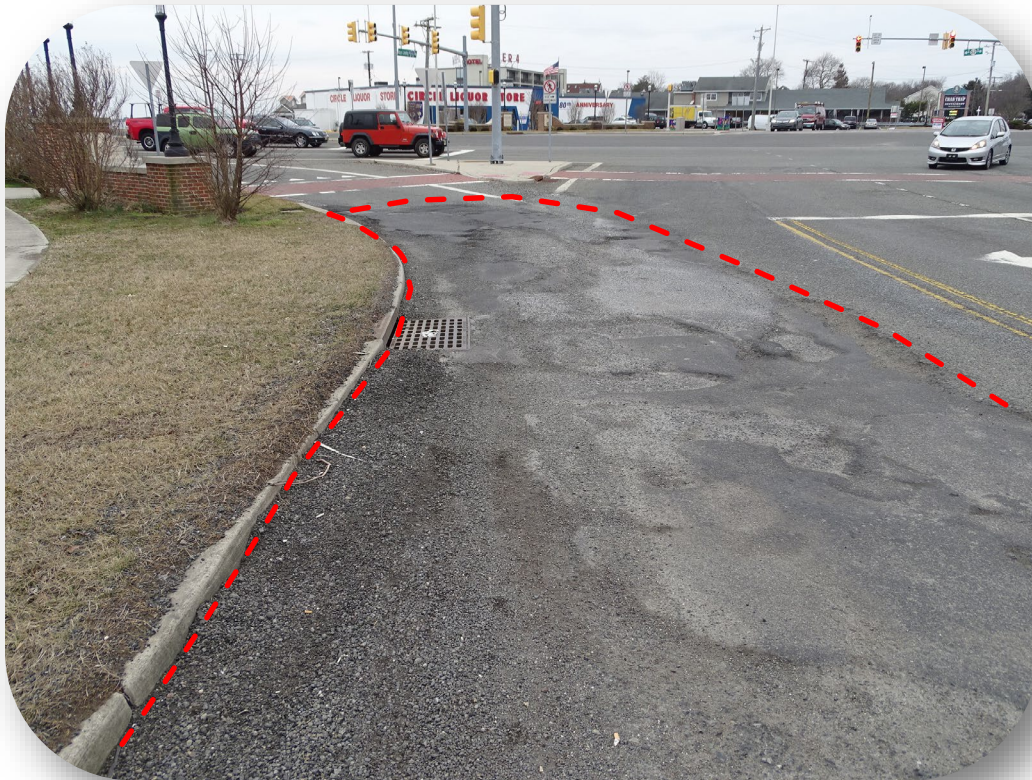
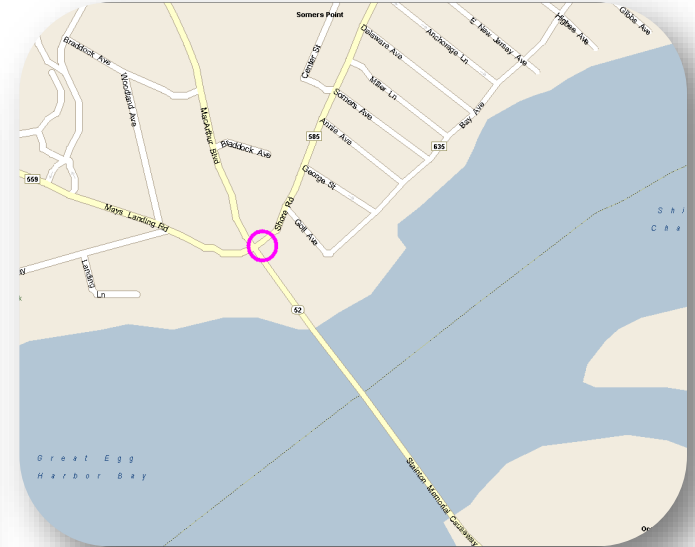
- The ramp from Route 52 WB to North Shore Road in City of Somers Point, NJ exhibited pavement failures that required frequent patching.
- The ramp was constructed between 2011 and 2012 as part of a project to eliminate the traffic circle at this location and premature failures were unexpected.

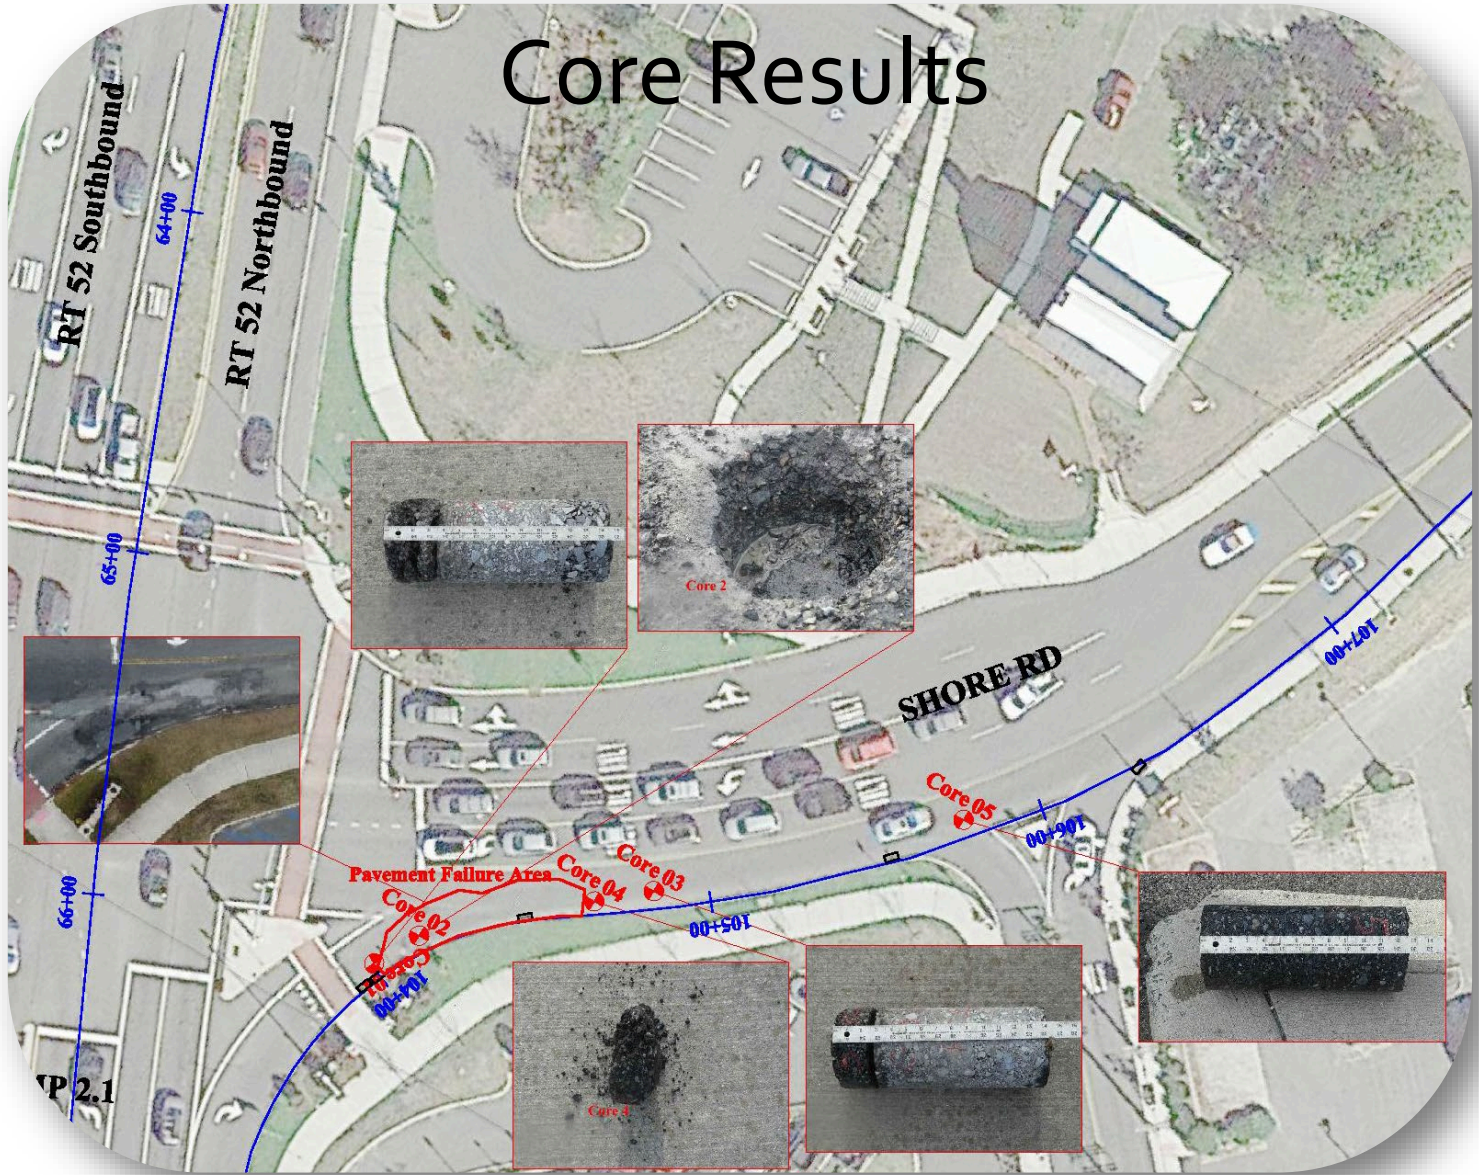
Core Results

- Five (5) core samples were extracted from the pavement.
- DCP testing was conducted for three (3) of the cores.
- Based on the core and GPR results, the pavement AC thickness varies from 9" to 14" (average 10").
- The aggregate base layer appears to have been stabilized and DCP could not penetrate indicating California Bearing Ratio (CBR) values more than 100%.
- The relatively thick pavement, strong aggregate base layer, and light traffic indicate that the pavement is structurally adequate. Hence, the cause of the pavement failure is not the structural capacity of the pavement.

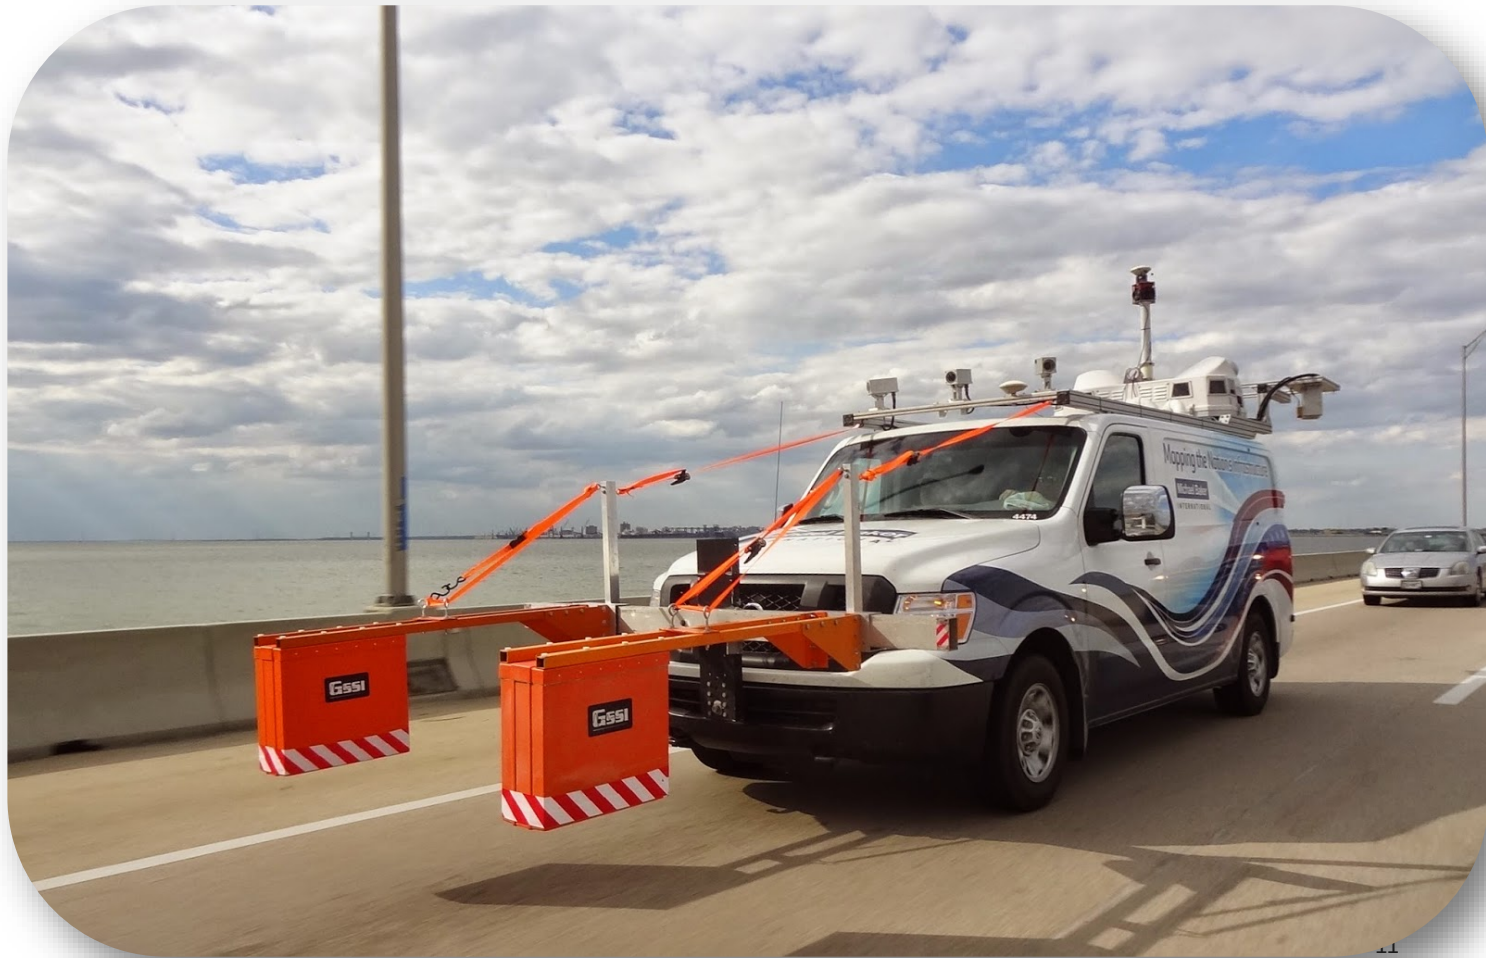
- GPR testing was conducted using two GSSI 2 GHz air-coupled antennas.

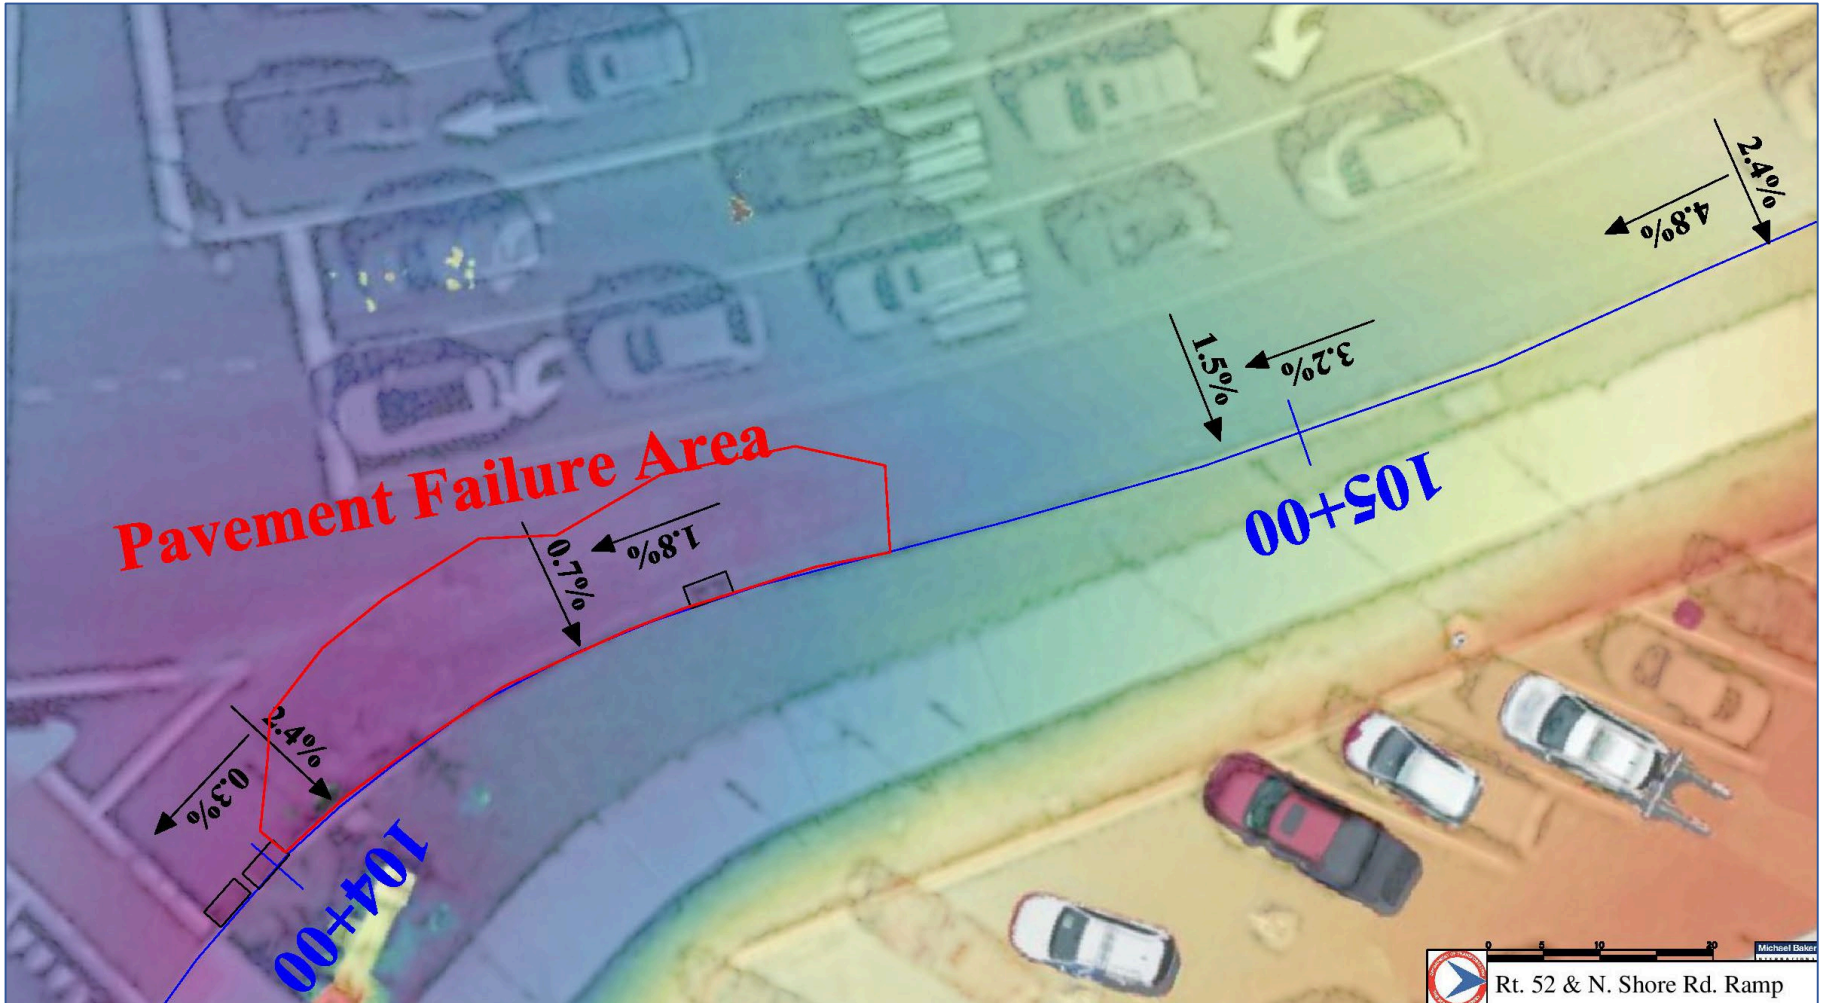
UAV Survey: Slope Measurement

Deposited Aggregates Inhibiting Flow of Water

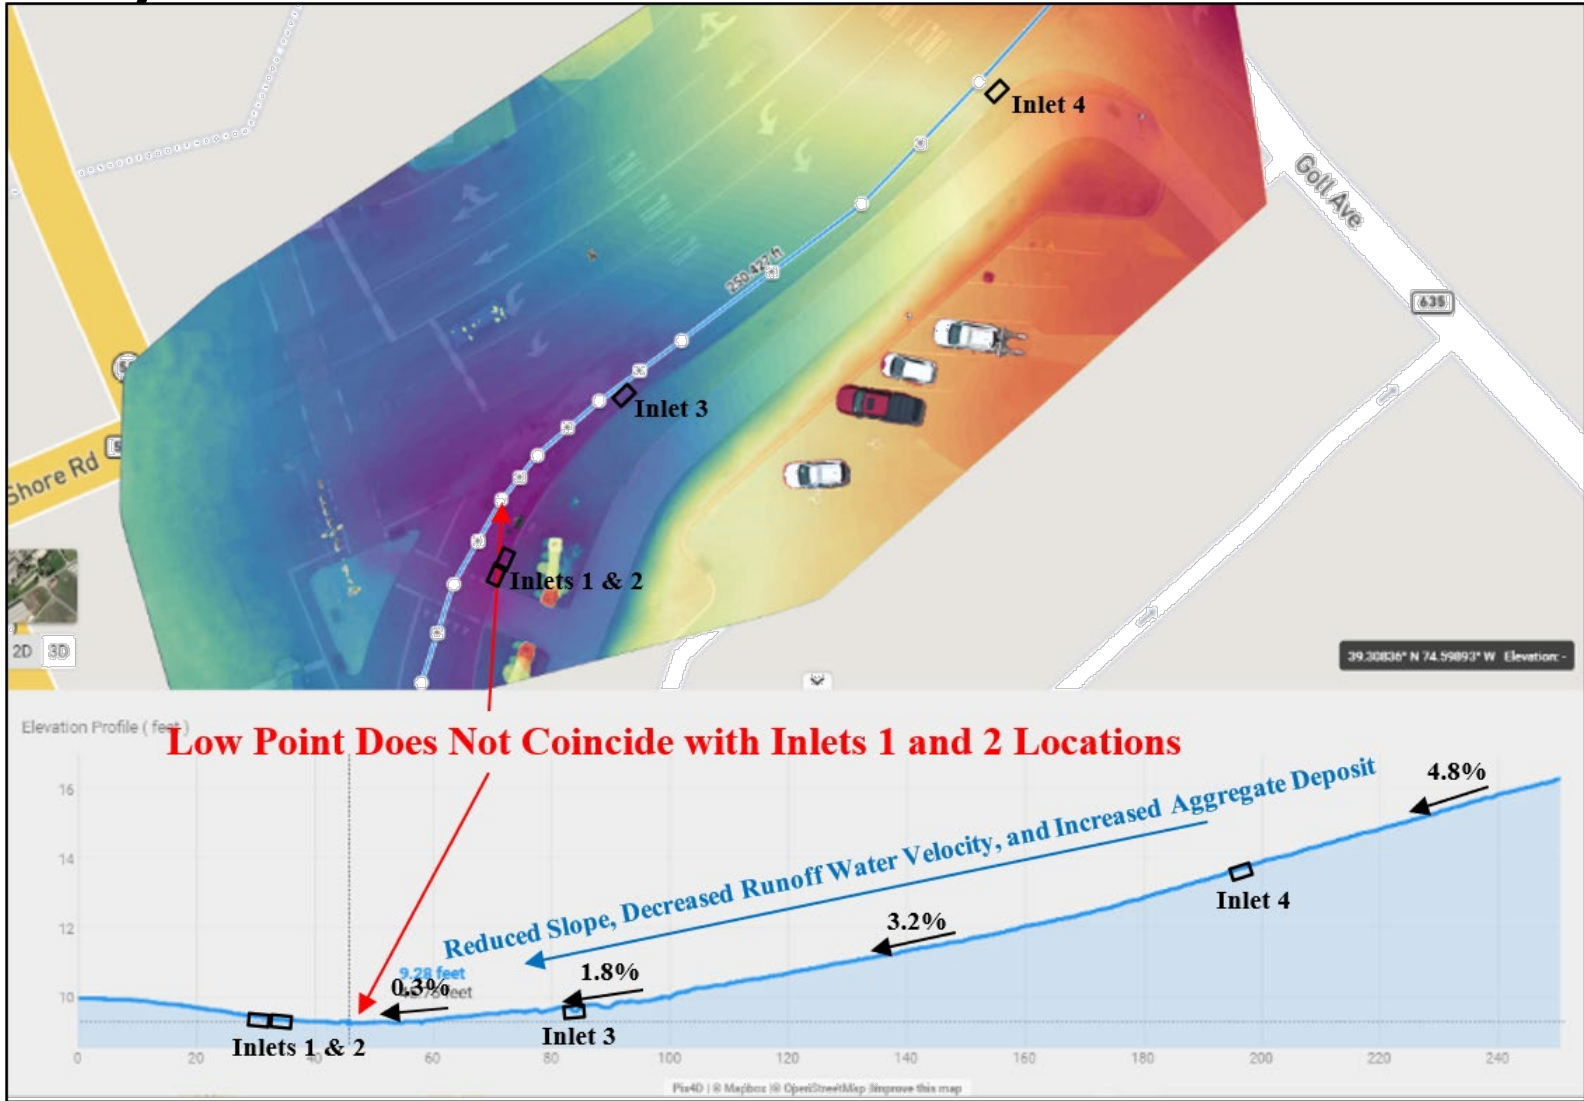
Analysis

- A visual survey of the project area indicated that the pavement failure area is at a low point receiving surface runoff water from the N. Shore Road Sta. 104+00 to Sta. 107+70.
- There are four inlets to catch the surface runoff water. Due to the relatively steep slope north of Sta. 104+46, it is expected that majority of the water is to be captured by Inlets 1 and 2 near the low point of the roadway.
- Inlets 1 and 2 do not seem to coincide with the low point of the roadway (next slide). The low point is approximately 15' north of the inlets

- Seal coat the pavement that was placed circa 2012 between Stations 103+90 to 109+90 (600') to delay further raveling and loss of aggregates.
- Remove the surface course in the failed pavement area to a depth of 4" and replace with a binder rich mix that can resist HMA stripping better. Use of anti-stripping agents in the mix may be considered.
- Regularly remove the deposited aggregates to allow for free flow of surface run-off water and avoid ponding potential.

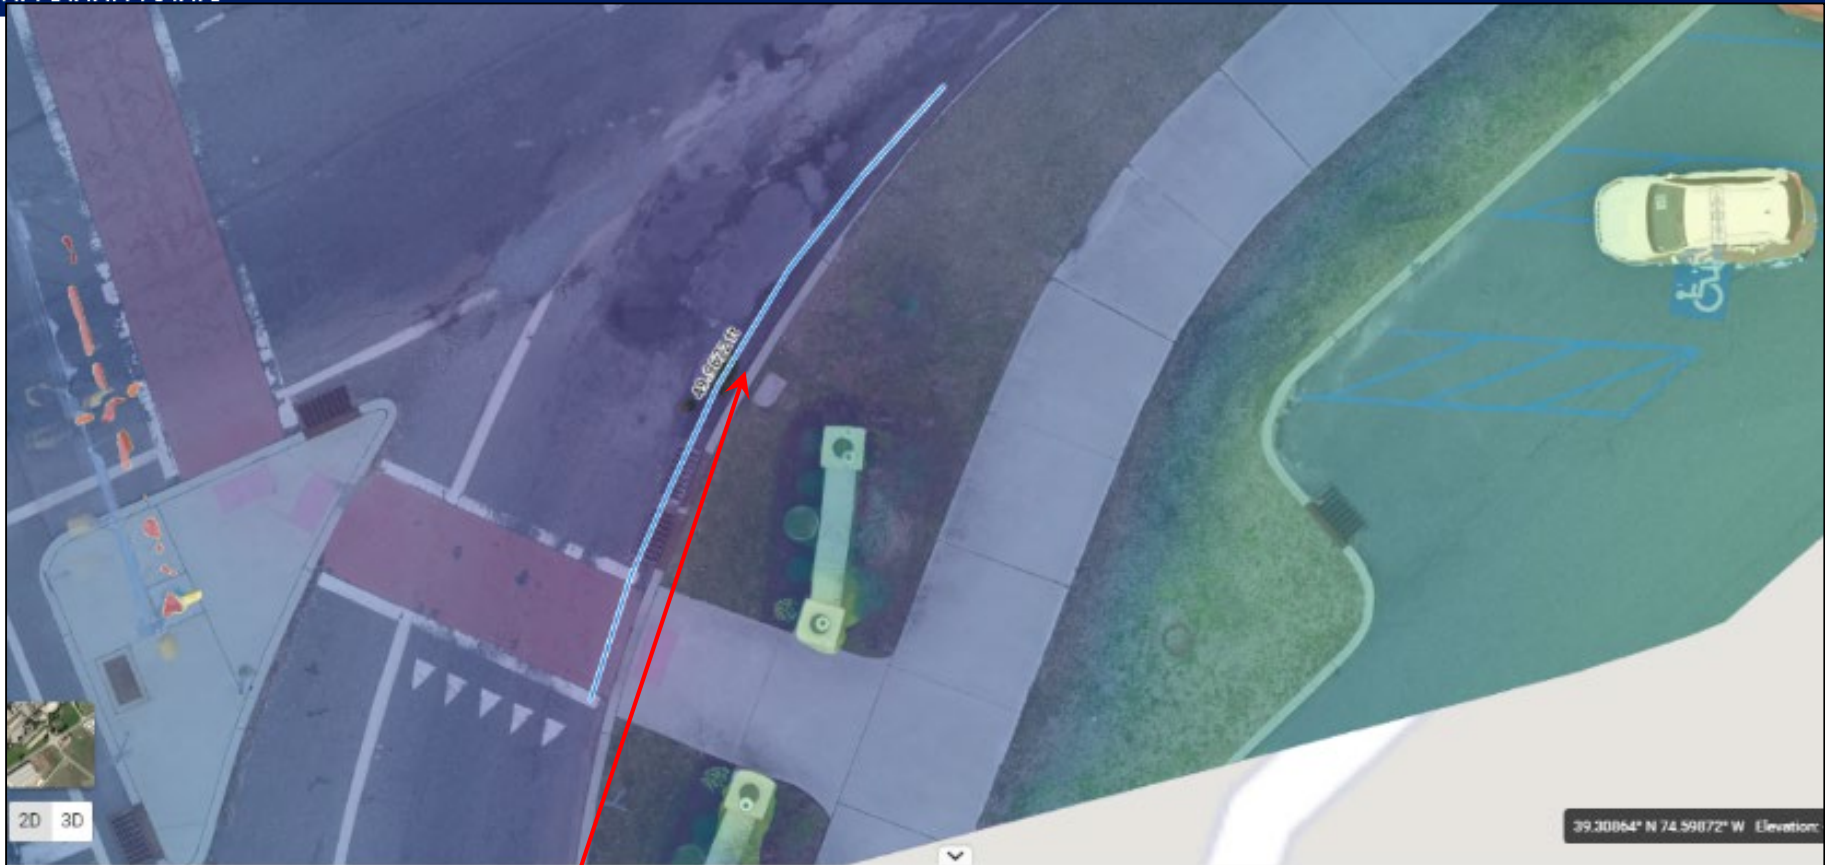
Inlets 1 and 2 Do Not Coincide with Low Point of Road

Approximate
Location of
Low Point of
Road

Deposited Aggregates Inhibiting Flow of Water

Low Point

Inlets 1 & 2
