Miami Pedestrian Bridge Collapse: A Computational Forensic Analysis

Anil K. Agrawal, Ph.D., P.E. and Ran Cao
The City College of New York, New York, NY

Sherif El-Tawil, Ph.D., P.E.
University of Michigan, Ann Arbor, MI

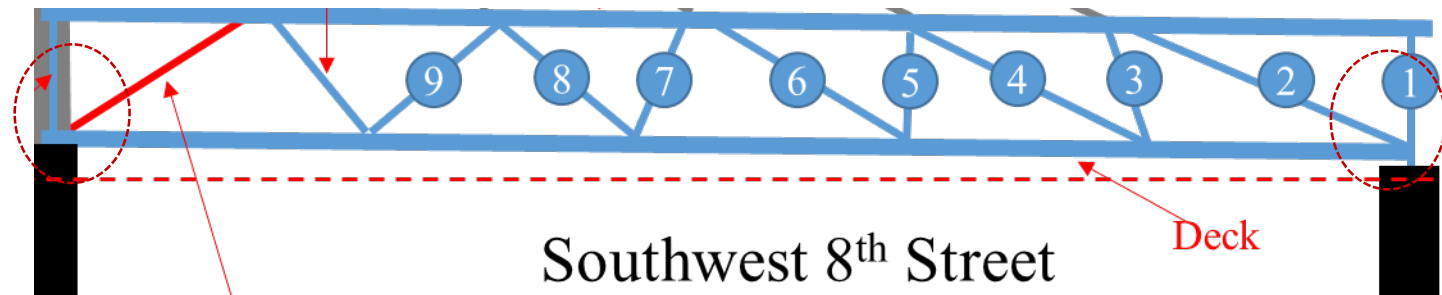
1. FIU bridge designers (1) made significant design errors in the determination of loads, leading to a severe underestimation of the demands placed on critical portions of the pedestrian bridge; and (2) significantly overestimated the capacity of the member 1/2 and 11/12 nodal regions.

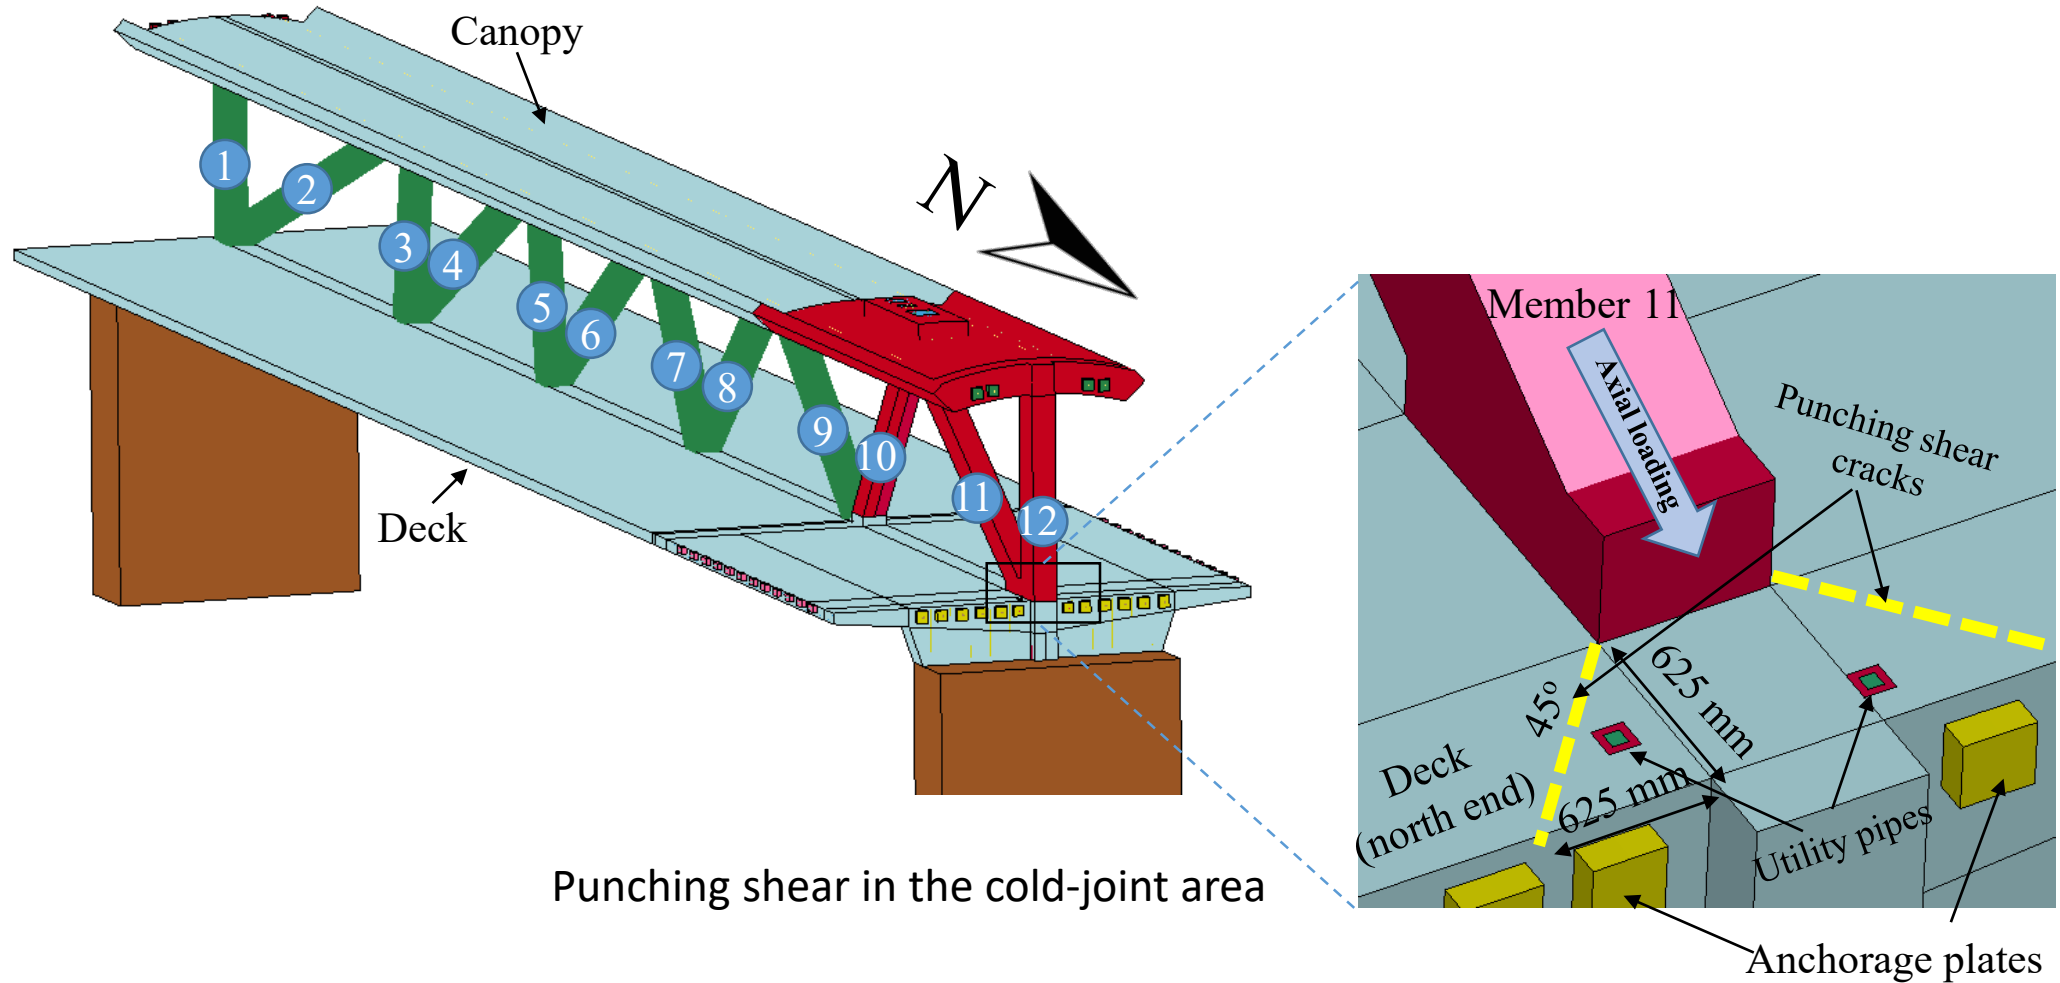
Punching-Shear Capacity of the Deck

➔ The joint may have been deficient regarding this type of failure regardless of how much of the tendons prestressing capacity had been engaged in preventing punch out.

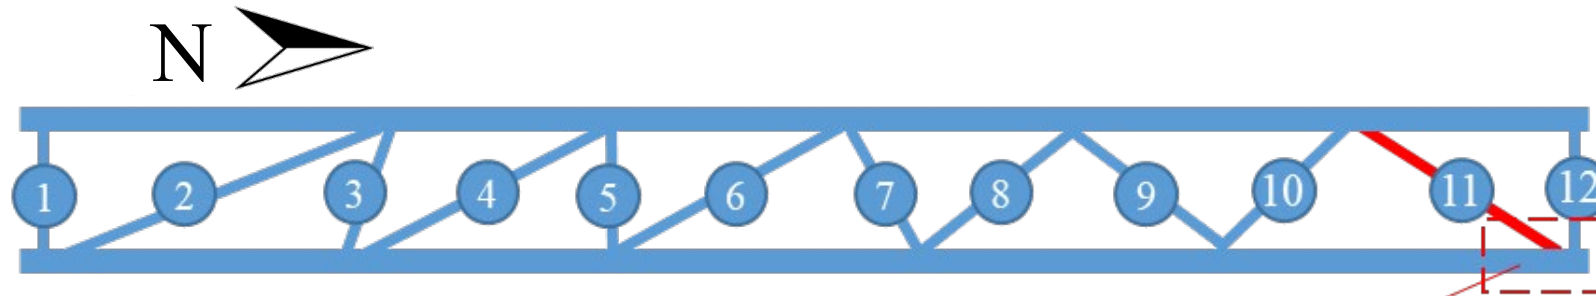
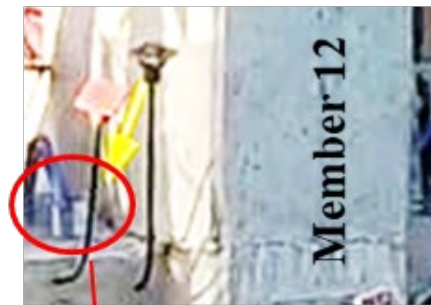
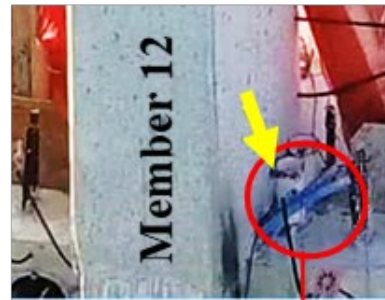
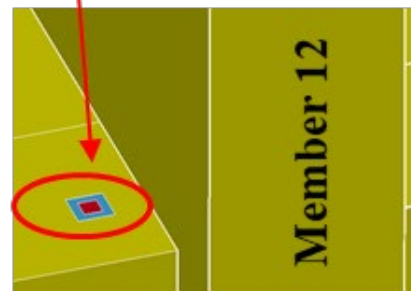
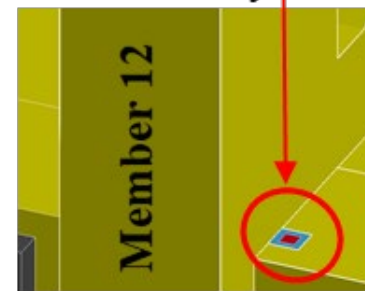
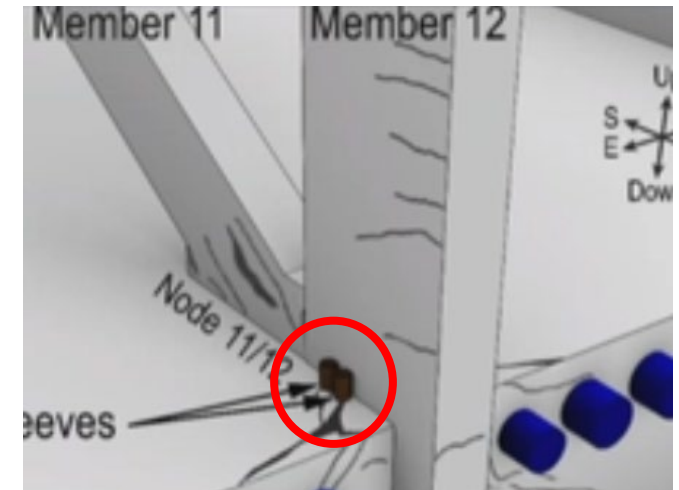
- Utility conduits modeling at the north end of the bridge

Utility conduits were modeled using 8-node solid elements with low strength concrete (20 Mpa).

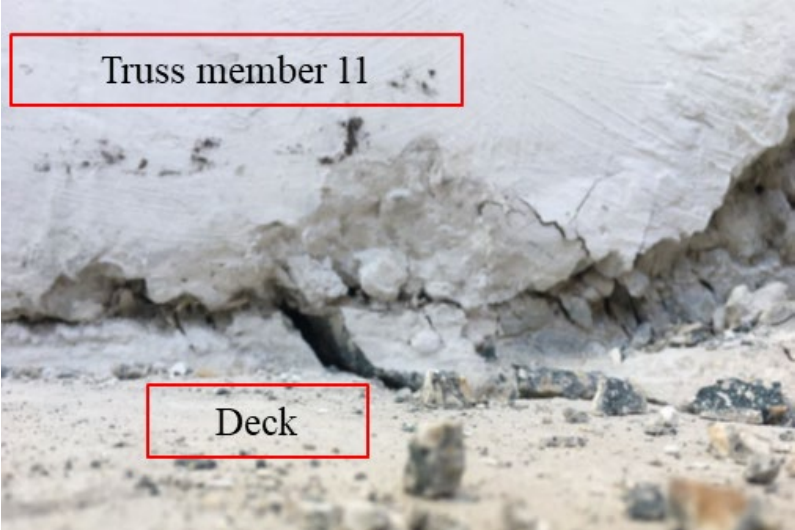
Slip at the cold-joint

- The original design relied on friction to resist the horizontal shear forces, but simulation showed that even a high coefficient of friction of 1.4 could not prevent severe damage in the cold-joint area.
- According to OSHA and NTSB reports, the surface of the cold joints was not intentionally roughened.

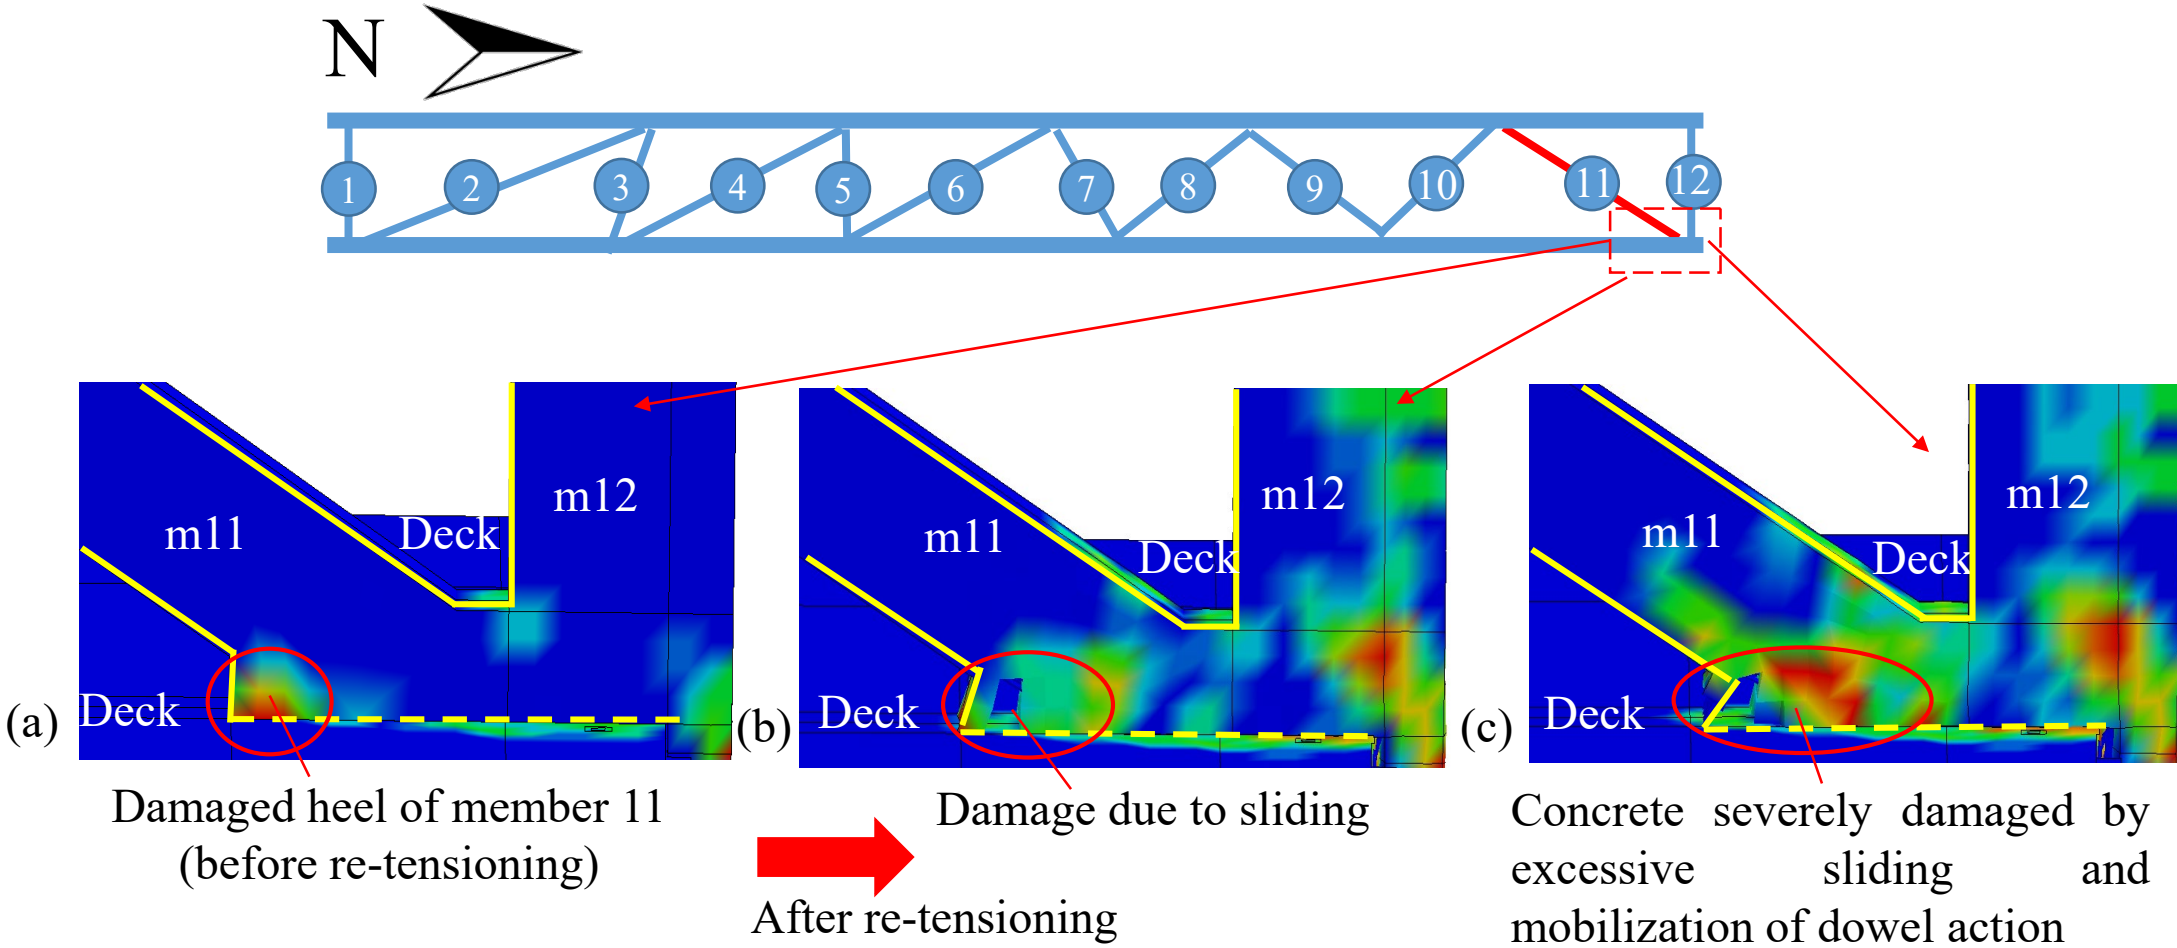
- Re-tension tendons in m11 to maximum jacking stress of the tendons, i.e. 94% of yield strength per ACI (2011)

Based on OSHA report, the tendons in member 11 were re-tensioned over 80% of the yield strength, which could cause significant increase in the cold-joint slip and may further cause collapse of the bridge.

4. Re-tensioning diagonal truss members should not be considered as an appropriate solution to remedy the cracks in the cold joint area.
5. Cracks in the cold joint area should be viewed as an important warning sign of impending collapse and immediate action should be taken to ensure the stability of the structure after detailed calculations or modeling.
6. The collapse of the bridge doesn't necessarily imply that accelerated bridge construction is risky, but certainly shows the need for adequate analysis simulating construction aspects such as the presence of cold joints or utility conduits, to ensure the safety of the bridge during and after the construction.

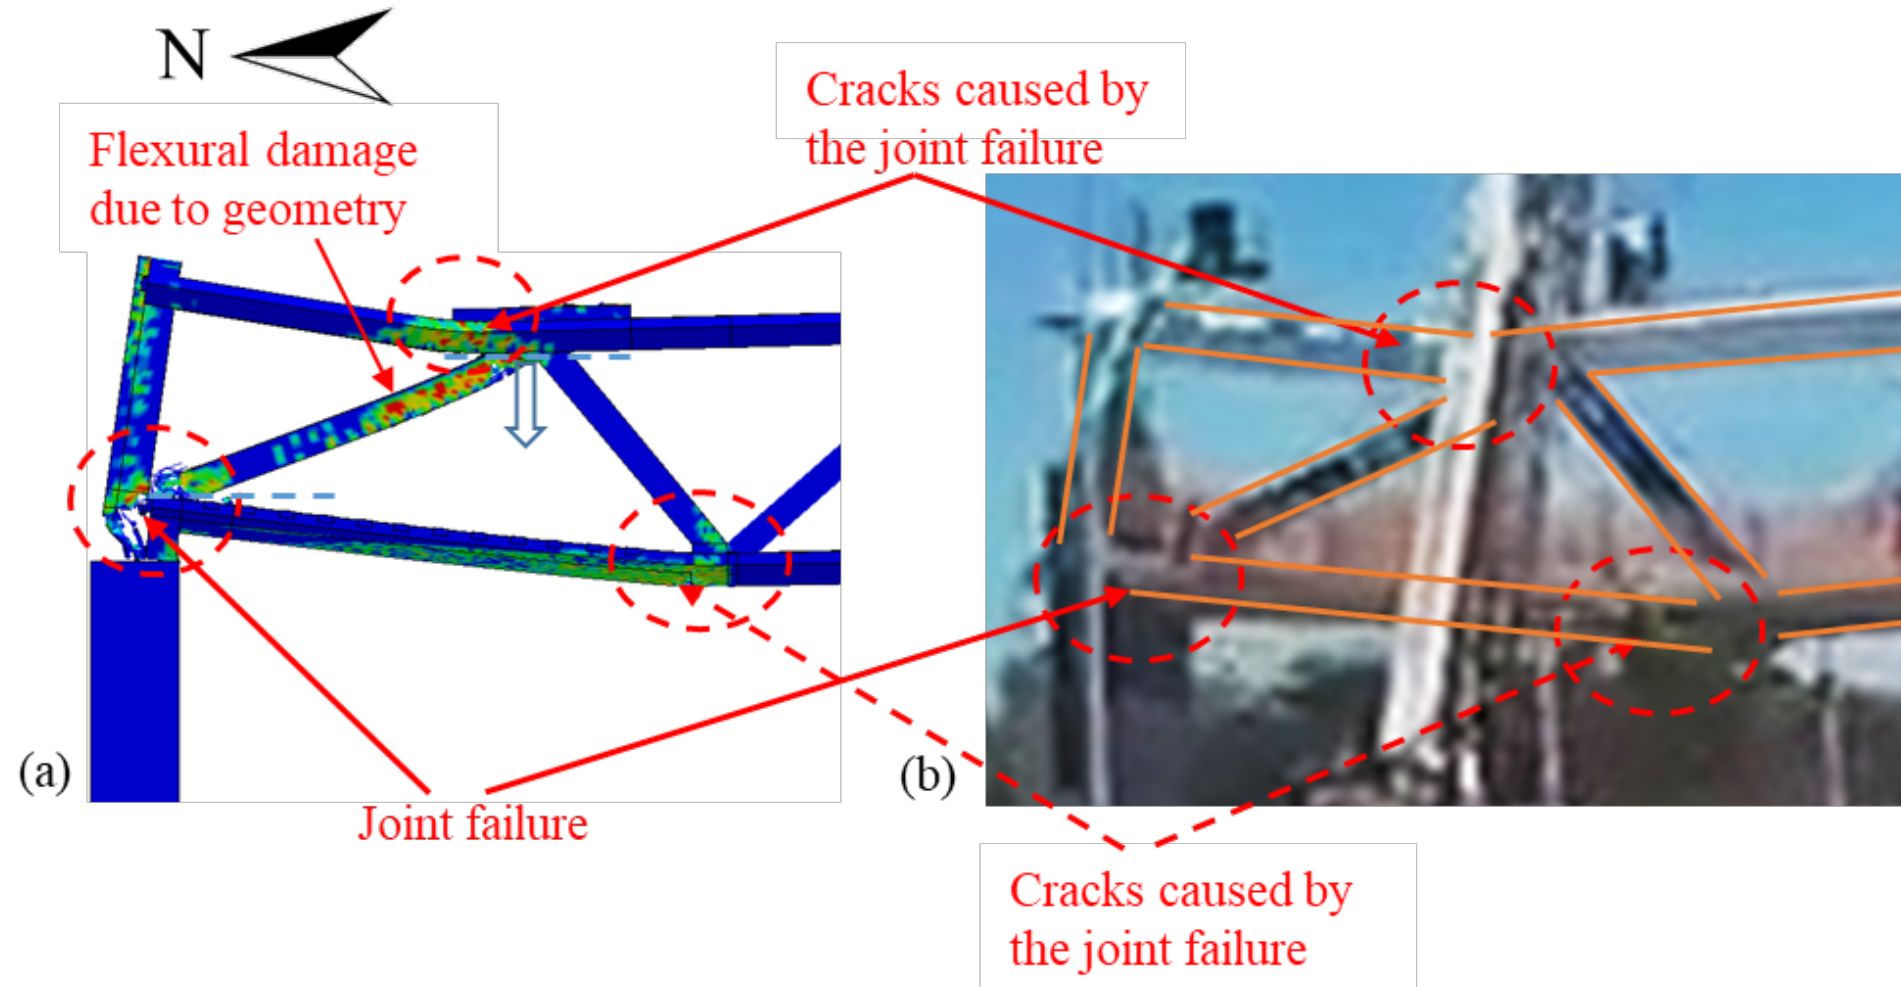
- Comparison of the failure mode

1. Damaged heel of member 11 under gravity and pre-stressing (before re-tensioning).
2. After re-tensioning, concrete in the cold joint area was severely damaged by excessive sliding and mobilization of dowel action, which also caused punching shear failure.
3. Member 11 and member 12 were pushed off the deck. The deck fell off the support, leaving behind a portion of member 11/12's joint wedged onto the pier.
