Evaluation of Different Paint Systems for Over-Coating Existing Structural Steel

Final Report
August 2018

1. Report No. FHWA-NJ-2018-006		2. Government Accession No.		3. Recipient's Catalog No.	
4. Title and Subtitle Evaluation of Different Paint Systems for Over-Coating Existing Structural Steel				5. Report Date August 2018

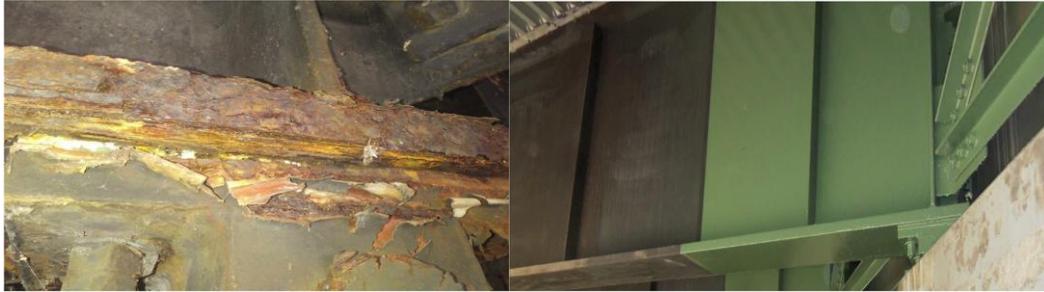
Figure 1. An Over-coated beam: US Route 202 over NJ Route 29 before and after Over-coating

A common practice for maintaining and repairing existing structural steel is to apply an epoxy mastic urethane overcoating. NJDOT has an active over-coating program, a typical application example is shown in Figure 1.

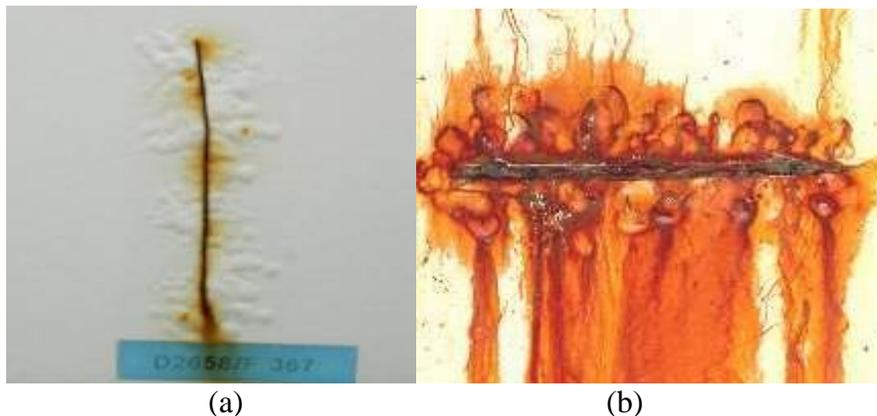
Figure 4. Creep growth at scribe: (a) without deep freeze cycles and; (b) with deep freeze cycles ⁽³⁰⁾

Research done by the automobile industry identified a method to further accelerate the creep growth ⁽³⁰⁾. In this test, the researchers found that deep-freezing and thawing cycles could increase the creep growth by an order of magnitude, Figure 4. Difference in coefficient of thermal expansion of coating formulations and the metal are found to be primary cause for this accelerated creep growth.

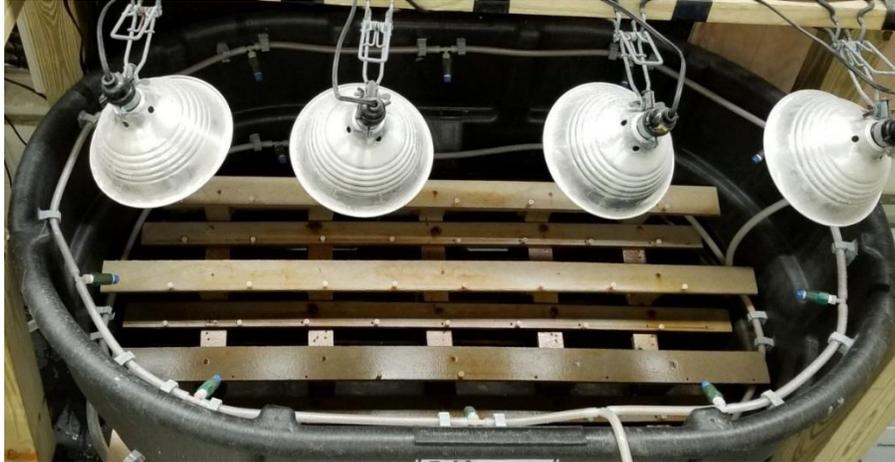
The chamber used for accelerated corrosion consisted of a plastic tank that does not corrode. Metal tanks that do not corrode can also be used instead of plastic tank. A holding rack for placing specimens was built inside the tank using the guidelines of ASTM D5894-16 ⁽⁷⁾ and ASTM B117-16 ⁽⁴⁾. The holding rack built using a non-

corrosive/conductive material, supports specimens at an angle between 15° and 30° from the vertical axis. These racks were placed parallel to the principal direction of the salt spray in the chamber.

Figure 5. Chamber for Accelerate Testing: Salt Sprayers and Holding Rack

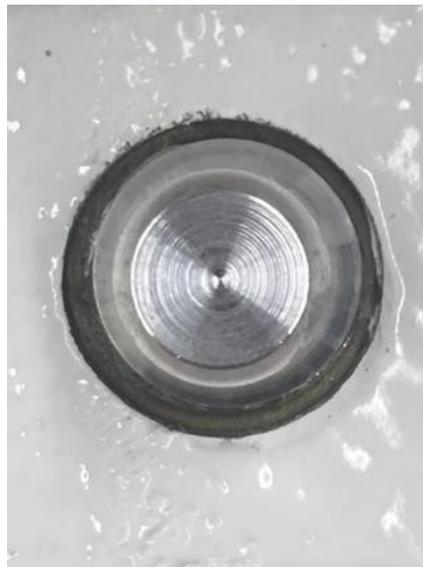
Figure 6. Pull Off Dolly (20 millimeter): Epoxied to Over Coated Steel Specimen

strength of the 20 mm diameter coatings isolated by the scribe, Figure 6, were measured at various stages of corrosion. The first set of adhesion strengths were obtained after proper curing of the coatings. For these tests, a minimum of three 20 millimeter pull off dollies were adhered to the circular painted areas within the scribe using a two-part manufacturer supplied epoxy, Figure 6. The epoxy was cured for a minimum of 24 hours. The pull off tester used was PosiTest® AT-M Manual Adhesion Tester, Figure 7 and 8. The tensile load was applied at a constant rate of 150 psi/s (1 MPa/s). This rate of loading was chosen to satisfy the requirement that the test has to be completed within 100 seconds. After each test, the maximum tensile stress and failure mode were recorded. The pull off dollies were then labeled and kept for comparative evaluation at various stages of corrosion. Once testing was completed, the specimens were placed in the test-chamber for accelerated testing. Pull-off tests were conducted for virgin samples and at intervals of 14 master cycles. Final tests were conducted after 100 master cycles of exposure.

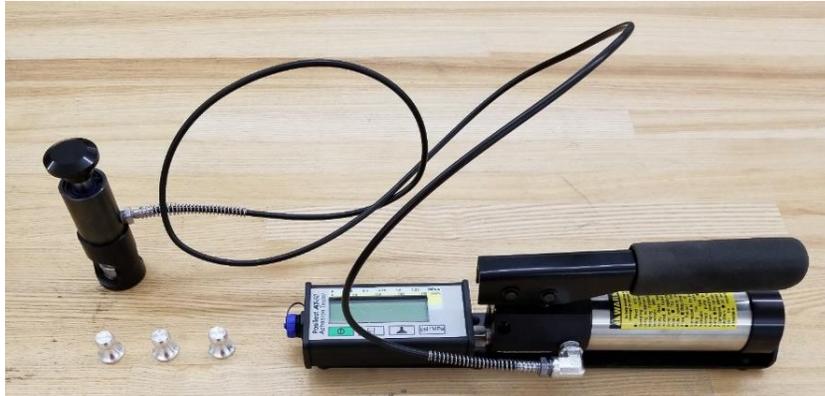
Figure 7. Pull Off Tester and 20 millimeter Pull Off Dollies

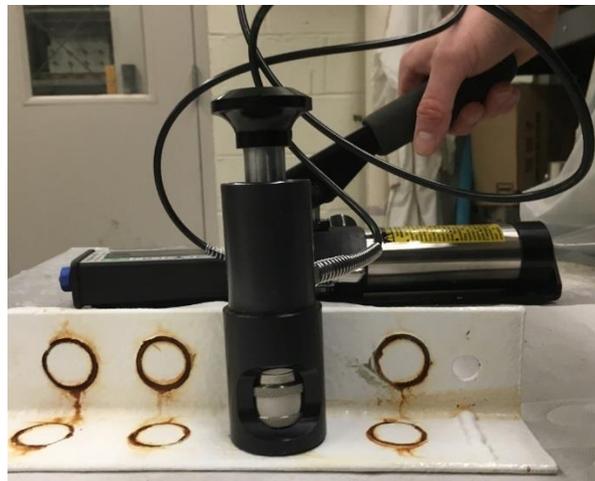
Figure 8. Pull-off test in progress

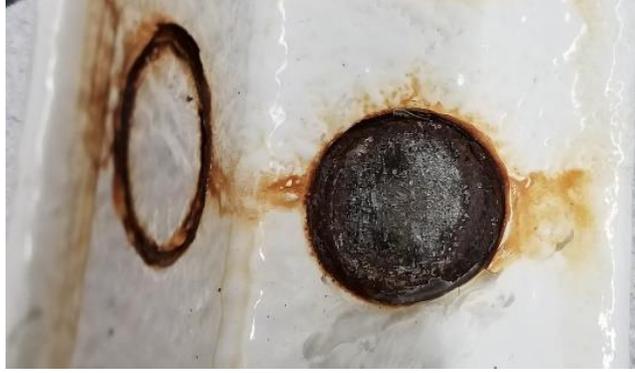
Figure 9. Images of circular coating: Before and after pull off test

After each 14 master cycles of exposure in the accelerated corrosion chamber, the specimens were taken out, rinsed with clean water to remove any debris or residue and dried with low-pressure compressed air. After cleaning, three 20-mm pull off dollies were adhered to the circular painted areas within the scribe using a two-part manufacturer supplied epoxy and cured for the required minimum of 24 hours. After the epoxy was cured, adhesion strengths were measured. The test in progress and the sample before and after pull-off are presented in Figures 8 and 9, respectively. Images of corrosion growth for the best and worst coating system evaluated in the current investigation are presented in Figures 10 and 11. These images were taken after the 20 mm diameter circular coating was pulled-off during the pull-off tests.

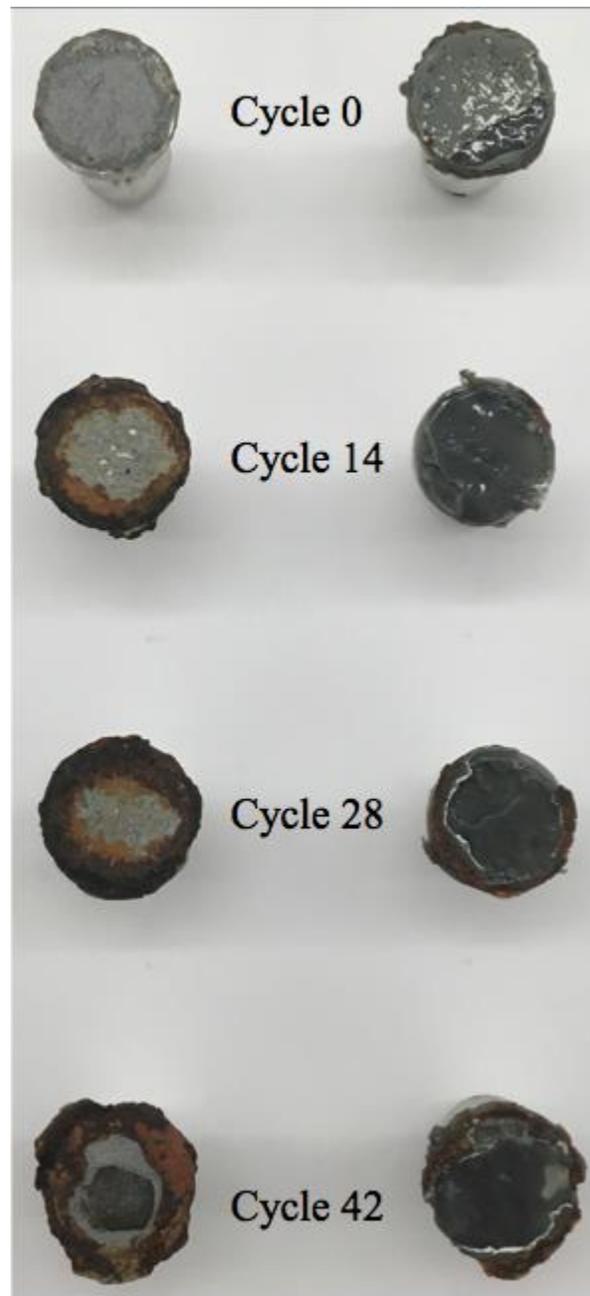
Figure 10. Worst and Best Performing Coating System: Images of corrosion growth after circular coatings were pulled-off, Cycle 0 to 42

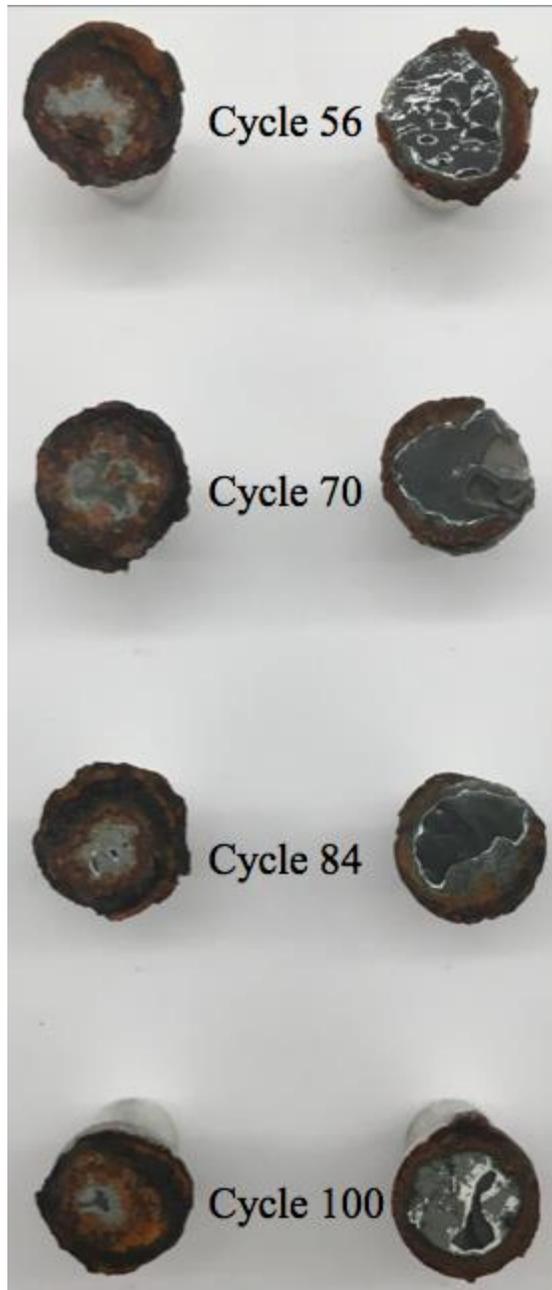
Figure 11. Worst and Best Performing Coating System: Images of corrosion growth after circular coatings were pulled-off, Cycle 56 to 100

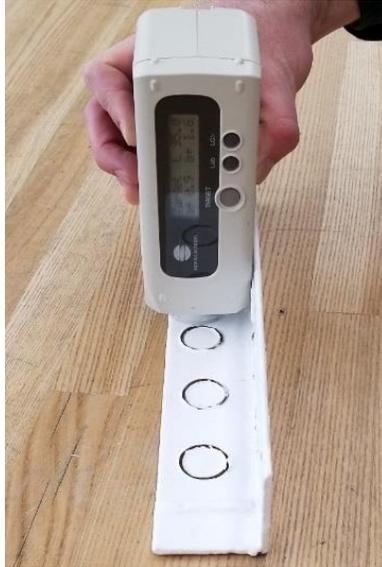
Figure 12. Konica Minolta CR-10 Plus Color Reader

Visual inspection along with a device called Colormeter, Figure 12, were employed to monitor the color change of the coatings during the testing. The Colormeter provides three readings designated as a*, b*, and L* coordinates. These coordinate numbers change with the change in the color of the coatings and provide a quantitative measure of the color changes. Since the color change is gradual and not significant, the measurements were made only at the beginning and the end of the exposure period, representing 0 and 100 cycles. Readings were taken at 9 random locations and the average was obtained. For the samples exposed to weathering, the surface was cleaned to remove the rust spots before taking the Colormeter readings.

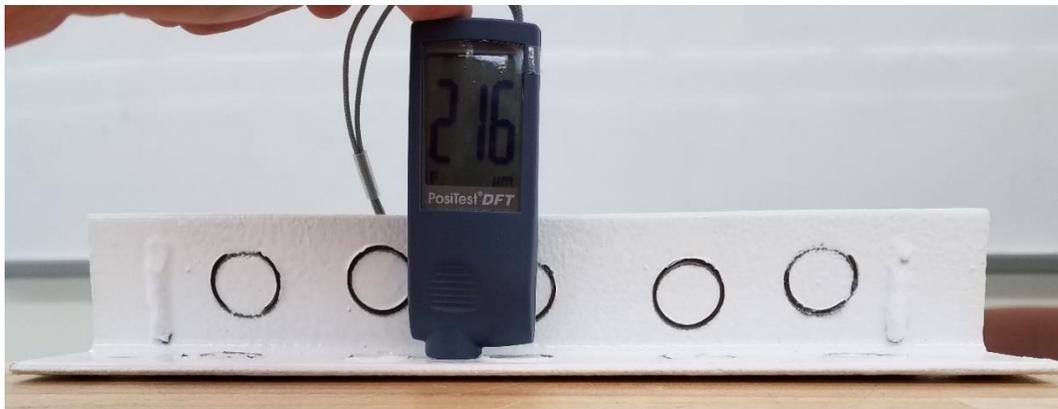
Figure 13. Thickness gage used for measuring the thickness of paint layers

Change in thicknesses of the coatings during the weathering cycle exposure were monitored using a thickness measuring gage, Figure 13. A minimum of three readings were taken to obtain an average thickness. Again, as the change in thickness was not significant, measurements were made only at 0 and 100 cycles. As in the case of color change measurement, readings were taken at 9 random locations and the average was obtained.

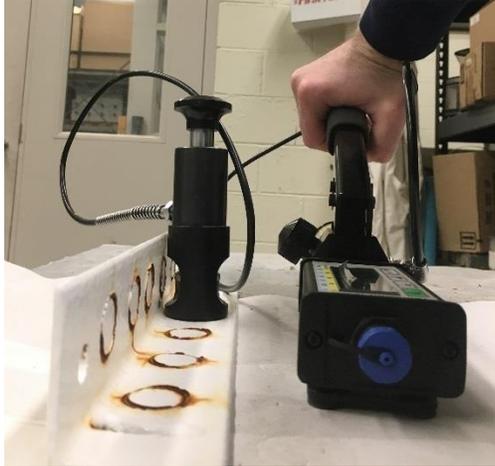
Figure 14. Typical Pull Test

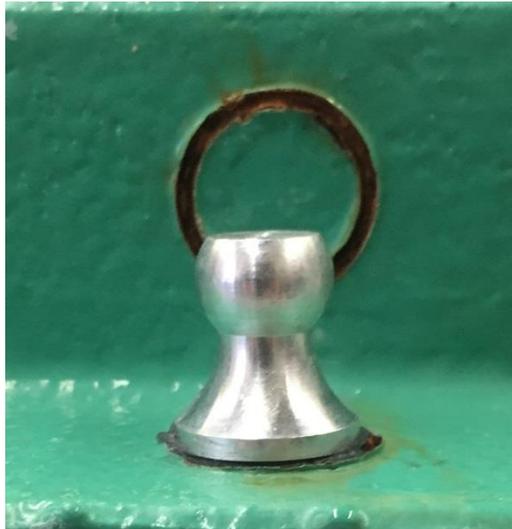
Figure 15. Pull Off Dolly (20 Millimeter): Epoxied to Inorganic Zinc Over Coated Steel Specimen

Tests were conducted using a minimum of 3 samples for each coating system. In addition, the entire test was repeated for one of the coating system to verify the repeatability of the test. The procedure outlined in the aforementioned sections were followed for all the tests. Pictures of test sample and use of measuring equipment for adhesion strength are shown in Figures 14 to 16. The typical pull-off test for a corroded sample is shown in Figure 14, in which the corrosion progress around the circular perimeter can be seen. Elevation and plan views of a typical dolly attached to the coating using epoxy are shown in Figures 15 and 16, respectively.

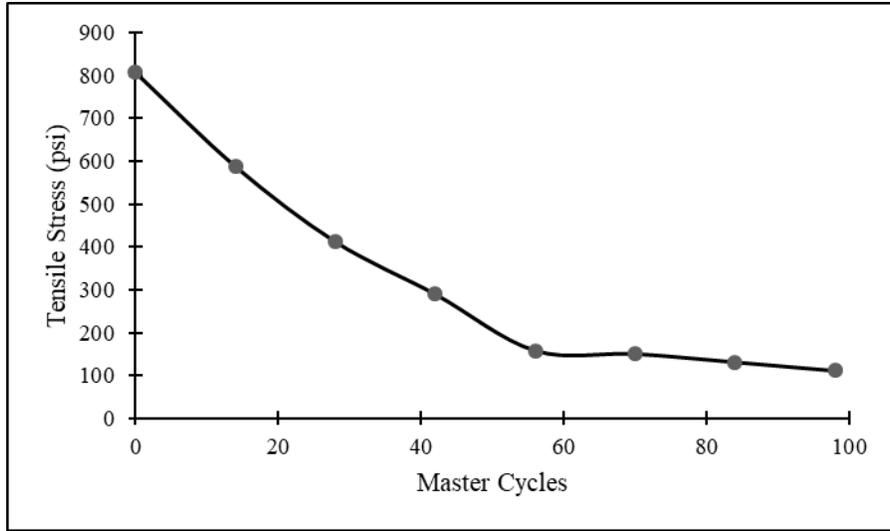
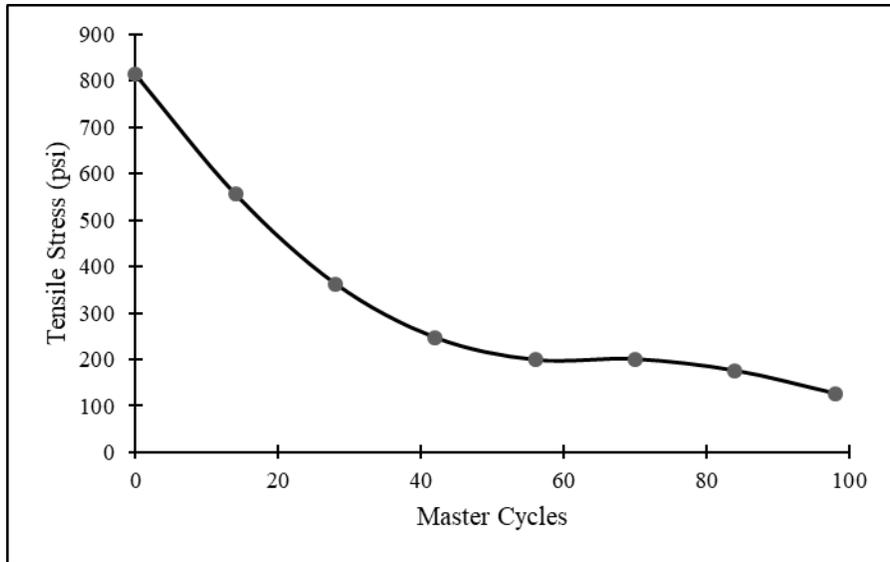
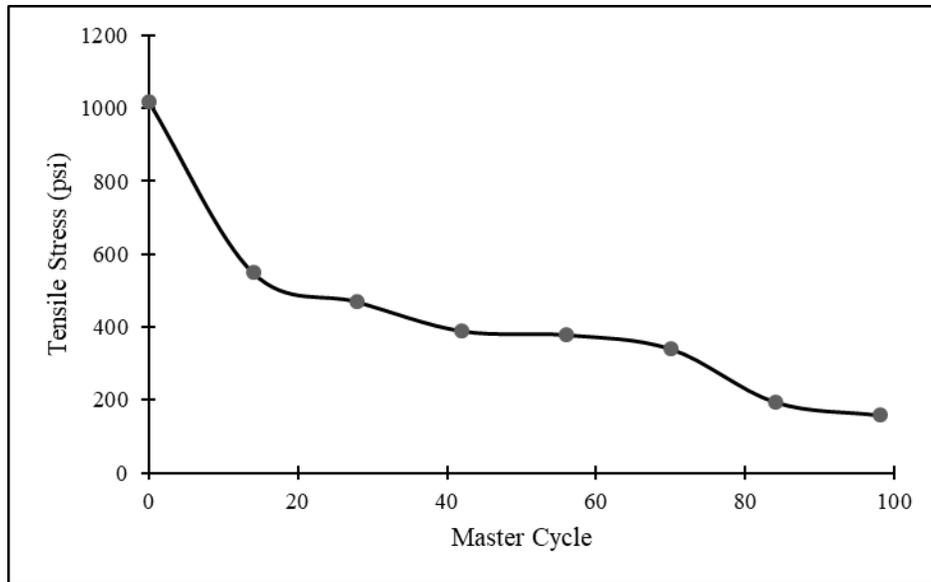
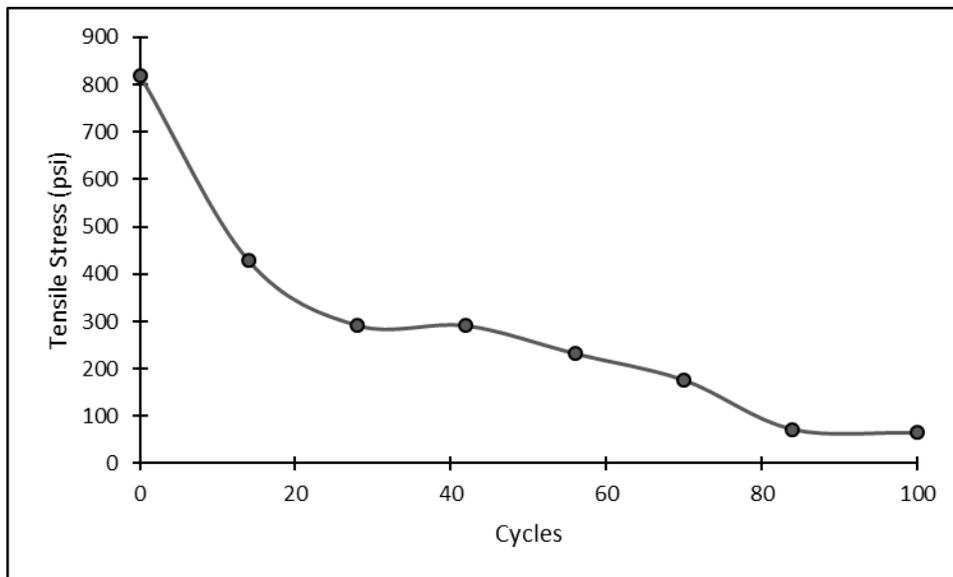
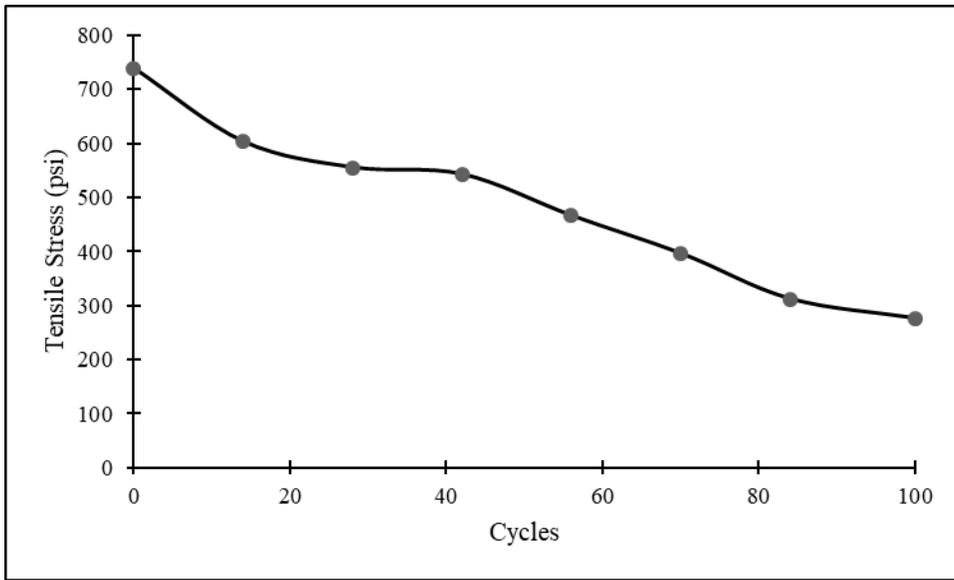
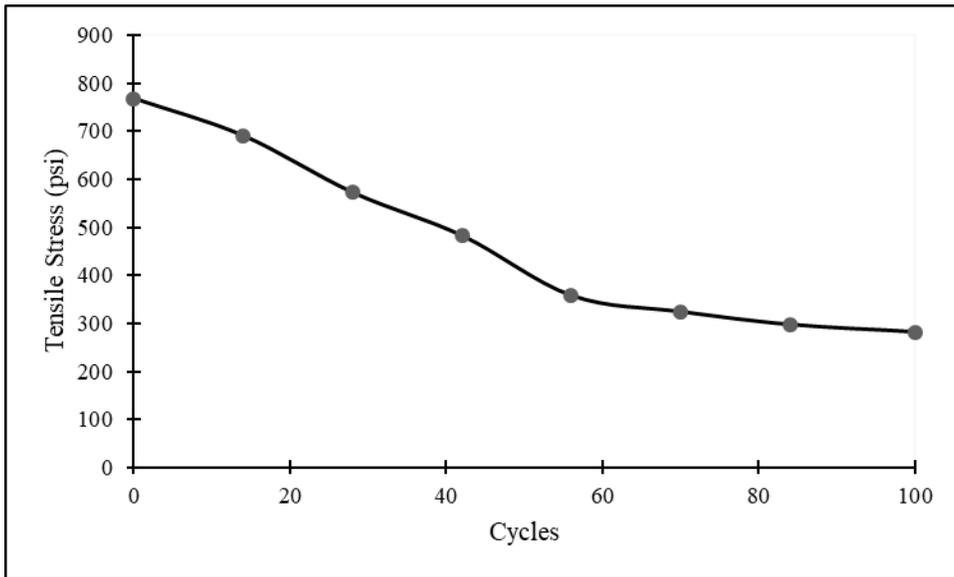
Figure 17. Direct Tensile Stress versus Number of Cycles: Coating 1

Figure 18. Direct Tensile Stress versus Number of Cycles: Coating 2

Figure 19. Direct Tensile Stress versus Number of Cycles: Coating 3

Figure 20. Direct Tensile Stress versus Number of Cycles: Coating 4

Figure 21. Direct Tensile Stress versus Number of Cycles: Coating 5

Figure 22. Direct Tensile Stress versus Number of Cycles: Coating 6

The results of the pull off tests are presented in Figures 17 to 22. Direct pull-off strength versus master cycles are presented for five coating systems and the replicate test of Coating 1. Note that 1 master cycle consist of: 8 cycles of wetting, 8 cycles of drying, 8 hours of UV exposure during the drying cycles and 8 hours of deep-freezing.

Based on the test results presented in Figures 17 to 22, the following observations can be made:

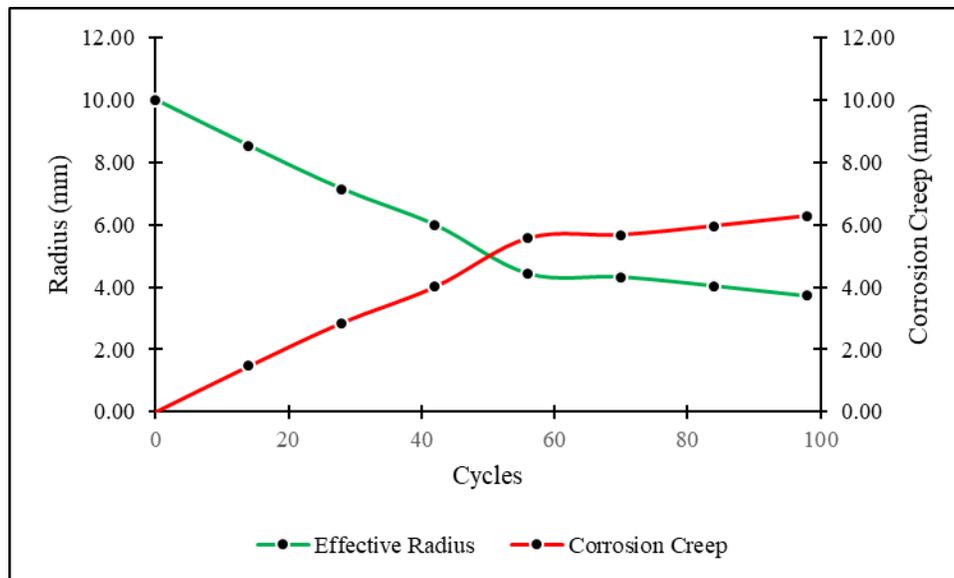
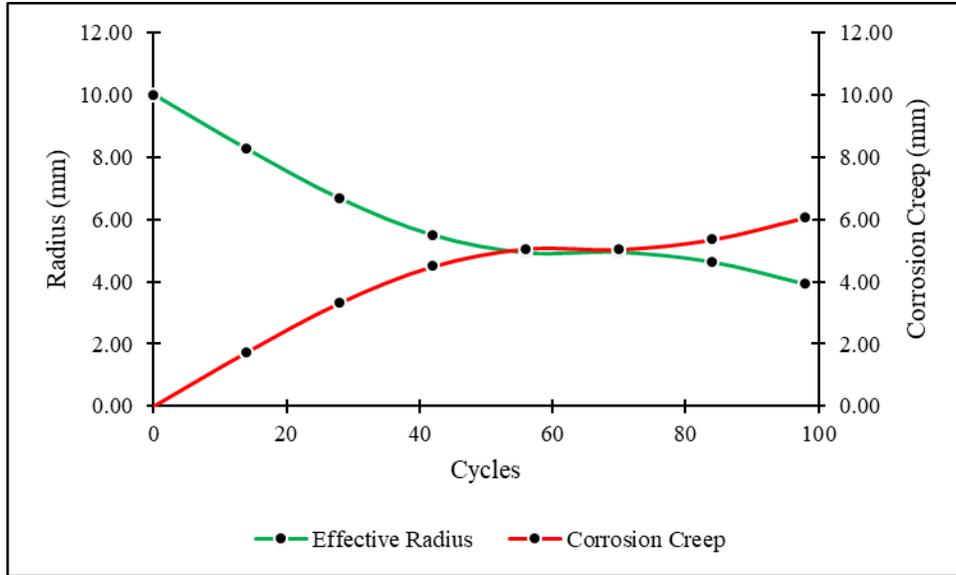
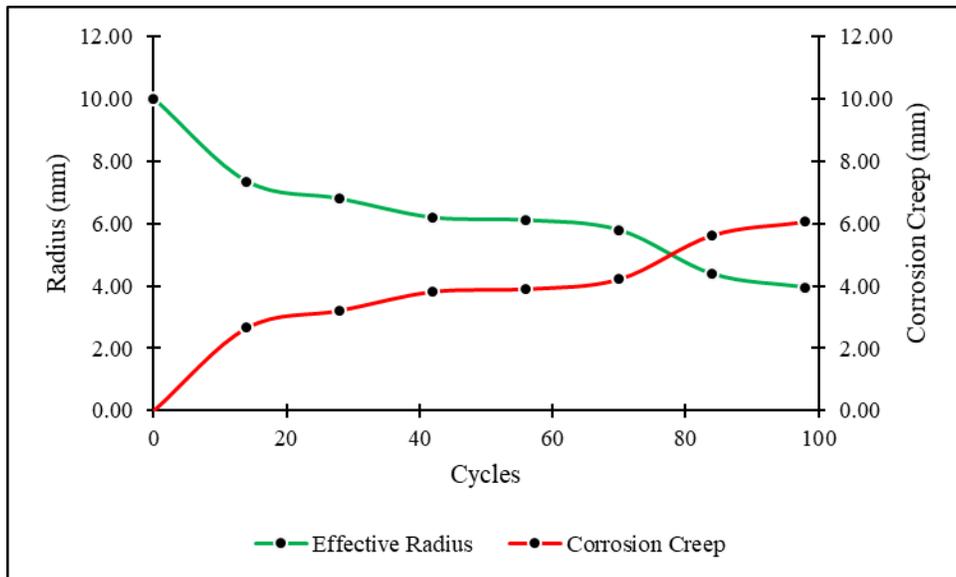
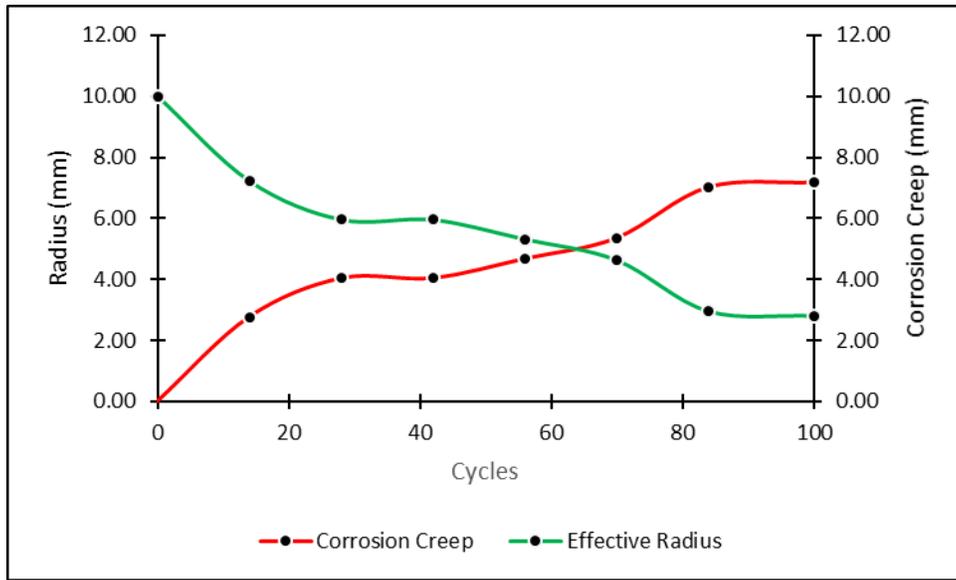
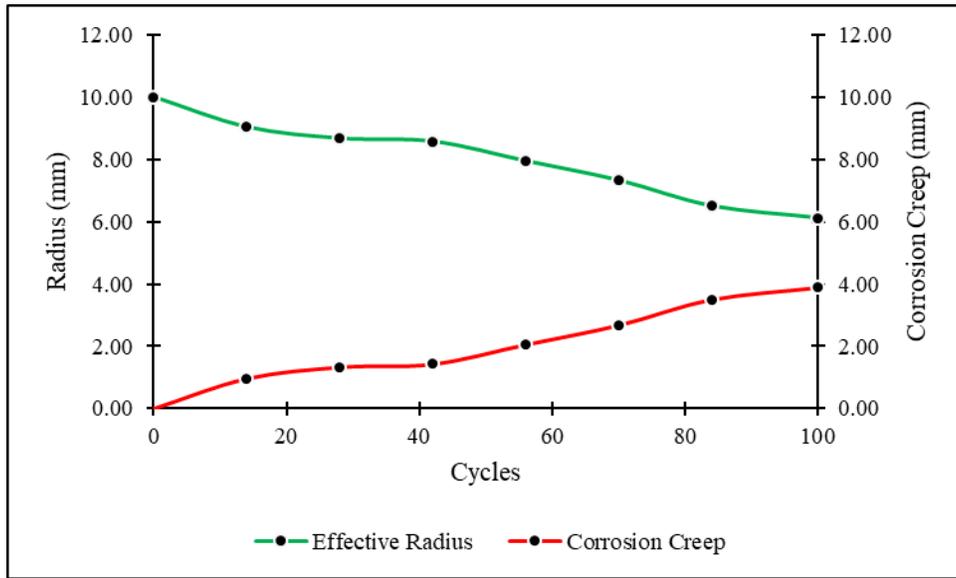
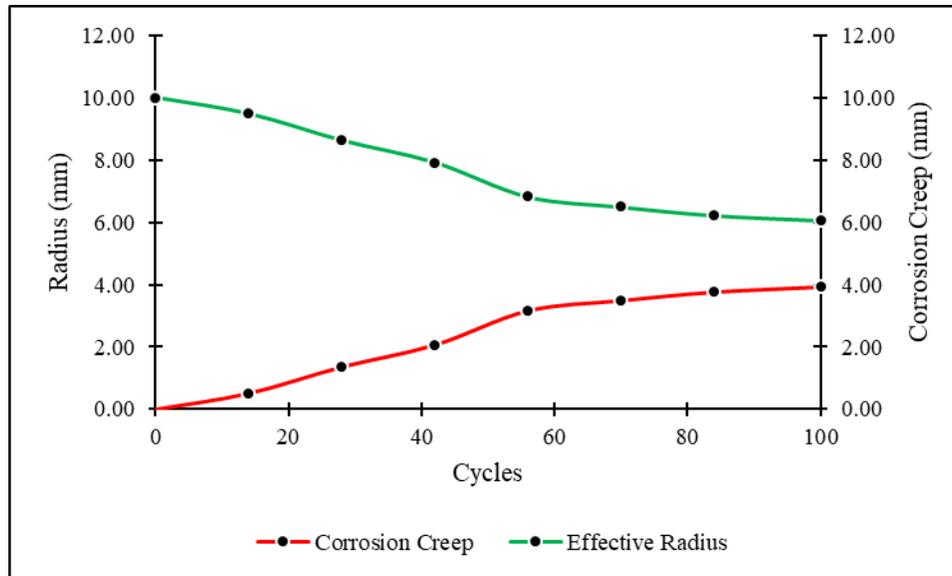
Figure 23. Effective Radius and Corrosion Creep Growth versus Number of Cycles: Coating 1

Figure 24. Effective Radius and Corrosion Creep Growth versus Number of Cycles: Coating 2

Figure 25. Effective Radius and Corrosion Creep Growth versus Number of Cycles: Coating 3

Figure 26. Effective Radius and Corrosion Creep Growth versus Number of Cycles: Coating 4

Figure 27. Effective Radius and Corrosion Creep Growth versus Number of Cycles: Coating 5

Figure 28. Effective Radius and Corrosion Creep Growth versus Number of Cycles: Coating 6

The adhesion strength results were used to estimate average creep growth using the procedure presented in section “*Interpretation in Pull-off Tests*”. The variation of reduction in radius and average corrosion creep growth are presented in Figures 23 to 28 for the 6 coating systems.

Since these results provide a different representation of the adhesion strength, the trends are the same. These graphs provide easier visualization for understanding the progress of deterioration and reinforces the observations made in earlier sections. Coatings 1 and 2 deteriorate rapidly under accelerated corrosion. Average creep growth at 14 cycles for these coatings were 1.6 mm. At 100 cycles of exposure, the corrosion creep increased to 6mm. Note that these coatings were judged to be weakest among the approved coatings of NJDOT. These numbers were 0.7 at 14 cycles and less than 4mm at 100 cycles for Coatings 4 and 5, that provided the best performance. The results of the current study concur with the generally accepted perception that zinc-based primers provide the best protection against corrosion. The results also correlate well with a 20-year field-performance study carried out by New Jersey Department of Transportation.

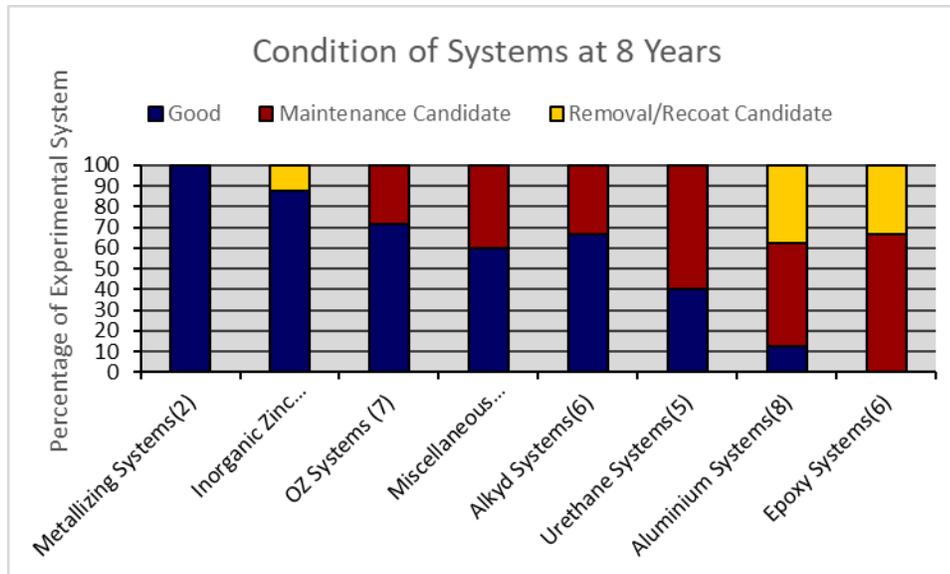
Figure 29. Condition of Systems at 8 Years from Mathis Bridge Study

The comparative performance of the 8 groups of coatings after 8 and 20 years of exposure are presented in Figures 29 and 30. In these figures the percentage of coatings within a chosen category that performed extremely well (Excellent, rating 7 or higher), reasonably well (Good, rating 4 to 7) and poorly (Poor, rating 4 to 0) are shown in the Y axis. For example, there were 8 coatings in Inorganic Zinc group. After 8 years of exposure, 7 out of 8 or about 90% provided excellent performance and after 20 years of exposure the percentage of coatings that provided excellent performance dropped to 25%. But even after 20 years of exposure only one coating system failed.

A careful review of the results presented in Table 11 and Figures 29 and 30 and the information obtained after only 1 year, lead to the following observations:

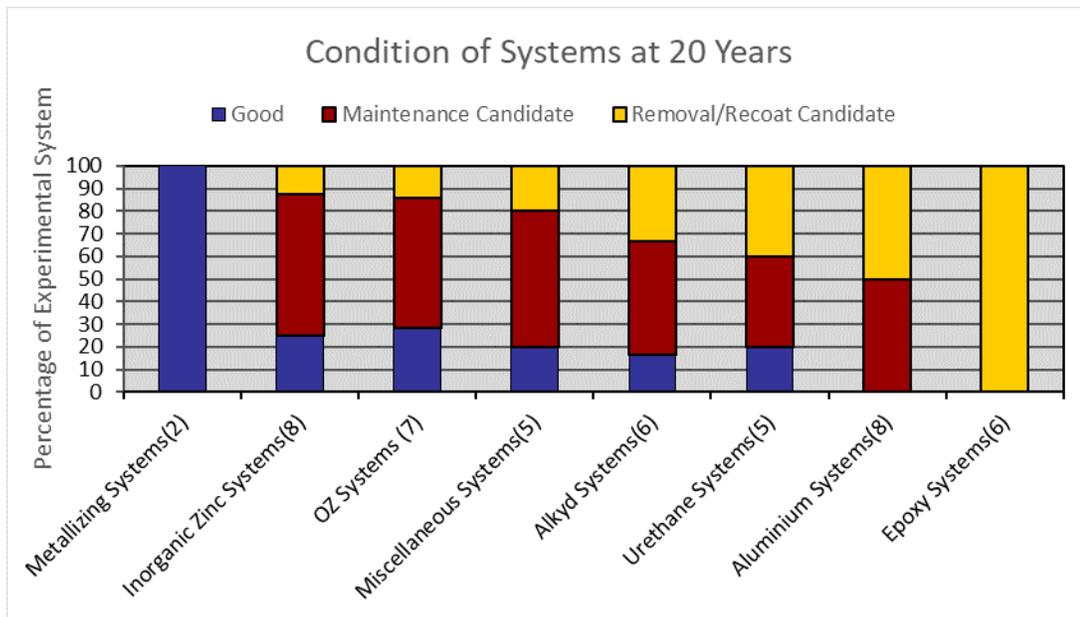
Figure 30. Condition of Systems at 20 Years from Mathis Bridge Study

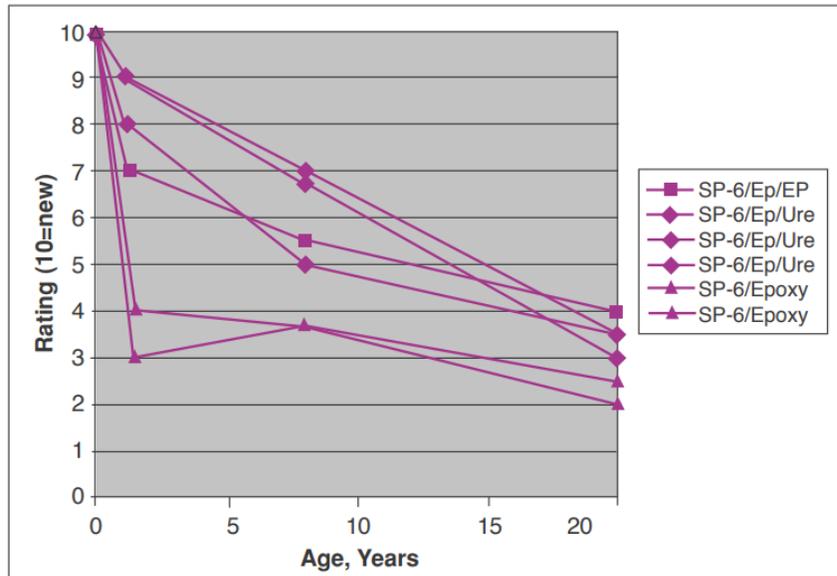
Figure 31. 20-Year Performance of Epoxy Systems from Mathis Bridge Study ⁽³⁴⁾

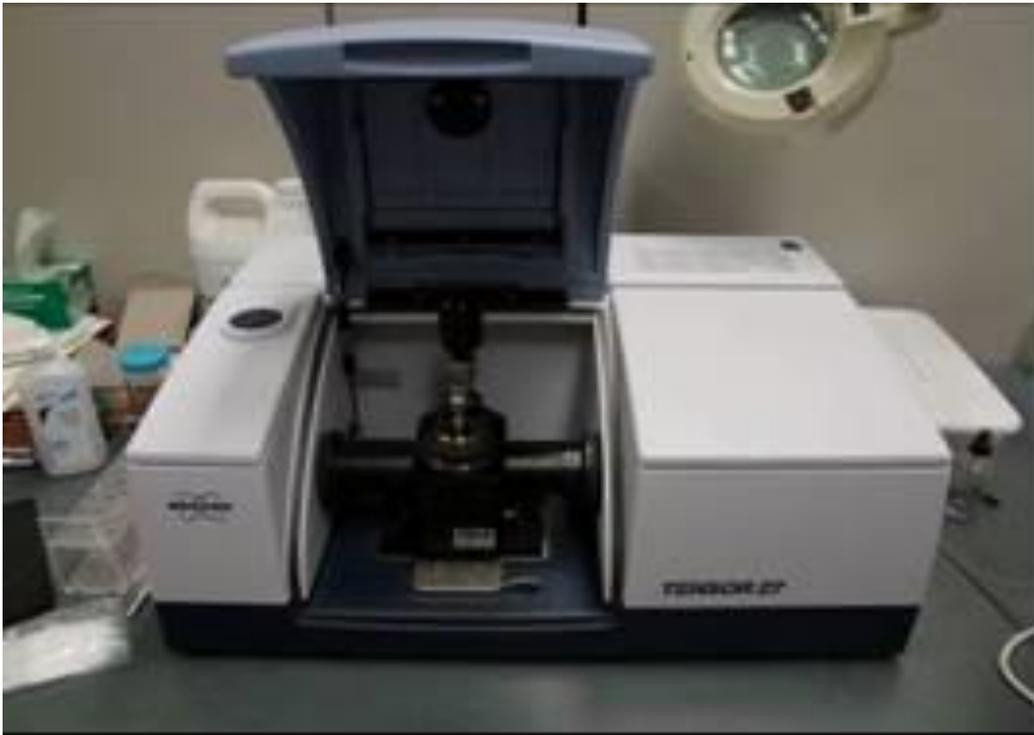
Figure 32. The Perkin-Elmer Infrared Spectrometer.

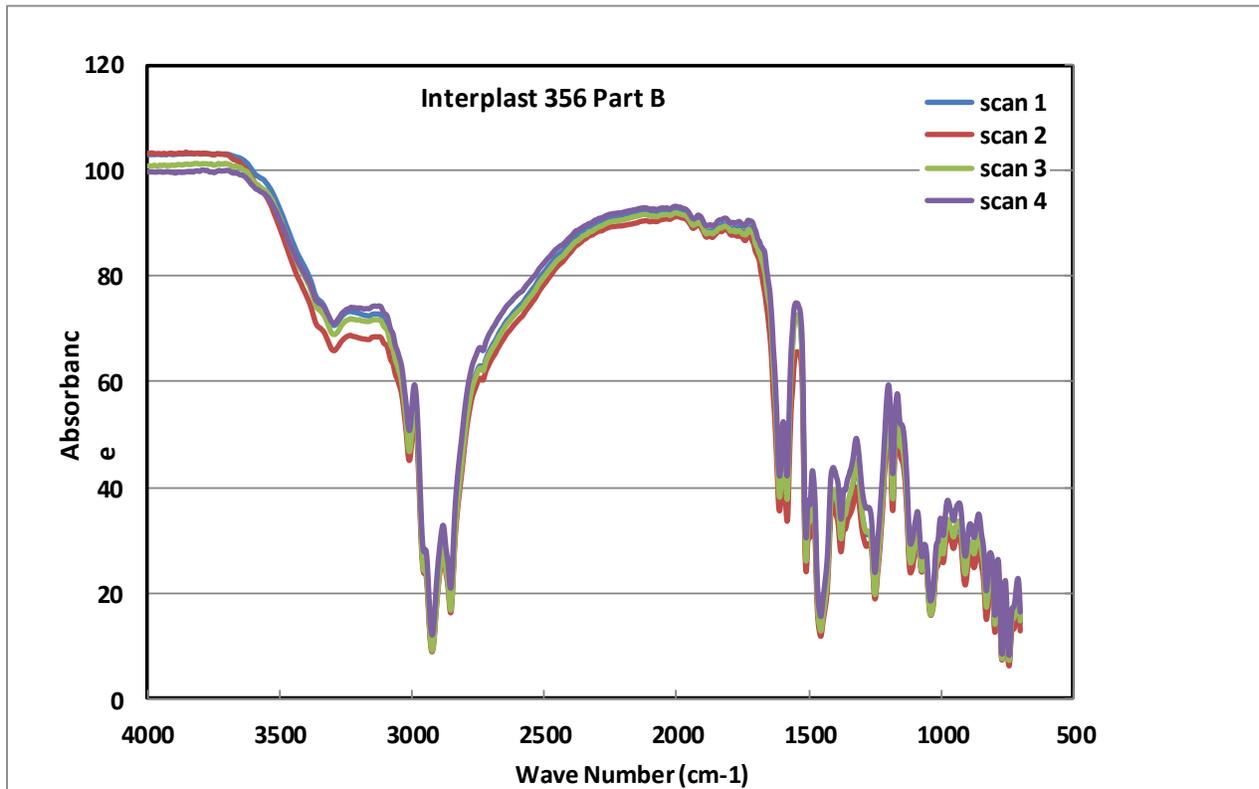
Figure 33. Plot of four (4) IR scans of Interplast 356 Part B from two batches

The IR scan of structural steels was relatively simple. The procedure included several simple steps as explained earlier that resulted in two scans from each batch. Two IR scans from each batch of steel paints were performed (scan 1 and scan 2). This resulted in a total of four scans from the two batches. For each scan the absorption versus the wave number was recorded and tabulated in an Excel spreadsheet. Typical IR scans for steel paints for INTERPLAST 356 PART B are shown in Figure 33. The figure shows consistent peaks and valleys of the IR scan from all three batches. Similar IR scans were observed for structural steel paints.
