## High Mast Drone Inspection

FINAL REPORT

1. Report No. NJ-2018-003	2. Government Accession No.	3. Recipient's Catalog No.	
4. Title and Subtitle High Mast Drone Inspection		5. Report Date October 2018

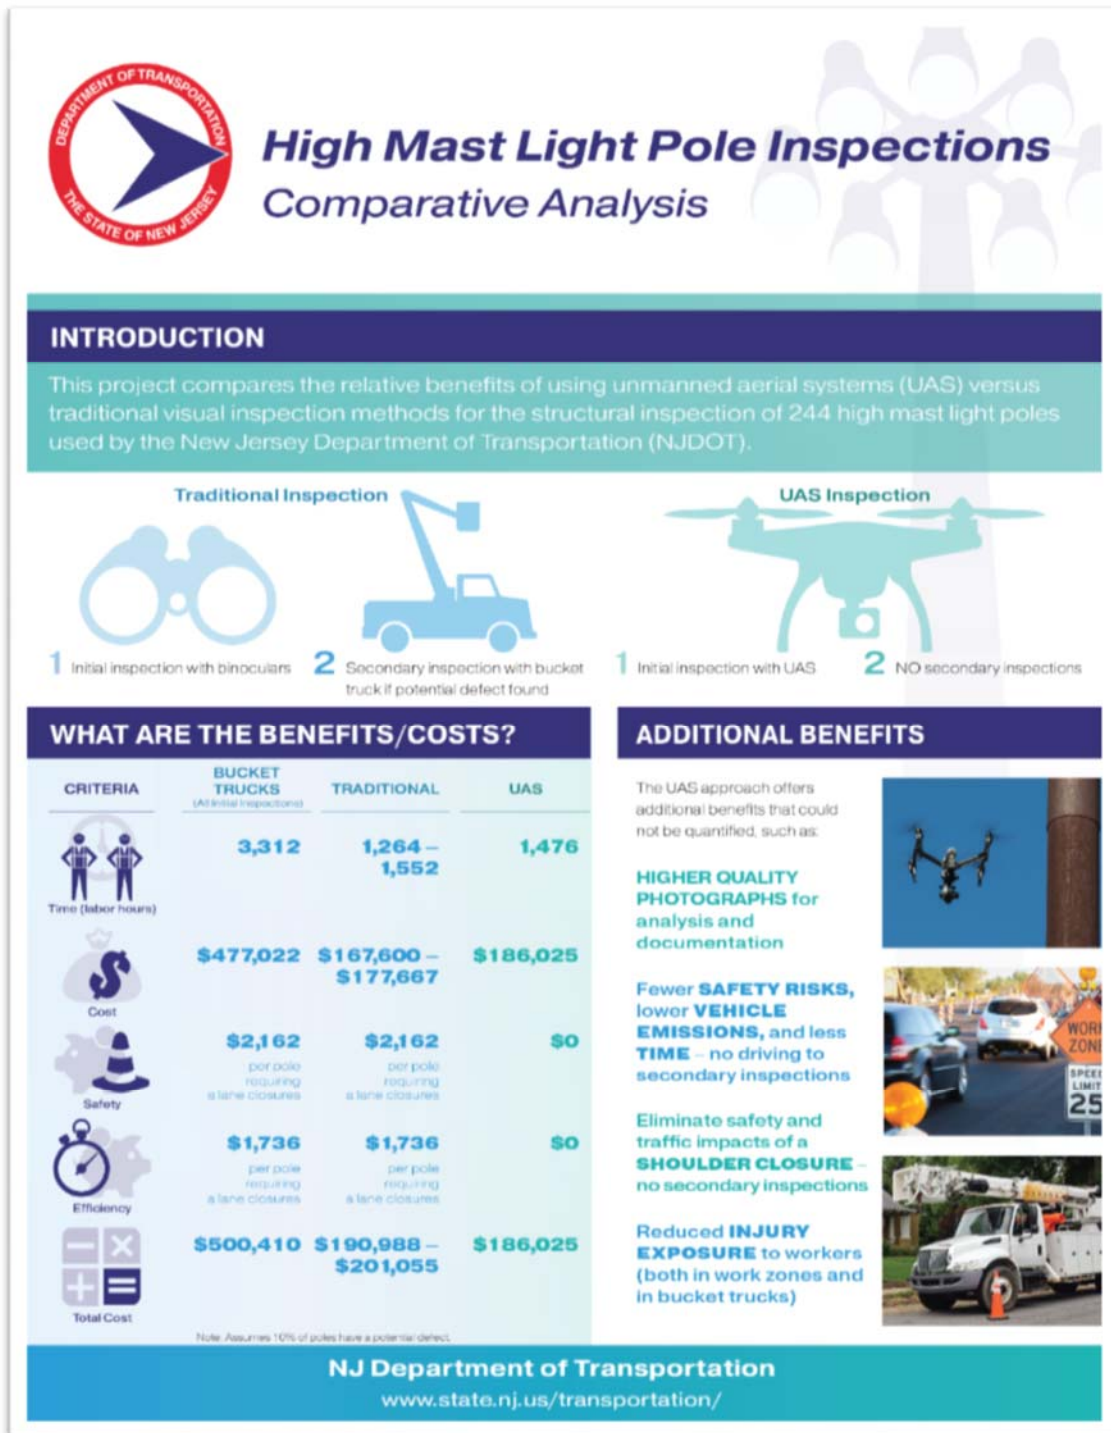
Figure 1. High Mast Light Pole Inspection Overview

The traditional inspection approach requires an initial inspection of all high mast light poles in the state by two engineers with binoculars. If any potential defects are noted, a second inspection using a bucket truck is required. Depending on the location of the pole, the secondary inspection may require a shoulder or lane closure and disturbance of a guiderail with associated impacts on highway safety and efficiency, personnel time and cost. The UAS inspection approach has a higher time requirement and cost during the initial inspection phase but eliminates the need for a secondary inspection and any associated traffic or safety impacts, leading to an overall cost savings. Finally, these approaches are briefly compared to a prior bucket truck approach which required a bucket truck for every high mast light pole initial inspection in the state. These benefits and costs are summarized in Table 1.

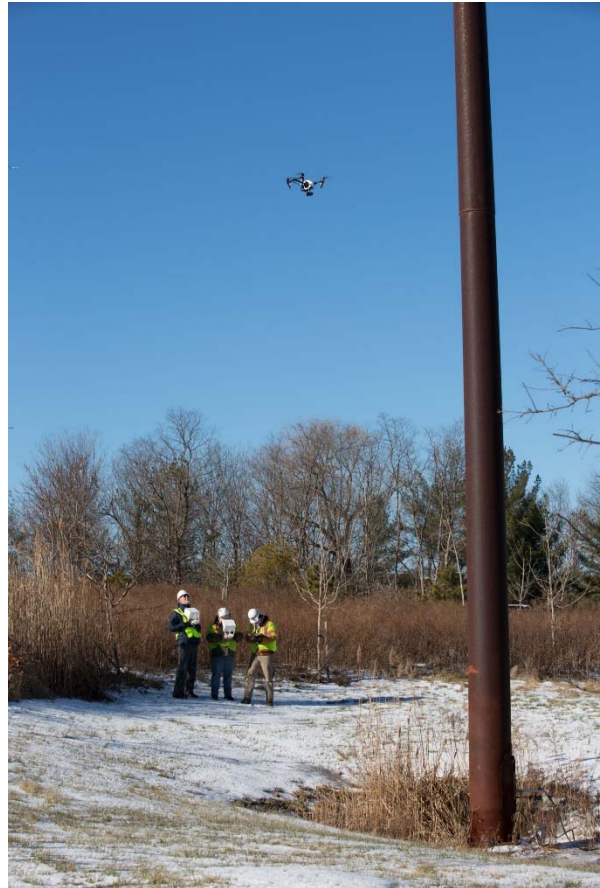
Figure 4. High Mast Light Pole Inspection Team

Using the traditional approach, the initial inspection of each high mast light pole is conducted by a pair of engineers, typically contractors working for NJDOT. The inspection of the high mast light pole covers a number of elements including:

- Concrete base;
- Anchor bolts;
- Lighting elements; and
- Light pole.

The inspection of the light pole itself takes approximately 15-20 minutes and is conducted from the ground with binoculars and photographs of the pole are taken from the ground using a hand-held camera. The entire inspection, including all pole elements, takes approximately two hours to complete.

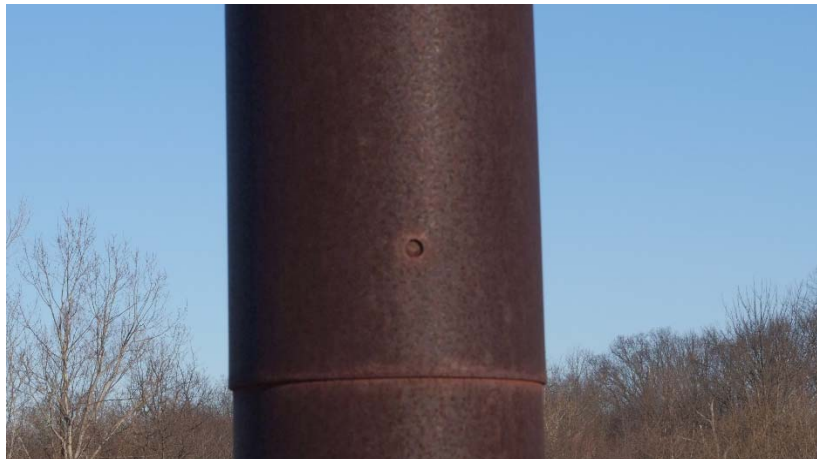
Figure 5. UAS Photograph of Potential Defect  
Source: NJDOT Aeronautics, 2016.

The UAS uses a high definition video camera during the inspection process to identify in real-time potential defects on the high mast light pole. The flight path of the UAS is consistent from pole-to-pole, reducing the variability between inspections. The UAS pilot and engineer on the ground monitor the feed and can take 20 megapixel (mp) photographs of any potential defects from close range (approximately 10 feet) during the initial inspection.<sup>11</sup> Figure 5 shows a picture taken via UAS of a potential defect. The traditional approach relies on engineers on the ground using binoculars or taking photographs from a camera with zoom during the initial inspection, or engineers in a bucket truck with a single vantage point to the pole using a hand-held camera during the secondary inspection. During both phases, the image quality is lower than available using UAS due to the need to utilize a zoom feature. While sufficient to meet inspection requirements, the higher quality data available from UAS is preferred and offers a better record to compare against future inspections.

The still images captured by the UAS also provides more redundancy during inspections as multiple people can examine the photographs in the office after the inspection. This helps control for differences in experience, eye strength, and other

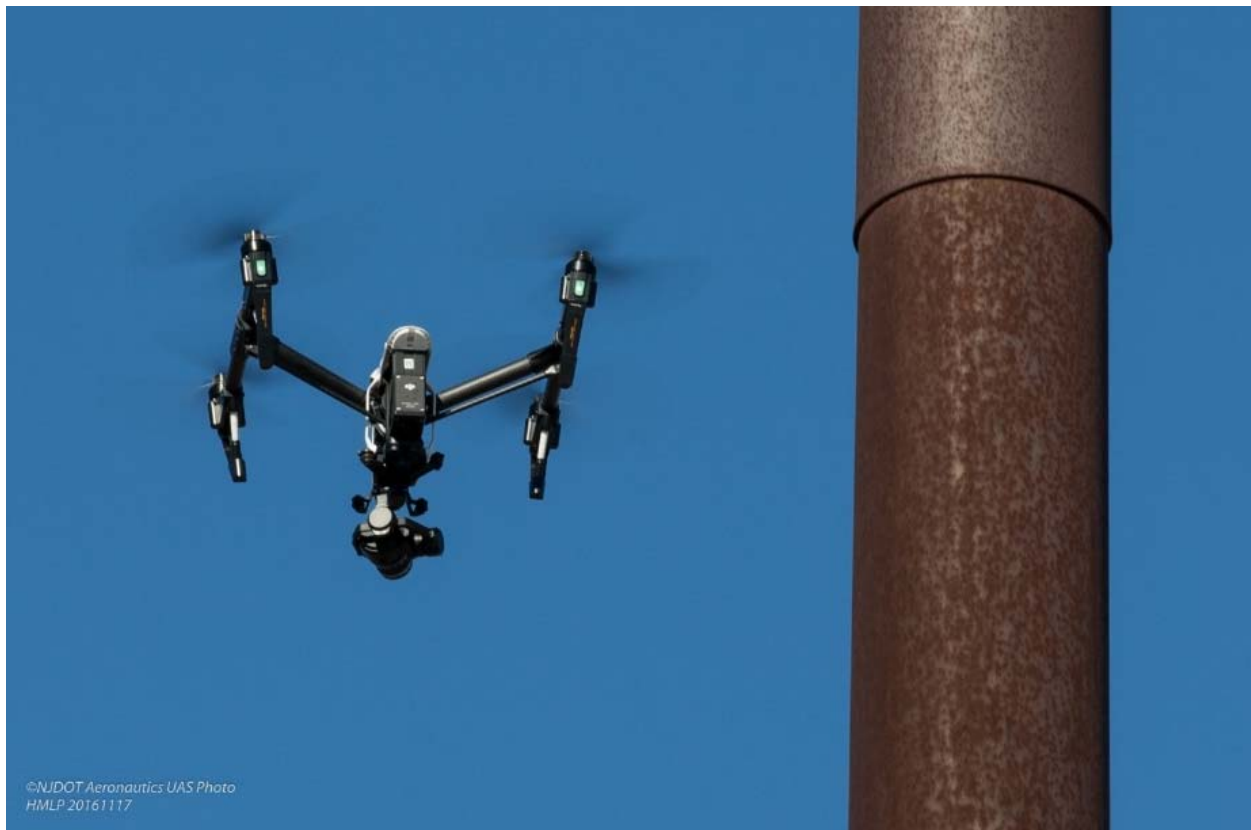
Figure 6. UAS Inspecting a High Mast Light Pole  
Source: NJDOT Aeronautics, 2016.

The UAS is deployed from a flat base set near the high mast light pole. Using a video camera to provide constant feedback to the team on the ground, the UAS makes a pass up the pole, rotates 135 degrees and comes down, rotates 135 degrees and goes up, then has a final pass back down to examine any issues if needed. Still photographs are taken of any potential defects. These photographs can be examined on-site by the team or examined back in the office in order to determine if maintenance work is required.
