# **Innovative Pothole Repair Materials and Techniques Volume II: Concrete Structures**

## **Final Report**

January 2024

New Jersey  
Department of Transportation  
Bureau of Research  
And  
U. S. Department of Transportation  
Federal Highway Administration

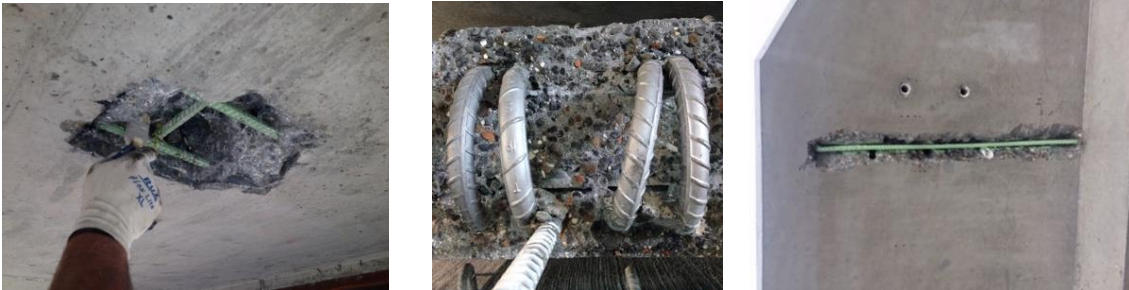
Figure 2. Overhead repair (left), vertical repair (middle), horizontal repair (right)

Typical cases for overhead, vertical, and narrow horizontal repairs are shown in Figure 2. New repair materials for overhead and vertical applications should have low flowability (stiff) so that they can be applied without the need of formwork in the field. On the other hand, for horizontal repairs (similar to the one shown on the right in Figure 2), to fill a very small size void in concrete, the material composition with very high flowability and low viscosity is needed so that the void can be fully filled. The ideal workability can be especially meaningful at the construction level.

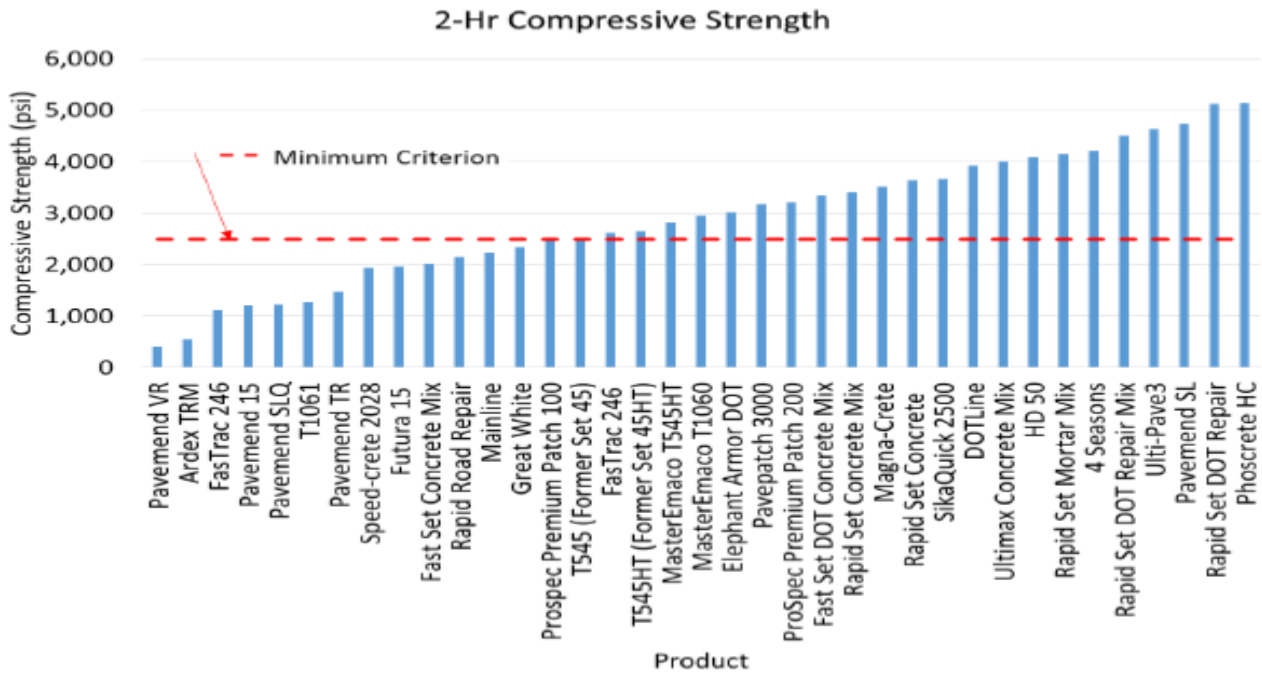
Figure 4. Summary of 2-Hr compressive strength of various products <sup>(10)</sup>

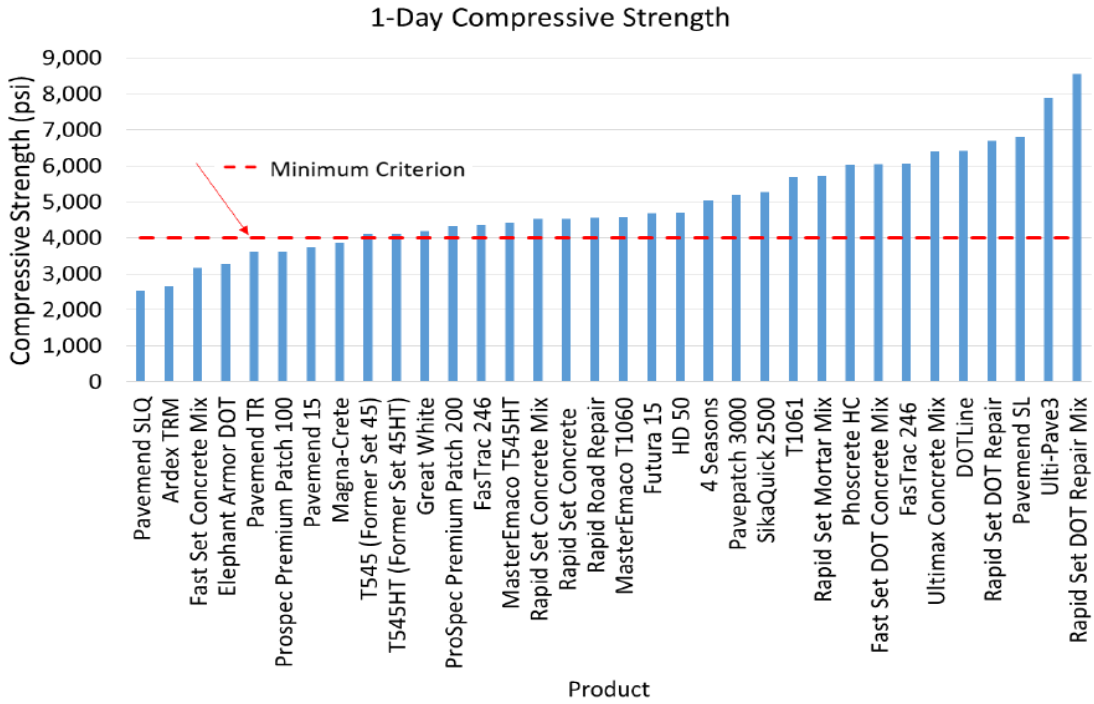
Figure 6. Summary of 1-day compressive strength of various products <sup>(10)</sup>

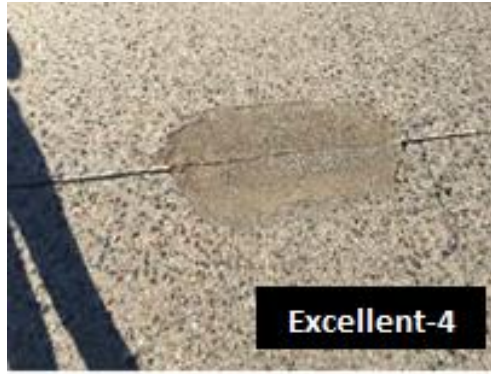
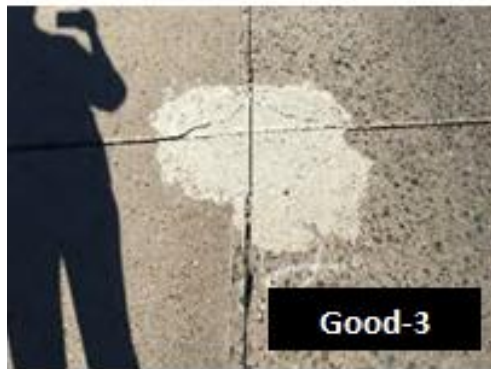
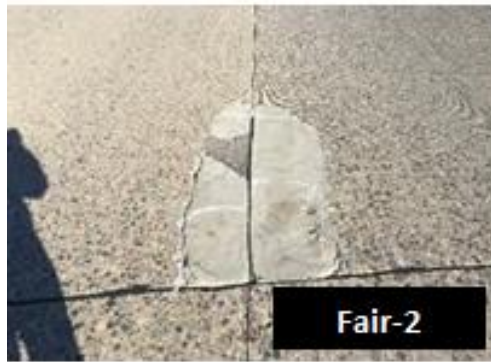
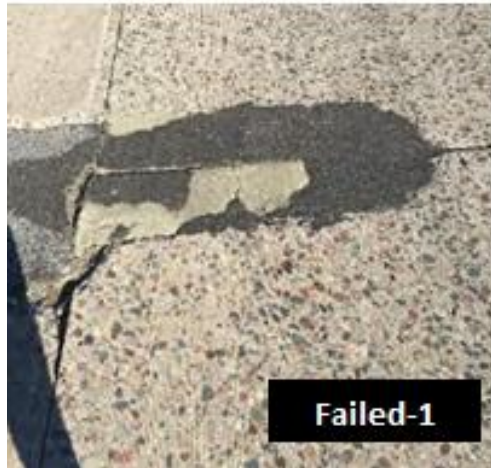
Figure 7. Photos showing condition ratings (adapted from <sup>(7)</sup>)

Rating	Patch Condition Description
4	Excellent; 100% of patch is intact, only shrinkage cracks present
3	Good; distresses (cracking and debonding) exist, but 100% original patch is in place
2	Fair; less than 50% of the original patch is gone/ been replaced
1	Poor; over 50%of the original patch is gone/been replaced
0	Failed; Original Patch no longer exists

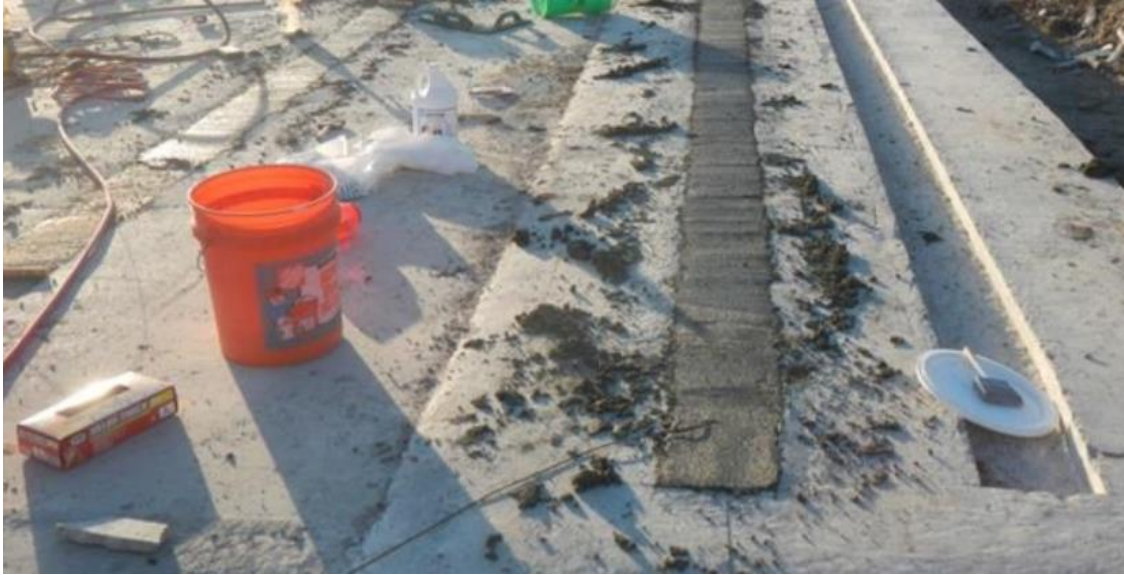
Figure 8. Field test slab with long rectangular defects being repaired similar to partial depth <sup>(13)</sup>

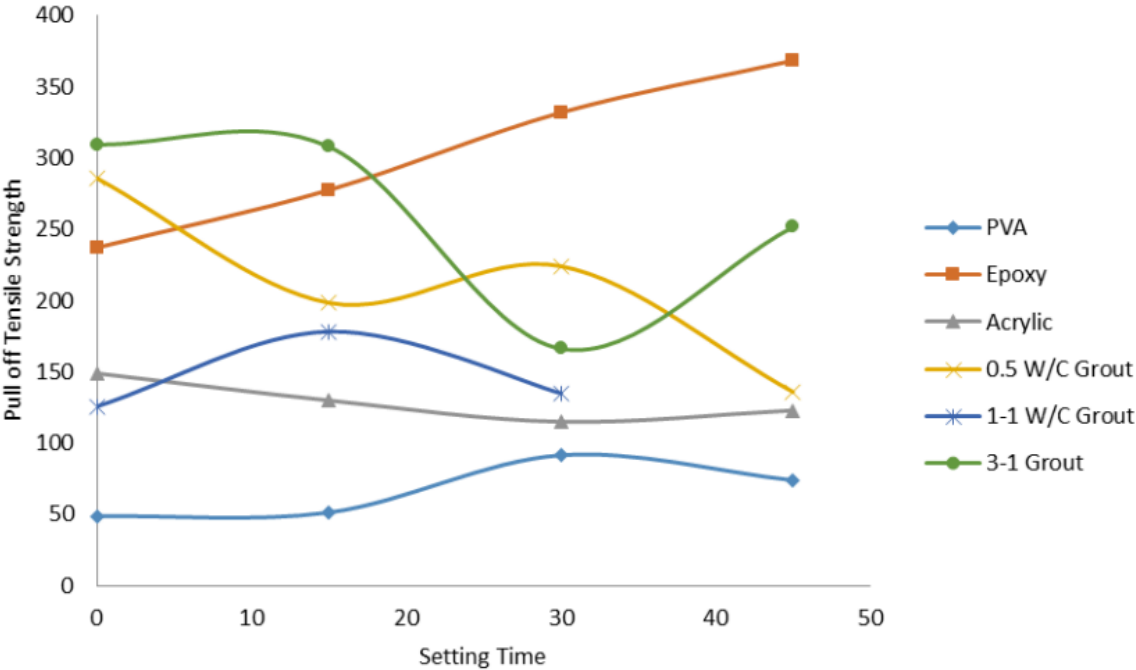
Figure 9. Pull-off tensile strength of repair material for various bonding agents for different setting times after 5 months <sup>(13)</sup>

For epoxy and acrylic latex, a waiting time less than their setting time did not have significant effect on bond. Polyvinyl acetate had higher bonding strength in the lab, but in the field bond loss was observed with time. Figure 9 shows the pull-off tensile strength of repair material for various bonding agents for different setting times after 5 months. <sup>(13)</sup> They reported based on laboratory and field studies, that a w/c ratio of 1.0 provided the best balance between workability, bond strength and wait time between grouting and application of the repair material. And they concluded in their report that results showed adequate bond strength for many repairs can be achieved by just applying the repair material directly to the concrete substrate on saturated surface dry condition free of debris, dust, oils, or other surface contaminants. <sup>(13)</sup>

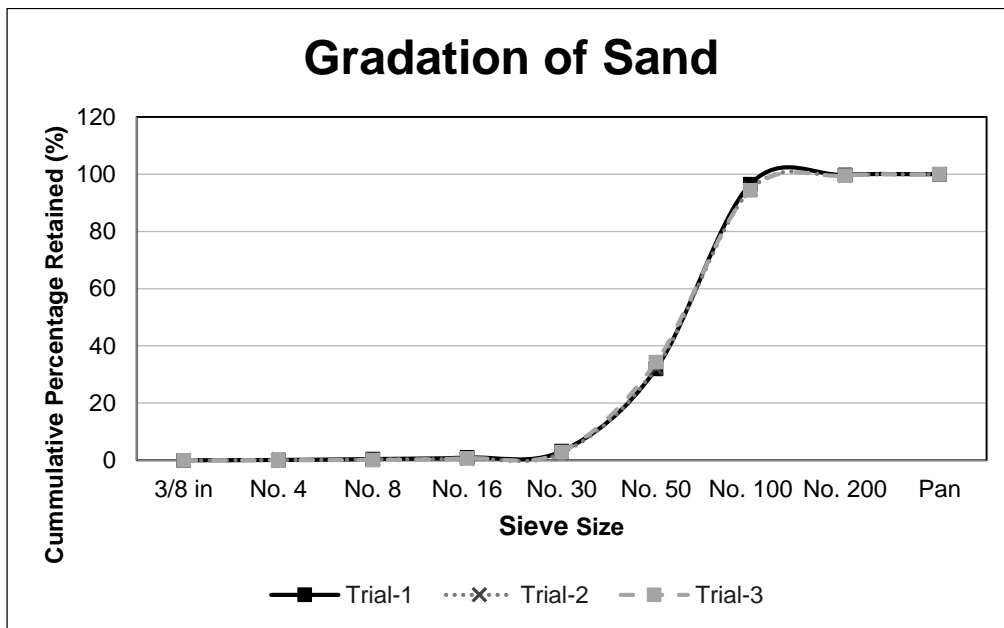
Figure 11. Gradation of sand used in the repair mix formulations

Sand was added in the mix formulations to increase the yield of the mix and to reduce the shrinkage. All the formulations contained oven dried sand to avoid interference of the sand moisture with w/c ratio of the formulations. Figure 11 shows the gradation of the sand utilized in the experiments. It should be noted that commercially available processed sand having majority of particles between the sieve sizes of No. 30 and No. 100 was chosen to avoid compromising the workability with the presence of finer particles. The dosage of sand used in the repair formulations was 15 percent by weight of cement-water paste.

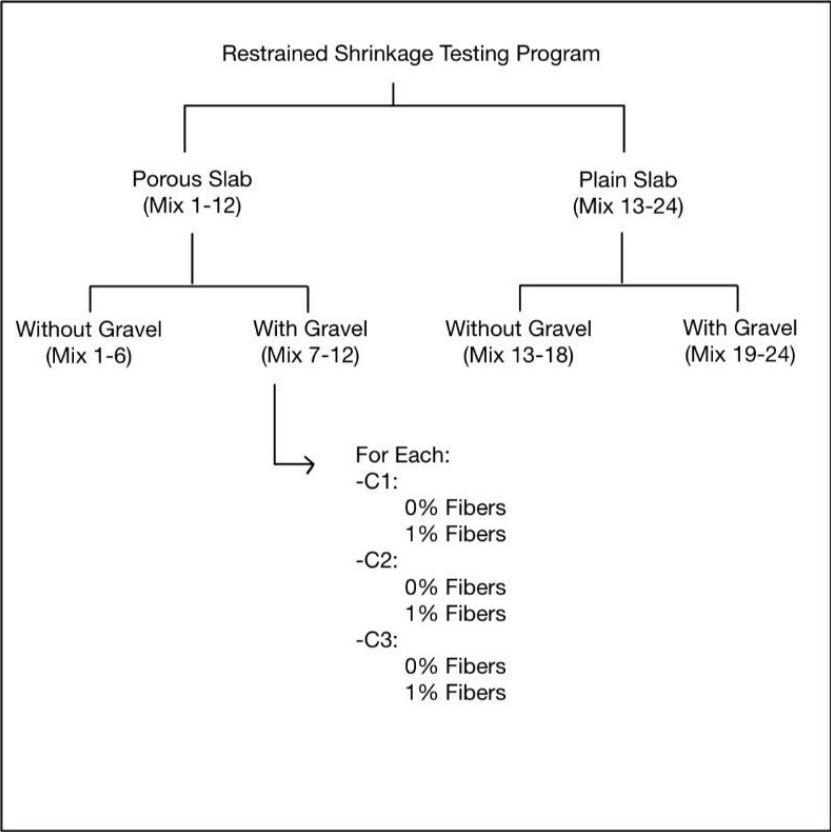
Figure 13. Restrained shrinkage testing program

The RS samples were first cast over the porous concrete slab surface using mix formulation no. 1-12. The same mix formulations were then replicated on the plain mortar slabs to compare the development of cracks over each slab surface. Hence, formulation no. 1 to 12 were used to cast RS samples over porous concrete slab surfaces. Whereas the formulations 13 to 24 were repetitions on plain mortar slab surfaces. The strength samples cast from mix formulations 1-12 were tested at 24 hours whereas the ones cast from mix formulation no. 13-24 were tested at 3 hours. Figure 13 shows an overview of the restrained shrinkage testing program.

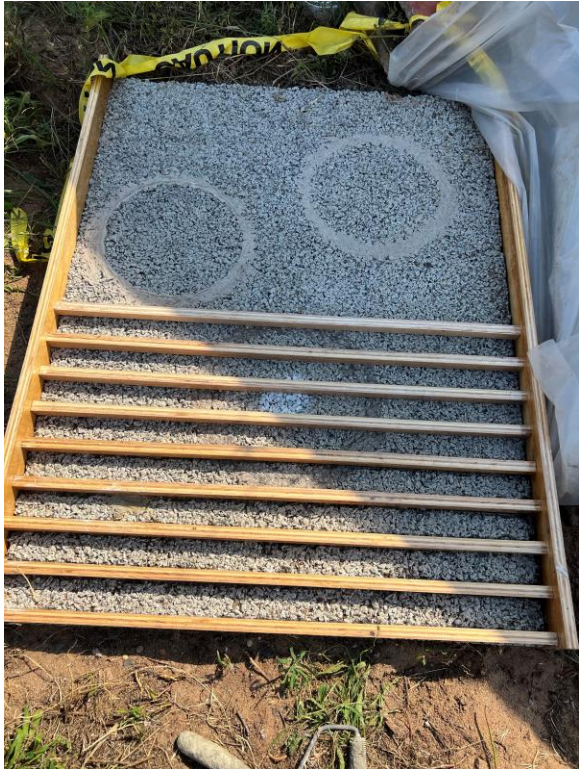
Figure 15. Formwork for porous slab

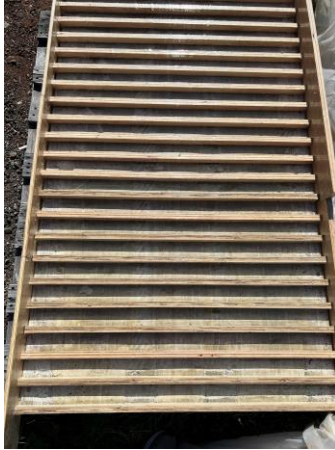
Figure 16. Formwork for Plain Slab

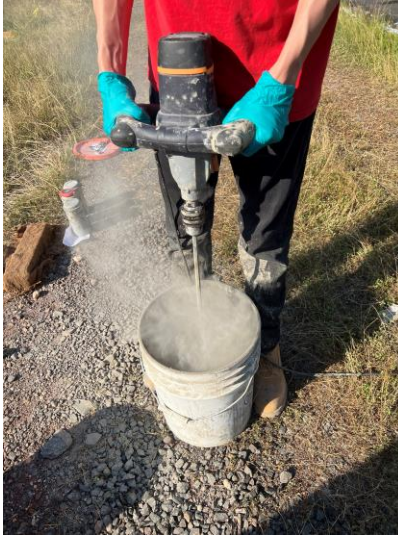
Figure 17. Dry mixing

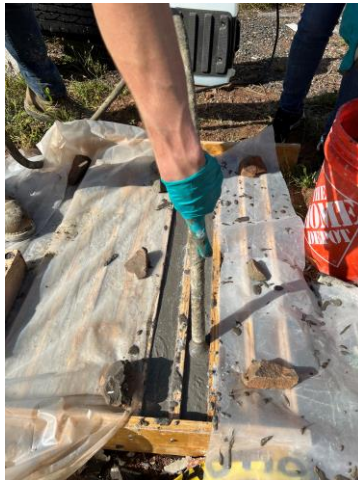
Figure 18. Vibrating the layers of concrete

The beam and cylinder samples for strength testing were also cast in similar fashion as RS samples, except that for cylinders, the sides were tapped according to ASTM C192 to close the voids after vibration. <sup>(32)</sup> Figure 17 and Figure 18 shows the dry mixing and vibration process being carried out for a typical mix.

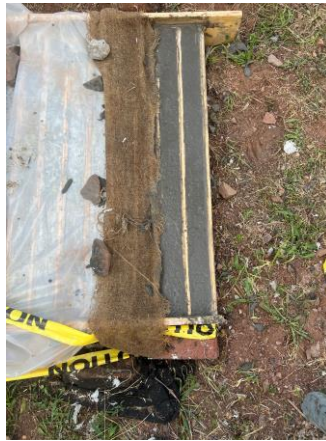
Figure 19. RS samples curing with burlap

The samples were covered with saturated wet burlap approximately 30 minutes after casting when they were visibly losing plasticity. More water was sprinkled over the wet burlaps after the samples were covered. The burlap was sprinkled with water again after 15-20 minutes of placing wet burlap over the samples. However, it was not sprinkled further and repeatedly for the next 24 hours to simulate the real conditions. It should be noted that the burlap stayed wet naturally for 2-3 hours, after which repair can be expected to open to traffic in a real application. Figure 19 and Figure 20 shows the curing of typical samples using burlaps. The burlap was covered with a plastic sheet to prevent evaporation of water.

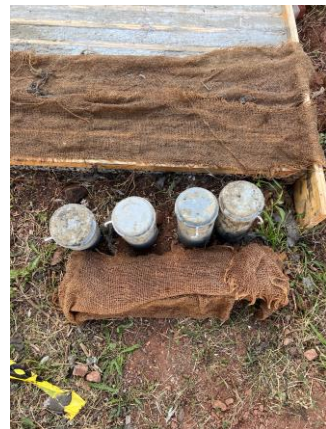
Figure 20. RS flexural and compressive samples curing with burlap

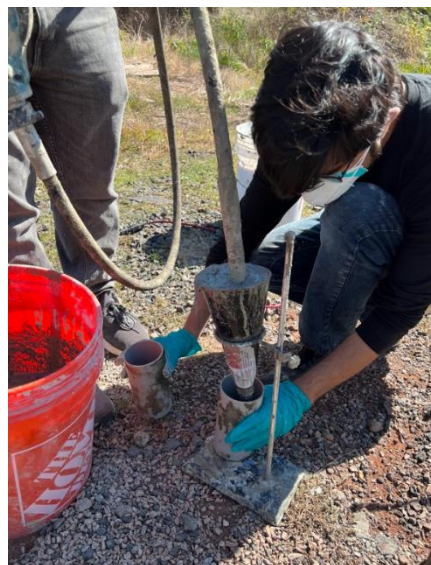
Figure 21. Inverted slump test

stand about 1 to 1.5-ft above the ground. The height of the cone above the ground is not a concern since the time was measured only to empty the cone and not to measure the time it took the mix to fall on ground, see Figure 21. Next, one of the two operators would lock the bottom 1-inch opening of the cone and the second operator would pour the mix from the top 4.5-inch opening to fill up the cone completely. Once filled up, a battery-driven needle vibrator would be inserted from top, and the first operator would let the bottom open at the same time. The time would be measured from the start of vibration (or opening of the bottom hole) until the entire cone gets empty. If the mix is having a thick consistency, it will take more time to empty the cone and vice versa. However, in some cases, the mix would be very thick, and a small chunk of the repair material would get stuck at the bottom. In such cases, comments were made during the slump test. While the needle vibrator was moved vertically during the slump test, it was not used to force any such chunk stuck at the bottom opening. Slump test was not performed for samples with gravel due to the aggregate getting stuck in the cone when slump test would not be valid for a highly fluid mix since in such a case, cone would empty within a few seconds. Being emptied.

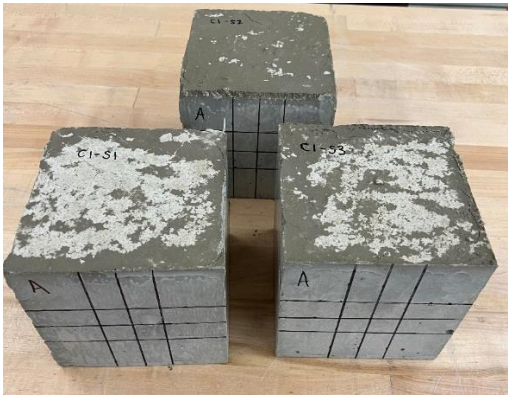
Figure 25. CSA cement cube samples for 3- hour testing

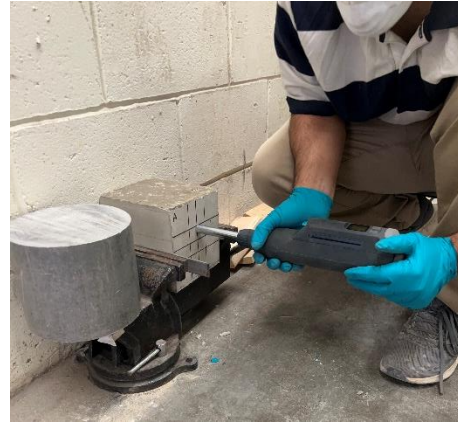
(a)

The test set ups were designed differently for hitting the sides of the cube verses hitting the top of the cube. Figure 26 shows the test set up for hammer testing in horizontal orientation. For hitting the sides, the hammer orientation was horizontal to the ground as seen in Figure 26 (b). Simulating the behavior of testing a large slab, the sample was clamped on the sides not being tested and braced against a concrete wall. This was repeated for both sides A and B.

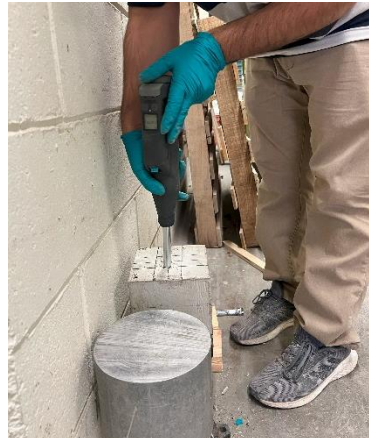
(a)

Figure 27 shows the test set up for orienting the hammer 90 degrees downward to the ground to test the top surface of the cube. Testing the cube samples from top required them to be clamped on the sides to provide a restraint on side. Since the hammer would hit the cube vertically downward the cube was rested on thick pieces of wood so that the readings would not be affected by vibrations at bottom of the steel clamp.

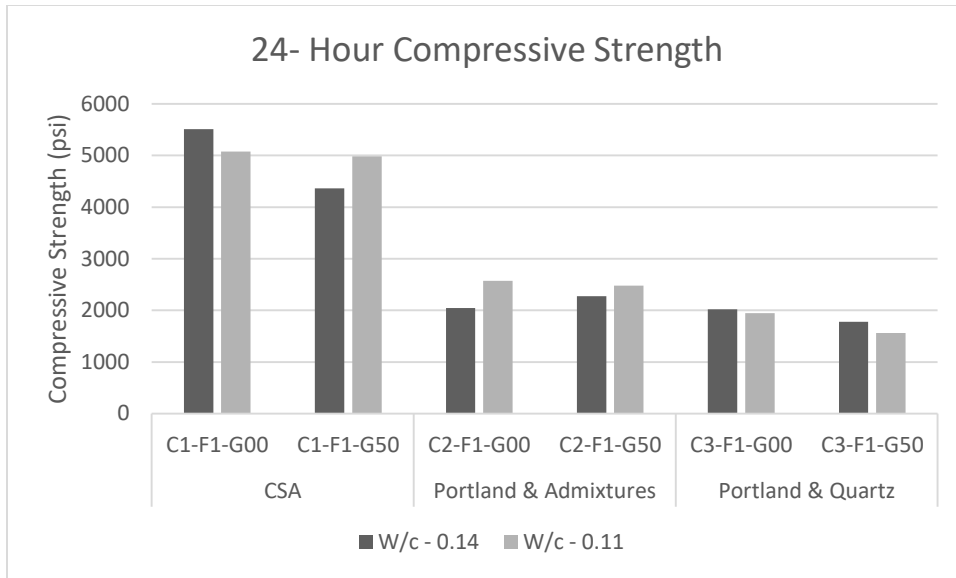
Figure 28. 24-Hr compressive strength comparison for w/c ratio of 0.11 and 0.14

A comparison is shown for improvement in compressive strength due to reduction in w/c ratio from 0.14 to 0.11 (see Figure 28). Minor variabilities were observed between lab samples and field samples. The CSA-cement (C1) based samples showed the highest compressive strength after 3 hours and 24 hours compared to C2 and C3. At 24 hours, the CSA cement (C1) and Portland cement with admixtures (C2) showed strengths above 2000 psi while Portland cement with quartz (C3) showed compressive strengths lower than 2000 psi (approximately 15% lower on the average). Since C3 is mostly used for overhead repairs, compressive strengths lower 2000 psi can still provide sufficient early strength for these applications.

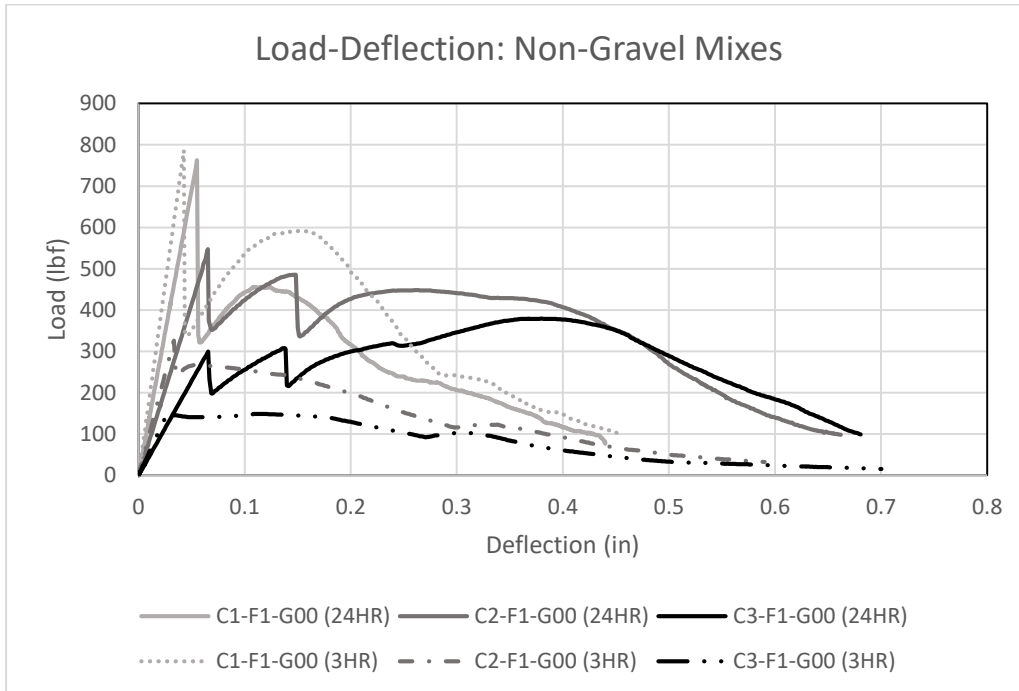
Figure 31. Load deflection curves for mixes without gravel

load rebound or load retention post cracking. However, gravel mixes are expected to perform better in terms of shrinkage cracking since the pea gravel is expected to restrain the cement paste from shrinking. Additionally, some researchers also reported that pea gravel provides internal curing effect due to hidden moisture in its pores. This can reduce shrinkage cracking and is investigated in restrained shrinkage experimentation in this research.

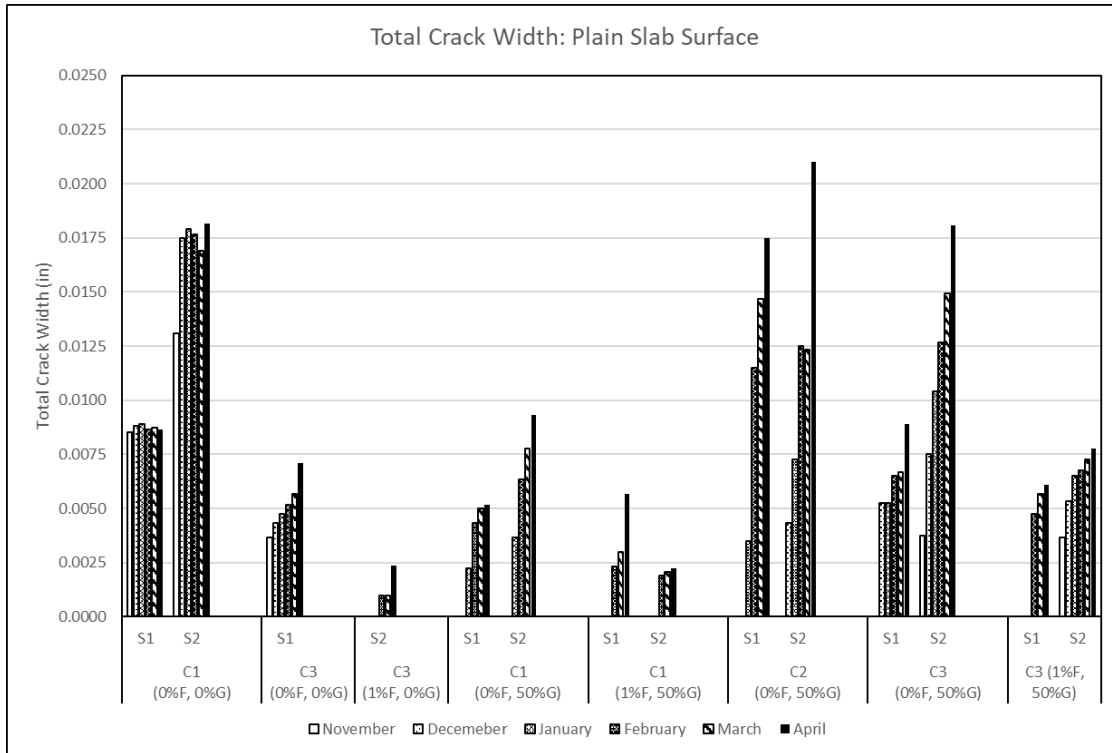
Figure 34. Growth of total crack width over plain slab surface

The total crack widths of the samples over plain slab surface are shown in Figure 34. The widths of the two samples from C1 base matrix showed significant inconsistencies, 0.00875 in vs 0.0175 in. The C2 cement base matrix samples did not show cracking over plain slab surface unlike the samples for the same formulation over the porous slab. The C3 cement without gravel showed a reduction of 66 percent in total crack width at 6 months in the 1 percent fiber formulation (C3-F1-G00) when compared to the base matrix (C3-F0-G00). The gravel counterpart of the C3 cement also showed a reduction in total crack width at 6 months from 0.0135 inch in C3-F0-G50 to 0.00695 inch in C3-F1-G50, a reduction of nearly 49 percent. Similarly, the average total crack width at 6 months for C1 cement with gravel reduced from 0.00725 inch in C1-F0-G50 to 0.004 inch in C1-F1-G50, a reduction of nearly 45 percent.

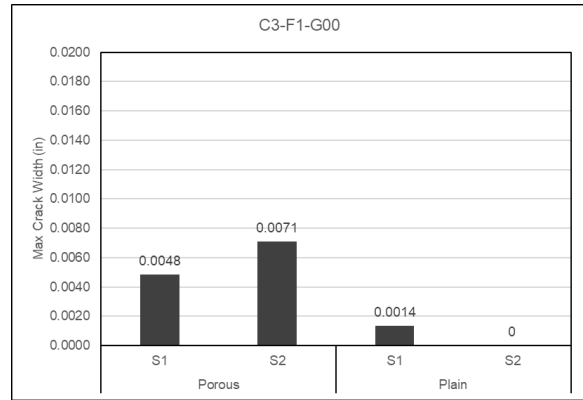
The average maximum crack width in C3 base matrix was over two times higher than both the C1 and C2 base matrices. The addition of 1 percent PVA fibers in C3 base matrix led to reduction of average maximum crack width by about 17 percent for porous slab samples while about 80 percent for plain slab samples. Similar behavior was observed upon adding 1 percent PVA fibers to C3-F0-G50 samples. The samples over plain slab showed a 46 percent reduction of maximum crack width from C3-F0-G50 to C3-F1-G50. Samples over porous slab were able to successfully resist the cracks for C3-F1-G50 compared to 0.0035-inch maximum crack width in C3-F0-G50. Moreover, the C3-F1-G00 formulation showed the widest crack width among all the three cement-formulations with fibers but no gravel. This crack width, 0.0071 inch is about 23 percent of allowable maximum crack width in NJDOT specifications.

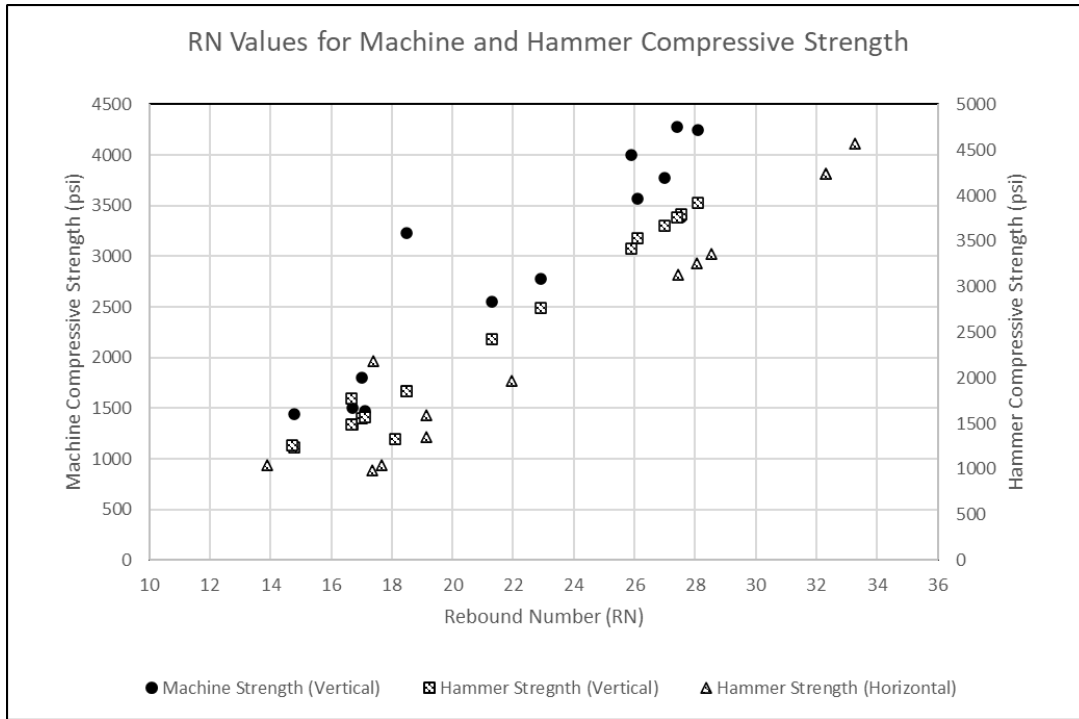
Figure 41. Compressive strength verses rebound number for all three rapid cements.
